Analysis of the failure mode of slopes with open sharp toe notches

Luis E. Vallejo

Mingzhou Li

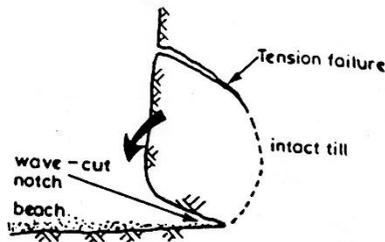
Figure 1. A wave induced notch in a till coastal slope located at Aldbrough on the coast of England (Hutchinson, 1986, 1988).

The slope shown in Figure 1 is located in the Holderness coast in the north east part of England. The height of the slope is about 3 meters, and its inclination is about 65 degrees. The slope is made of the Holderness till (Hutchinson, 1986, 1988). The slope in Fig. 2 is made of loess. Its height is about 10 meters and

The notches and the failure surfaces in the soil slope shown in Figure 1 was the result of wave action at their toes (Figure 4)(Vallejo and DeGroot, 1988). The action of the ocean water waves on this coastal slope consists primarily of

the erosion of previously intact soil occupying the slope foot and adjacent to the wave-cut platform. The erosion takes the form of wave impact and abrasion. The net result of the wave erosion is the formation of a notch at the foot of the coastal slope. The notches shown in Figure 1 act as stress concentrator and causes the tensile failure of the material surrounding the notch

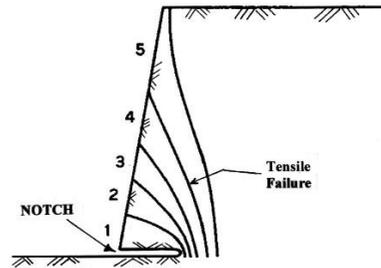
Figure 2. Progression of toe failures from an open notch in a soil slope located at Vicksburg, Mississippi (Lutton, 1969).

its face is inclined at 70 degrees with the horizontal (Lutton, 1969).

For the case of the loess slope shown in Figure 2, the notch was produced by the water induced slaking of the loess. After rain, water accumulates at the toe of the slope resulting on the slaking of the slopes' toe material (Vallejo, 2011). Like in the coastal slopes, the notch acts as stress concentrator that causes the tensile failure of the slope as shown in Figure 2.

For the case of the case of the slope shown in Figure 2, the notch was produced by the water induced slaking of the loess. After rain, water accumulates at the toe of the slope resulting on the slaking of the slopes' toe material (Vallejo, 2011). For the case of the soil slope shown in Figure 2, the first tensile failure surface was inclined at about $\alpha=160^\circ$ in a counter clockwise direction with respect to the horizontal [Fig. 6(b)]. The second failure surface was inclined at about 130° . The subsequent failure surfaces took place at smaller angles than the first two. The notch shown in Figure 2 acts as stress concentrator that causes the tensile failure of the slope. The soil slope in Figure 1 also failed when a tensile crack inclined at an angle $\alpha > 90^\circ$.

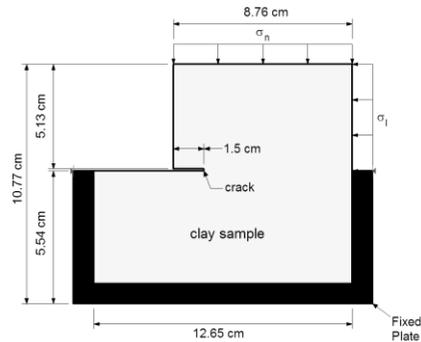
Figure 3. A clay slope with an open crack at its toe for testing in the PSDSA.

Fig. 3 represents a simulated vertical slope with an artificial horizontal open crack at the toe of slope. The clay slope simulated a slope with a vertical face. Figure 3 presents the dimensions of the clay slope model and Fig. 5 shows the actual laboratory sample with the original horizontal crack that measured 1.5 cm in length before [Fig. 5(a)] and after the test [Fig. 5(b)]. The applied normal stress (σ_n) simulates the gravity stress acting on the slope and the lateral stress (σ_l) simulates the lateral earth pressure (Fig. 3). Both of these stresses can be applied by the PSDSA. When the sample was ready to be tested in the PSDSA, the water content in the sample, w , was equal to 10%.

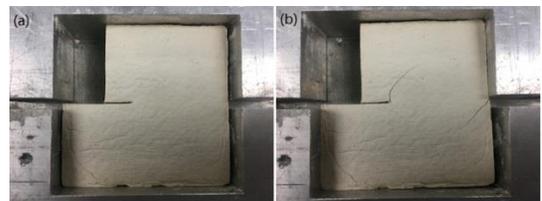
Figure 5. (a) The fissured clay sample before testing, and (b) after testing in the PSDSA.

shear stress, τ , on the solid horizontal section of the crack [Fig. 5(a)]. The lateral stress (σ_l) was gradually increased until the toe crack began to propagate, which occurred when the shear stress $\tau = 513$ kPa [Fig. 5(b)]. The toe crack propagated in the model in the form of a secondary crack that extend from the toe of the pre-existing crack and deviated from the original horizontal direction. Figure 5(b) shows the clay model after the test. The secondary tensile crack propagated at an average angle of 80° with the direction of the pre-existing horizontal crack.

For the case of the laboratory slope the angle of secondary crack α was equal to 80° . For a ratio between τ/σ equal to 6.3. For this ratio, the theoretical value of α given by Fig. 8 is about 80° .
