Small extent, high risk: a landslide at the Kiel Canal and its investigation using FEM

C. Wolff

M. Pohl

ABSTRACT: The Kiel Canal is the most frequented canal worldwide and links the North Sea to the Baltic Sea. In 2015 an unusual slope movement of a 30 m wide section moving towards the canal was detected leading to a limitation for the traffic. The slope built by both cutting and embankment, consists of glacial sediments showing a typical disordered layering. A ground investigation with boreholes and CPTs showed sand lenses embedded in till as well as high and in parts artesian groundwater levels. An extensive laboratory testing program was carried out, including triaxial and permeability tests. The detection of a zone with softened glacial till was of particular significance. This irregularity can be seen as a potential sliding plane. Long term monitoring of the slope revealed a correlation between the slope movements and the local precipitation. A FEM analysis based on the above mentioned findings was carried out applying the method of phi-c reduction for the safety analysis of the slope. The resulting failure mechanism is in good agreement with the one observed in reality. To

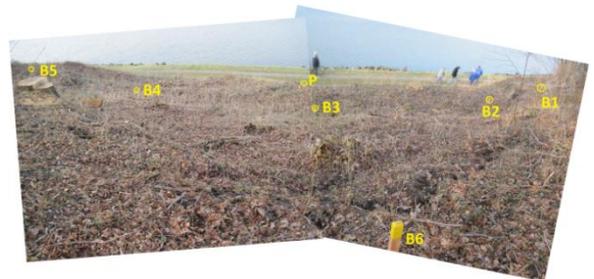
Figure 2. Measuring points in the slope

From February 2016, the displacement of measuring points within the slope (points P, B1 to B6) and along the maintenance road (points 1 to 11) are being monitored. The position of the slope points is depicted in Figure 2, the points along the road are shown in Figure 4.

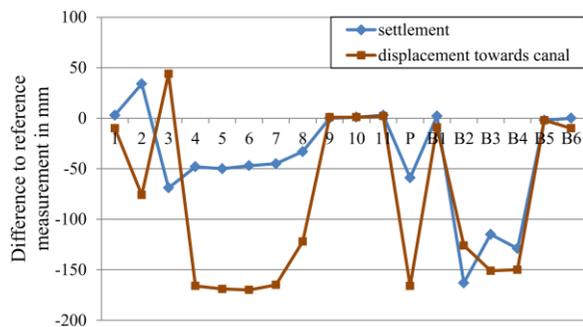
Figure 3. Movement of control points in the period from 02.2016 till 06.2017

As illustrated in Figure 3, over a 16 month period the slope moved about 16 cm both downwards and in the direction of the canal. The points showing no offset (1, 9, 10, 11, B5, B6) are located outside of the moving slope section.

At this point, two aspects must be taken into account: major displacement took place before the start of the regular geodetic surveying and the development of these displacements is not evenly distributed over time. An investigation of the seasonal development of the recorded displacements is presented in Chapter 3.4.

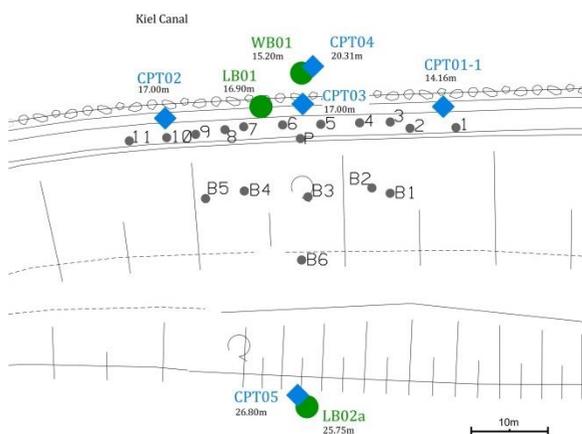
Figure 4. Exploration and control points

from a pontoon. 3 rotary core drillings (●) and 5 CPTs (◆) were sunk, the layout is illustrated in Figure 4. The CPTs and boreholes were arranged in pairs. The small numbers underneath the symbols indicate their total depth.

Underneath the maintenance road, softened till was found at a depth of 6.10 m to 8.10 m. Here, a low c_u -value of 19 kPa was derived using the pocket penetrometer, compared to c_u -values above and underneath this 2 m-zone of over 100 kPa. In the corresponding CPT 03 at a depth of 5.5 m as well as at 6.6 m unusual high tip resistance values are observed. These are indicators for stones, embedded in sand bands. So it is assumed that locally, the permeability is increased.

Due to the CPTs on the maintenance road next to the moving slope section more such permeable zones were detected. CPT01-1 shows a loose sand zone at a depth of 4 m, CPT02 in-

dicating a stone or a thin dense sand band at 5 m depth.

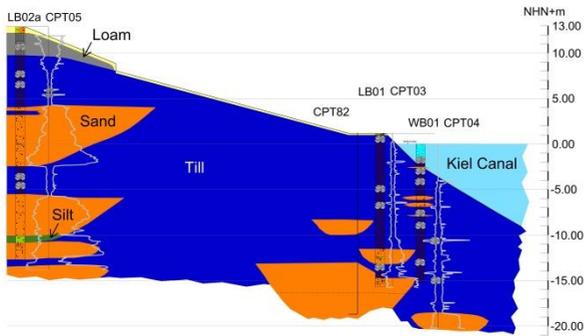
Figure 8. Soil model, cross section

In general, the CPTs showed results as expected: where till was encountered, the tip pressure shows a slight linear increase with depth, while the absolute values remain small. Tip pressures from 4 MPa up to 33 MPa indicate sand. In combination with the assessment of the boreholes, the CPTs led to the following soil model (Figure 8 and 9):

The exact position of the sand lenses is unknown, especially the lateral extent is estimated. It is likely, that further similar sand deposits existing within the slope have not been investigated.

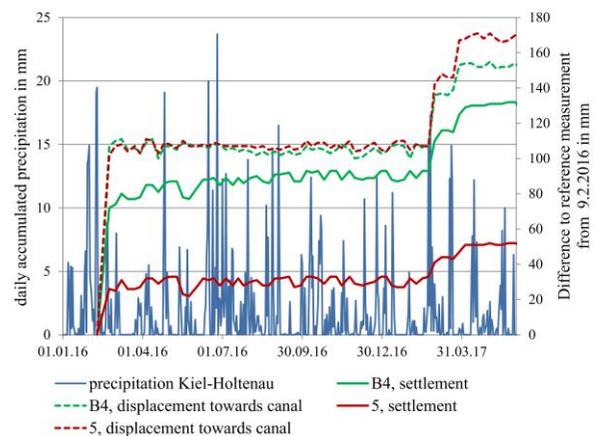
Figure 10. Correlation of displacements (points 5 and B4) with precipitation

On the basis of this consideration, it was investigated whether an influence of precipitation on the landslide can be detected. Figure 10 shows the daily precipitation measured at a weather station 8 km far away at Kiel-Holtenau. The data was provided by the German National Meteorological Service (DWD). The displacements and settlements of two control points, on the maintenance road (5) and in the slope (B4), are shown as well.

It can be seen, that the displacements remain nearly constant and rise significantly after two heavy precipitation events during winter. In the warmer seasons, the rain events with even more precipitation show no influence.

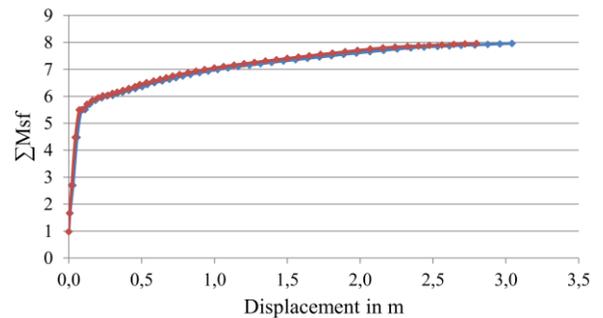
Figure 14. M_{sf} as a function of displacement

After 1000 steps, the failure pattern and the values of M_{sf} are evaluated at two points inside the sliding body. If M_{sf} becomes an approximately constant value, it can be presumed that a failure mechanism has fully developed. As shown in Figure 14, this is the case for $M_{sf} = 8$. The safety factor corresponds to a friction angle of 4.8° . The slope failure is illustrated in Figure 15. The absolute values of the displacements are not relevant.

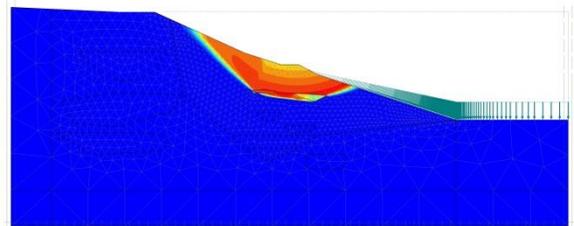
Figure 15. Slope failure

In the model, softening was only simulated for a limited area. In nature, the reduction of shear strength occurs everywhere in the till where coarse-grained material borders the cohesive soil. Since the investigations only provide punctual information about the subsoil, the layout of possible further softening zones is not known. But the subsoil excavation as well as the finite element analysis leads to a failure mechanism in good accordance with the one in reality.

It can be assumed that the embankment slips before the shear strength is reduced locally to $\varphi = 4.8^\circ$ as a result of further unexplored softening zones.

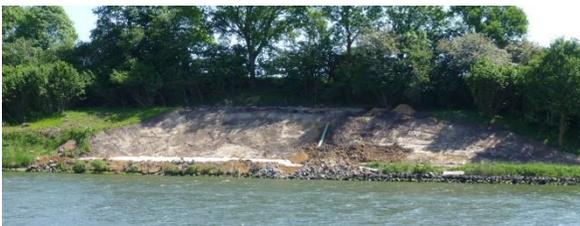
Figure 16. Slope with collecting pipe in the centre (WSA Kiel-Holtenau)

There are two basic options for the reconstruction: reducing the load on the slope or installing structural retaining elements. In view of the forthcoming expansion of the Kiel Canal, the first option was chosen. First of all, using only light equipment, a longitudinal drainage directly above the moving slope section was installed. Then, the upper soil was excavated from the side in stages down to one meter below the maintenance road. The material was replaced by gravelly sand. At the toe of the slope, alongside the road, a new drainage was installed and connected to the existing one. To reconstruct the road, the soil there was excavated, replaced by sand and a geogrid in combination with recycled concrete were used.

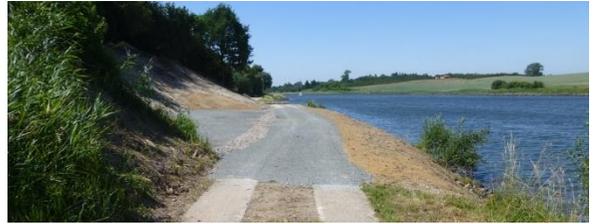
Figure 17. Refurbished maintenance road (WSA Kiel-Holtenau)
