The cause of the landslides of 1st and 2nd April 2016 in Tosbotn, Norway

Following the Tosbotn landslides of April 2016 the local government in Nordland County, Norway, appointed the authors of this paper as an investigation committee. The present paper gives an overview of the two landslides and concludes on the most likely failure mechanisms based on an integrated geological and geotechnical study.

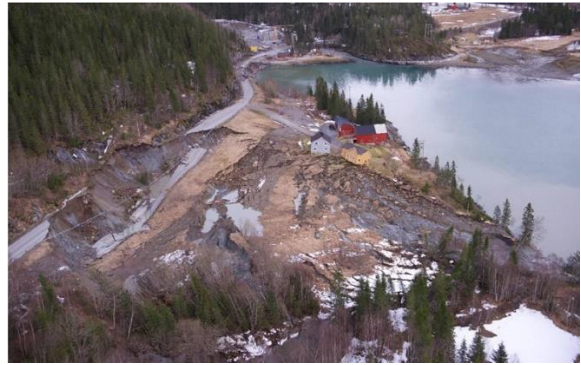
Tosbotn is situated in Nordland County, Norway, approximately 250 km north of Trondheim. The first landslide in Tosbotn took part of the coastal road “FV 76” in the early morning on April 1st 2016. The road is the only ferry free connection to the city of Brønnøysund. The following day, while geotechnical engineers and construction workers focused on reopening the road, a much larger landslide of about 130 000 m³ occurred, forcing the road to remain closed for 3 months. No lives were lost and no persons were injured by the landslides, but the road and three houses were destroyed. The two landslides were very close, but not in physical contact, Figure 1. As seen on the photo, the sliding surface for the landslides seems to be deep and rotational movement was involved.

Figure 1. Overview. The first slide, Bjørnstokkvika and the power plant in the back, the second slide Bekkevold, in the front. Foto: Jørn Horn.

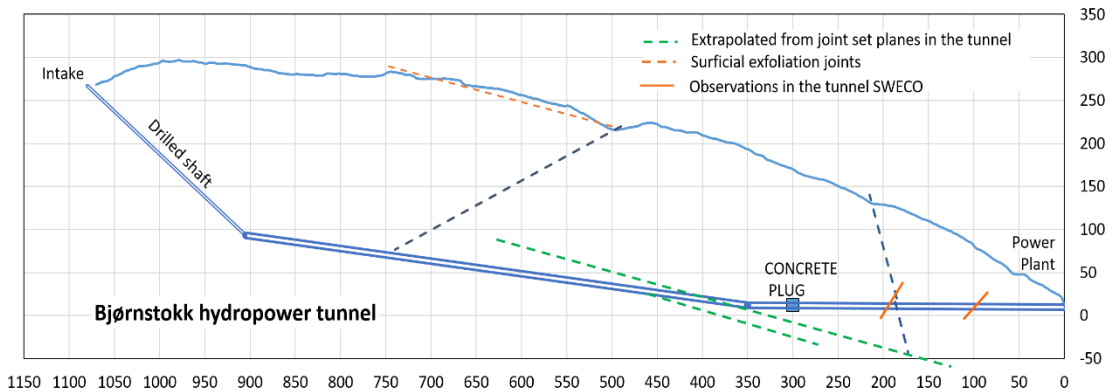
Figure 3. Vertical section showing the Bjørnstokk hydropower tunnel and rock joints.

Figure 2 shows an aerial view of the position of the hydropower tunnel relative to the slides. Figure 3 shows a vertical cut through the waterway to Bjørnstokk Power Plant. The waterway starts with a river intake at elevation 267 meter from which the water goes through a 250 meter drilled shaft, inclined 45° downward, where after the waterway continues in a wider, unlined, blasted 600 meter long rock tunnel sloping 8° downward

Unfortunately, at Bjørnstokk it became apparent too late that the minor principal rock stress was too low. This caused leakage from the tunnel after hydraulic fracturing when the waterway was filled in order to start production. Ground noise and vibrations felt by people in the area and also recorded by earthquake stations are most likely related to the fracturing. The original waterway

design was therefore, after the landslides, redesigned by moving the concrete plug and extending the cast iron pipe 300 meter further into the tunnel. The tunnel was originally designed based on empirically based criteria without measurements of rock stresses. This is not uncommon for small-scale power plants in Norway (Broch 2000).

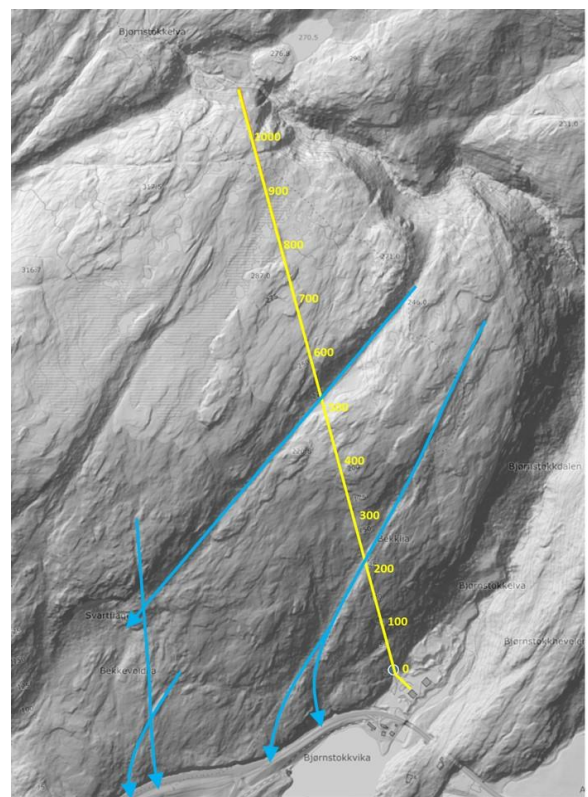
Figure 4. The tunnel (numbered) and possible paths for flow of water (arrows) in rock joints. The Bjørnstokk power plant and slide area at the bottom.

Hydraulic fracturing then opened cracks in the rock around the tunnel and sent water through existing rock joints down and outwards in the direction of the fjord and the landslide areas.

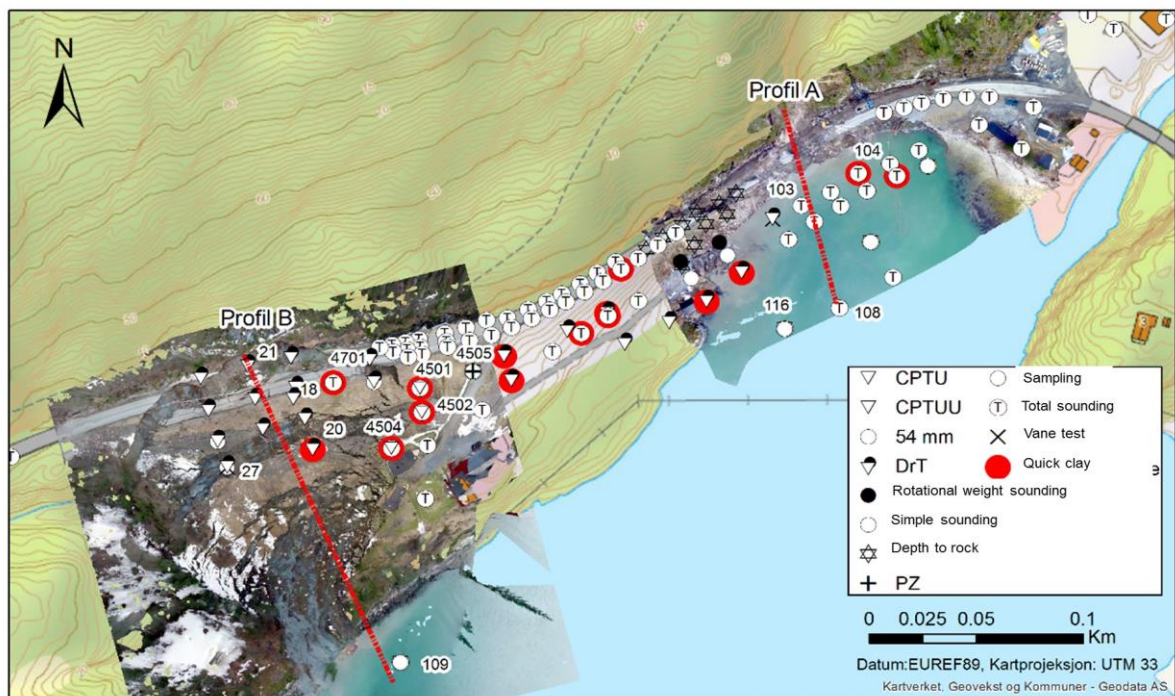
Figure 5. Soil investigations. Total Sounding to bedrock, CPTU, sampling and old vane tests were interpreted to show 4 layers with some road fill material on top, then a silty/sandy layer (Bekkevold only) over the dominating layer of silty clay, partly quick in some locations (red dots), over a gravelly/sandy layer.

Both landslide areas are dominated by a layer of silty clay which is sensitive and partly quick. Local variations are seen by lenses of silt and sand. Most of the soil in Bjørnstokkvik (slide 1) slid into the sea and at Bekkevold (slide 2) the remaining mass is heavily disturbed. Thus it is hard to get the proper soil parameters. They have primarily been estimated based on CPTU, performed in undisturbed soil close to the landslide scars, Table 1. Friction parameters are estimated based on the NTNU method, (Sandven 1990), Table 1. Undrained strengths are estimated based on Karlsrud et al (2005), and active strength is taken to be $25 + 3 \cdot z$ [kPa], where z is depth in meters from terrain. The plasticity index is $I_p \leq 10$ (%).

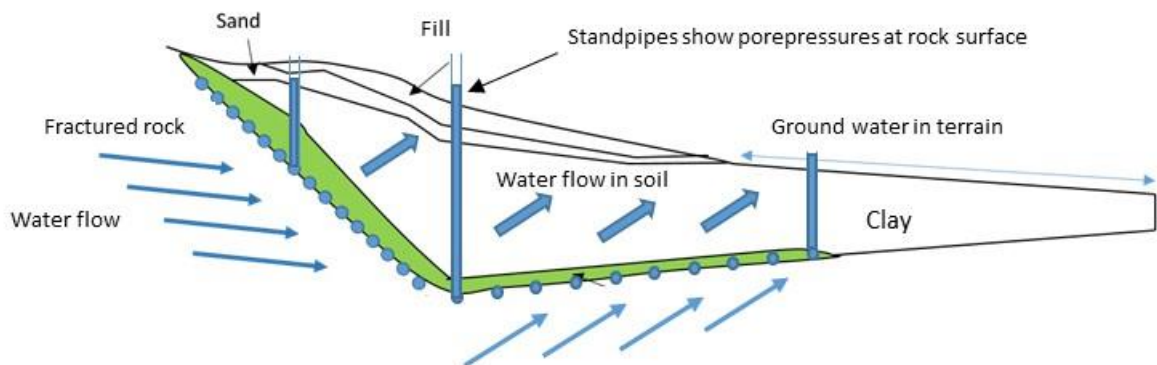
Figure 6. Illustration of how the leakage of water from the hydropower tunnel may create excess porepressures in the coarser soils along the rock surface at Bekkevold. Standpipes illustrate the excess pressures. In principle the same concept can be used for Bjørnstokkvik.

Analyses were performed to simulate the possible effect of excess pore-water pressure deep down under and behind the slopes. The simulations follow the idea sketched in Figure 6. In Bjørnstokkvik a pore pressure increase of 1 meter is enough to initiate failure. At Bekkeveld a pore pressure increase of 3,5 meter is necessary to initiate failure. The theoretically predicted mechanism in Figure 7 and 8 fits well with observations from the actual slides.

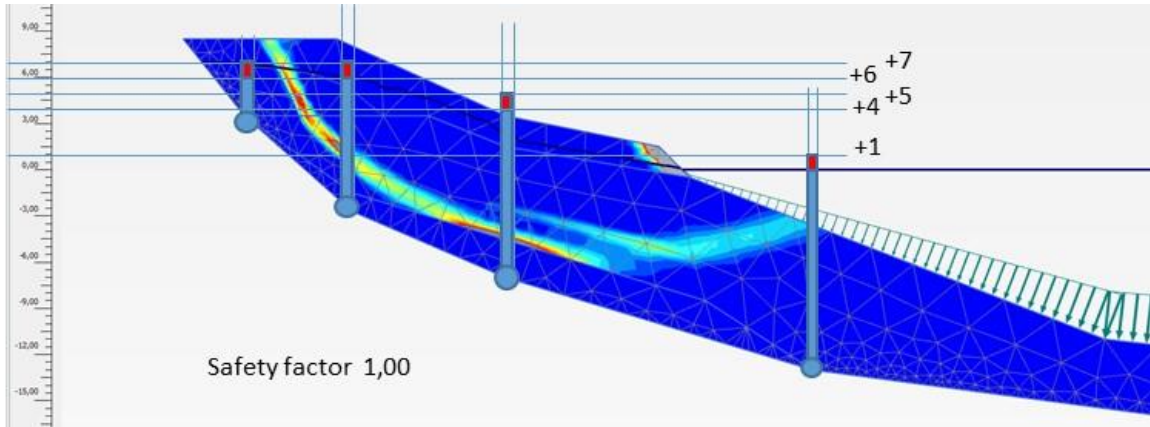
Figure 7. The slope at Bjørnstokkvika failed after an increase in porepressures by less than 1 meter in drained soil layers under and behind the slope. The results are very similar independent on whether the clay is considered drained or undrained. The red colour in the standpipes indicate the porepressure increase leading to failure. Results from Plaxis.

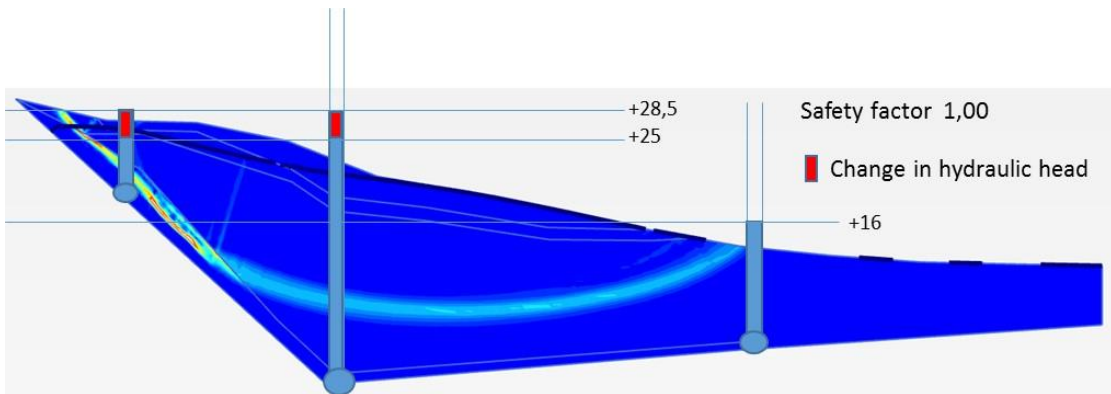
Figure 8. The slope at Bekkevold failed after an increase in porepressures by less than 3,5 meters in drained soil layers under and behind the slope. The clay is considered undrained due to rapid stress redistribution. The red colour in the standpipes indicate the porepressure increase leading to failure. Results from Plaxis.

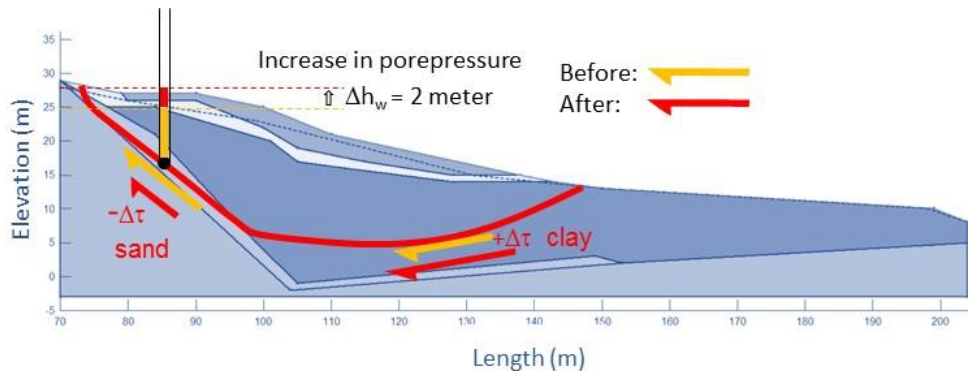
Figure 9. Illustration of stress redistribution due to a porepressure increase. The porepressure increase reduces the shear capacity and reduces the shear stresses in sand layers transferring undrained loading onto the clay.

factors and show the variation found in different analyses. It is observed that while the safety factors are generally low in Bjørnstokkvik, the drained analysis show good stability at Bekkeveld. The undrained analysis at Bekkeveld, however, shows very low robustness against anything that might involve undrained stress changes. Figure 9 illustrates how an undrained stress change may occur due to a porepressure increase in the more sandy layers close to the rock surface.
