# Use of Compaction Grouting as Ground Improvement Technique in Compressible Solid Waste Landfill

G. Tsitsas (corresponding author)

*GT Ground Engineering & Construction Services, Bucharest, Romania*

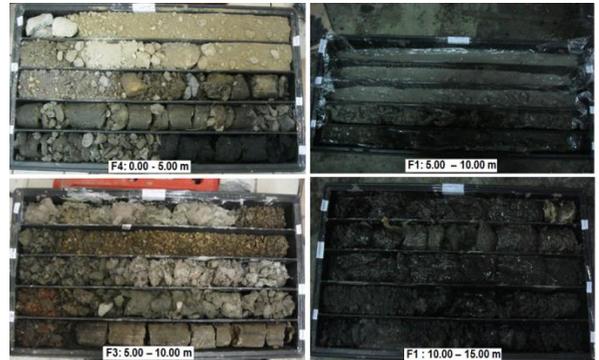
The fill material is encountered throughout the footprint of the structure under consideration and has a varying thickness ranging between 2.8 and 14 meters. It has a very high proportion of organic material, in state of decomposition; thus, presents high compressibility. In addition, traces of methane gas emission have been reported in the fill layer by 13 borings. In fact, for 100 m<sup>2</sup> of ground surface, emissions ranged between 0.2

Figure 1. Soil samples from 0 to 15 meters.

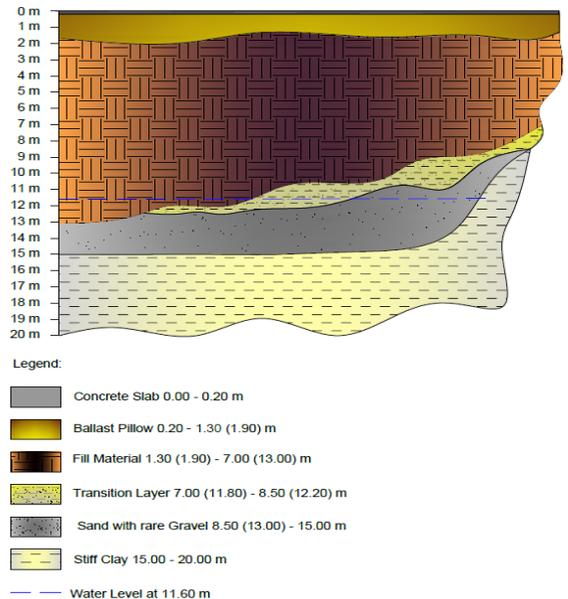
Based on a detailed evaluation of the available soil borings, the soil conditions in the area of the project consist of layered soils, including a layer of non-homogeneous fill of varying thickness followed by layers of sand, with some gravel and stiff clay. The groundwater table was measured at 11.60 m below ground level. Figure 1 presents drilling samples from different depths and locations underneath the structure; hence, providing a qualitative display of the subsurface conditions.

Figure 2. Soil profile at the site under consideration.

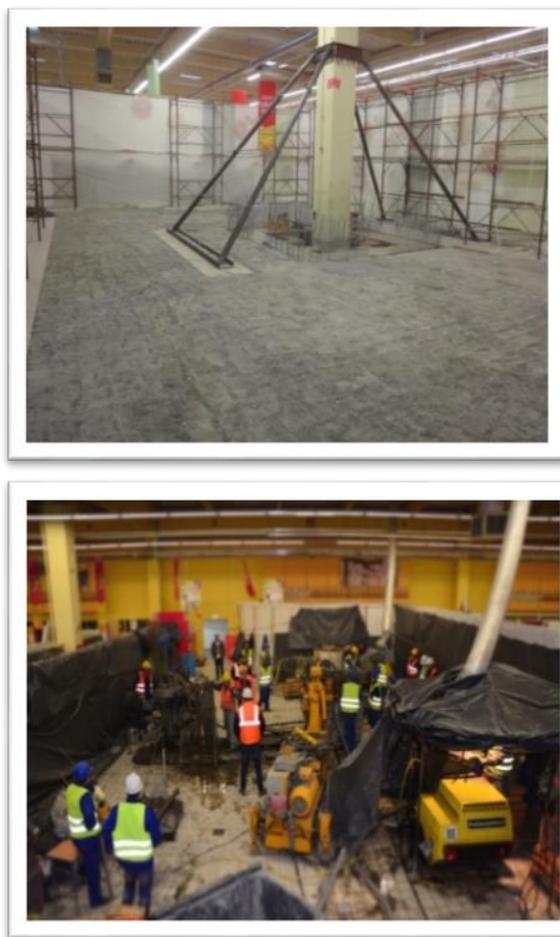
Figure 3. Views of the injection works inside the structure.

The objective of the performed works was to stop excessive settlements, which were ongoing for several years and varied in some areas between 5 and 24 cm. Works were scheduled in night shifts, in order to minimize disturbance, given that the commercial activity could not cease during the project. The columns' injection was generally performed on a primary and secondary grid to achieve optimum confinement. Underneath the concrete slab of the structure, grout columns were injected at a centre-to-centre distance of 2 meters, whereas around the footings, 8 columns were injected in total, 4 vertical and 4 inclined by 6 degrees. The total volume of the injected mortar exceeded 5,000 m<sup>3</sup> and the minimum and maximum mortar injected in one column ranged between 3 m<sup>3</sup> and 12 m<sup>3</sup> respectively, which indicates a highly non-uniform soil. In Figure 3 typical views of the performed works are presented.

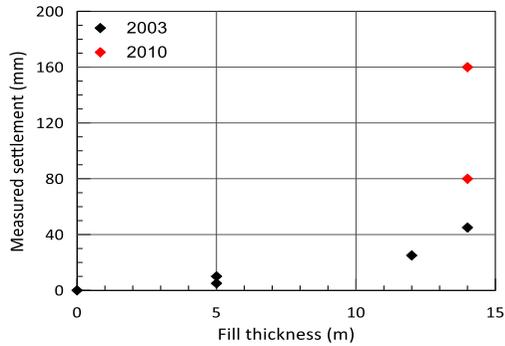
Monitoring of the settlements started in 2003 (immediately after construction) for 60 columns of the structure, making up almost 25 percent of the total number of columns of the building. Significant settlements were measured already from the first year, which were analogous to the thickness of the fill material and reached up to 45 mm in the areas of the maximum thickness of the compressible layer. Then in 2010, settlements had accumulated to 160 mm in the same location with 0.5 – 0.8 mm settlement being added per month at the critical columns. This was a clear indication of the emergency of the situation. The above measurements from 2003 and 2010 are shown in Figure 4, as a function of the fill thickness, from where a direct link between the thickness of the fill and the magnitude of the settlements is observed. Namely, at the locations where the thickness of the fill material was 14 m, the settlement increased by a scale of 2 to 4 times reaching the level of 80 to 160 mm.

Figure 4. Measured settlements in 2003 and 2010, as a function of the fill thickness.

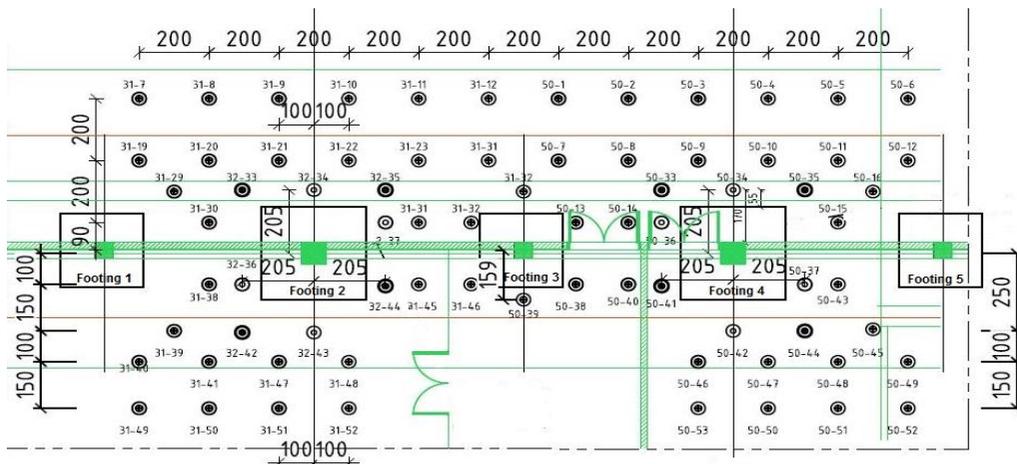
Figure 5. Plan view of the treated area in 2017.

In the present paper, the data from works performed during the last intervention that took place in 2017, are used. The particular intervention covered an area of 361 m<sup>2</sup>, where smaller settlements accumulated. In total 74 CG columns were injected for the stabilisation of 5 spread footings (Figure 5).

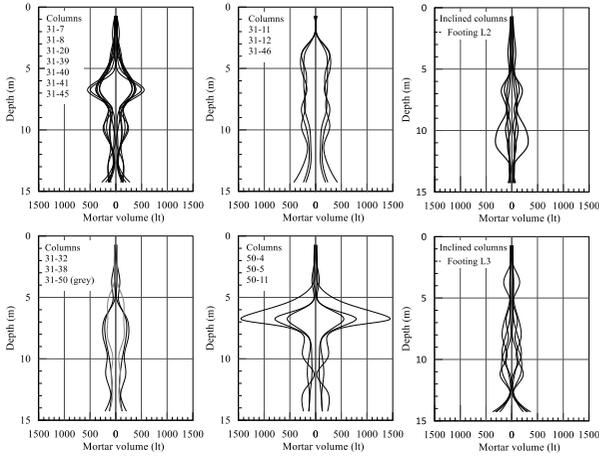
Figure 6 presents the distribution of mortar volume with depth from various locations of the treated area. These are grouped based on their shape and the amount of mortar used, in order to

obtain a better understanding of the nature and the response of the fill material to CG. Based on this figure, the highly non-uniform nature of the fill material becomes evident, as the used mortar volume presents a great variation between 3 and 12 meters. In addition, there is a direct influence of the soil layering on the column shape. Namely, in most cases the cross section of the column presents a significant bulging between 3 to 12 meters, implying the presence of a soft layer and in the sequel the cross section is reduced again, as compaction grouting progresses to the stiffer soil layers. This picture is also consistent with what is described in ASCE guidelines [1] and Figure 7. In the top 3 meters most of the column cross sections are rather narrow, implying the injection of low mortar volumes. This is expected, as due to the low overburden stress, the applied injection pressures need to be kept at low levels, to avoid damaging the superstructure. Based on the information from the entire database of the column logs (74 columns), it is estimated that the vertical columns absorbed from 0.79 to 3.94 m<sup>3</sup> of solid grout, giving an average of 1.43 m<sup>3</sup> with a standard deviation of 0.48. The inclined columns exhibited a higher consistency in terms of the absorbed volumes, ranging from 1.23 to 2.39 m<sup>3</sup>, with an average equal to 1.87 m<sup>3</sup> and standard deviation of 0.40.

Figure 6. Mortar volume distribution with depth from selected locations from the treated area.

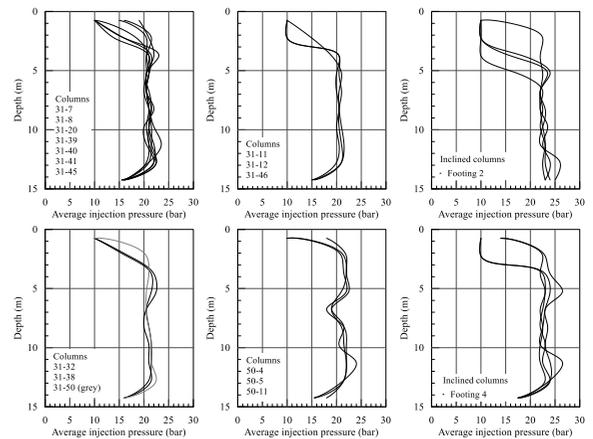
Figure 8 summarizes the distribution of the injection pressure with depth for selected locations of the treated area, including the inclined columns, which were constructed around foundations 2 and 4. It is observed that – on average and within the fill material (3 to 12 m) – the injection pressure remains constant and equal to 20 bar for all vertical columns. Regarding the inclined columns, a slightly higher injection pressure is recorded, which is equal to approximately 23 bar. Moreover, it is observed that in the top 3 meters, the injection pressures are significantly lower given the low overburden pressure.

Figure 8. Average injection pressure with depth for selected columns of the treated area.

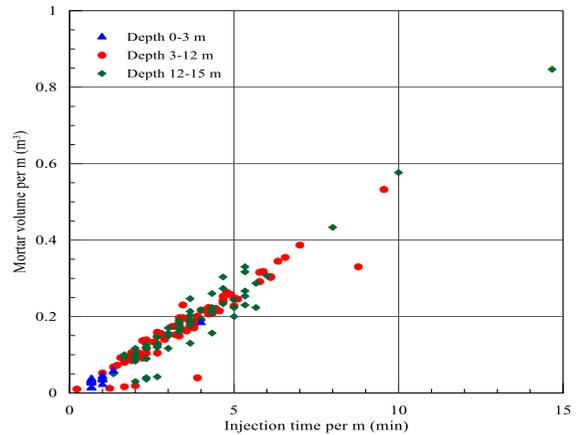
Figure 9 illustrates the correlation between the normalized mortar volume and the normalized total injection time for each distinct soil zone (as explained earlier) and each column. It is observed that for all three zones there is a linear correlation between the injection time and the mortar volume. The performed normalization here, essentially does not reveal what is observed in Figure 6, namely that in the middle zone there is the highest absorption of material, due to its compressibility.

Figure 9. Normalized mortar volume against normalized injection time.

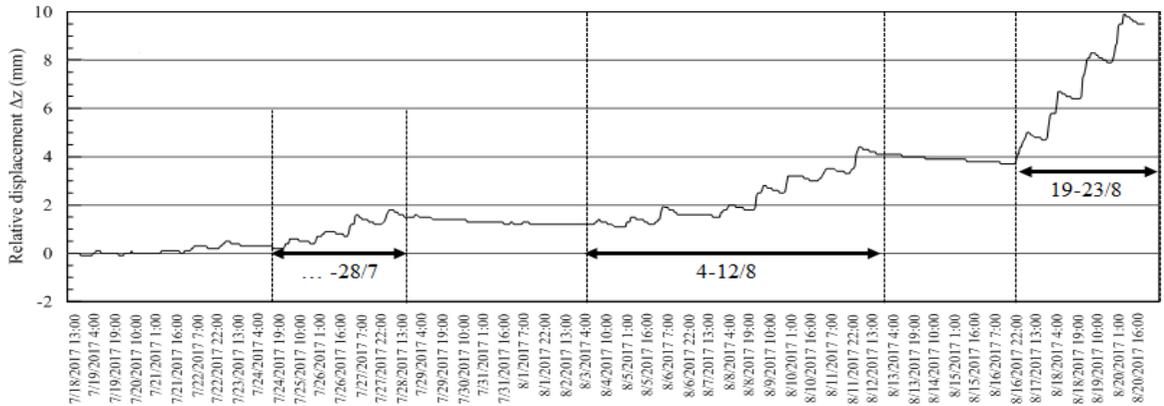
Figure 10 shows the vertical relative displacements ( $\Delta z$ ) of footing 2 as recorded by the monitoring instrumentation, performed by total stations and prisms. It is observed that three separate sections of uplift are recorded. Part I of the heave measures approximately 1.5 mm and occurs from the beginning of the works until July 28, 2017. During this time period, there were no ground improvement works taking place in the vicinity of footing 2, hence this is attributed to works performed in adjacent footings. The second part of uplift measures roughly 3 mm and was recorded from 4 – 12 of August of the same year. During that time, records from the columns logs show that columns 31-20, 31-21, 31-22, 31-23, 31-31, 31-48, 31-47, 31-41 and 31-40 were

injected. The final part of uplift, measures approximately 4 mm and was recorded between 19 – 23 August, when columns immediately neighboring the footing were injected, that is, 32-33, 32-34, 32-35, 32-36, 32-37, 32-42, 32-43 and 32-44. The conclusion was that the columns located closer to the footing have caused the greatest uplift. Horizontal relative displacements were insignificant.

Figure 10. Relative vertical displacement footing 2.

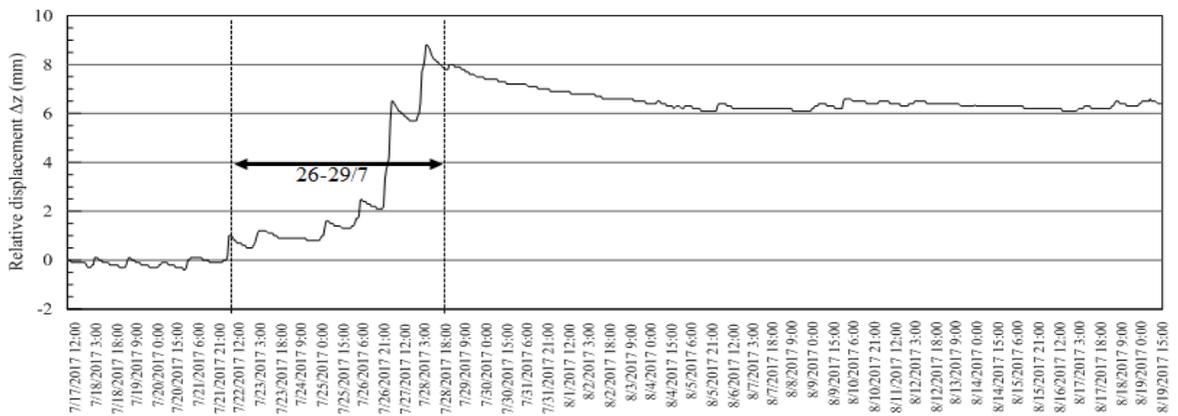
Figure 11 summarizes the vertical relative displacements ( $\Delta z$ ) of footing 4. It is observed that the recorded uplift reaches up to 6 mm between 26 - 29 of July. During that time, columns 50-33, 50-34, 50-35, 50-37, 50-42, 50-41, and 50-36, located in the vicinity of the footing were injected.

Figure 11. Relative vertical displacements for footing 4
