# CPT investigation of mining-induced fissures and implications in respect to built development, Staffordshire, UK

R. D. W. Lowman

*Wardell Armstrong, Stoke-on-Trent, United Kingdom*

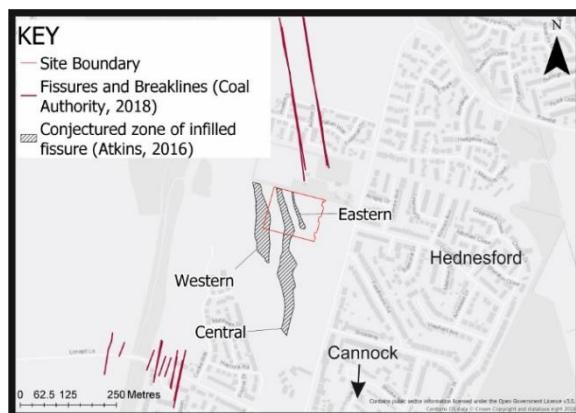
*Figure 1. Site location plan showing fissures identified by previous investigations (Atkins, 2016) and The Coal Authority (Coal Authority, 2018)*

Geophysical surveys have been undertaken at the site in 2011 and 2013 to investigate the location of the fissures employing magnetic gradiometry, resistivity and ground probing radar survey techniques. The results of the surveys recorded 3 main linear features (Figure 1), which have subsequently been defined as the Western, Central and Eastern Fissure respectively (Atkins, 2016). The maximum widths of the broadly defined fissures (conjectured zone of infilled fissures) are recorded to be c.34m, c.18m and c.14m in respect of the Western, Eastern and Southern Fissures (Atkins, 2016).

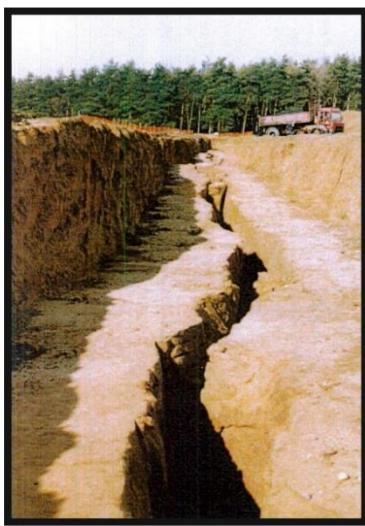
Mining-induced fissures have been observed to reach up to about 1m in width and several hundred metres in length (Donnelly, 2006; Donnelly and Rees, 2001) extending to considerable depths. Where superficial deposits overlying fissures are granular and permeable, surface water and/or groundwater can wash the granular deposits into open fissures causing surface subsidence. Weathering can weaken the sides of fissures producing a “spalled zone” towards surface, with the fissures reducing in width with depth. Figure 2 shows an example of an open fissure which has been exposed by excavation.

Figure 2. Photograph of an exposed open fissure within Permo-Triassic sandstone, Nottinghamshire Coalfield (Coal Authority, unknown)

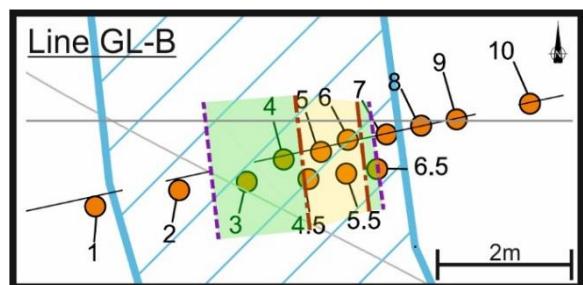
Figure 5. Section line GL-B showing broadly defined extent of infilled fissure prior to investigation (cross-hatch), conjectured extent of fissure (yellow), spalled zones (green) and probehole locations (Wardell Armstrong, 2018)

The depth of probeholes within the fissure vary from 12m to 16m, within the spalled zone from 3m to 5m depth and immediately outside the fissure probehole refusal depths were of the order of 3m. The fissure width is reasonably well defined at c.0.8m, indicated by a significant change in probehole depths. The materials within the fissure are characterised by the presence of extremely low strength fine grained soils and loose to very loose sands. Cone and sleeve friction resistance values reach almost zero within the fissure.

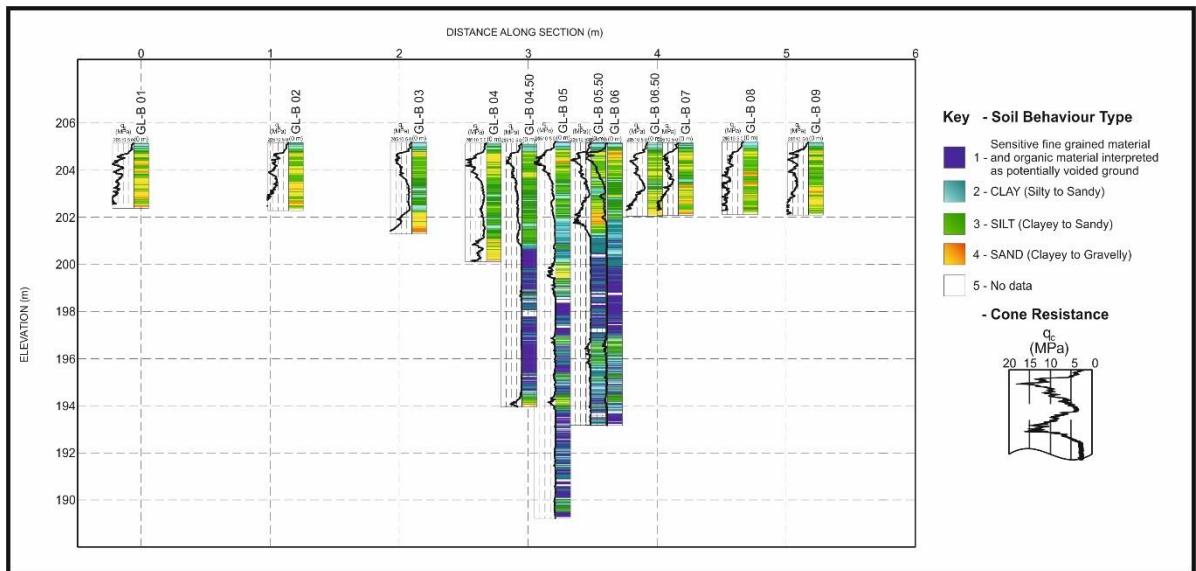
Figure 6. Cross section of line GL-B showing depth of probeholes, cone resistance values within and outside of the fissure and soil behaviour types. Produced by In Situ Site Investigation (In Situ Site Investigation, 2018) and edited by the authors

Illustrations of and cone resistance and sleeve friction responses to define the fissure along the section are shown as Figures 6 and 7 respectively. This comprises responses at test locations 02 (outside of fissure), 04 (within the spalled zone) and 06 (within the fissure).

Location 2 (outside the fissure) - High cone and sleeve friction resistance responses are recorded, with cone and sleeve friction resistance reaching 20 MPa and 500 kPa respectively. The material is reported as high strength silt and clay overlying dense to very dense sand and gravel, with probehole refusal at 2.9m.

Location 4 (within the spalled zone) - High cone and sleeve friction resistance responses are recorded at levels of up to c.20 MPa and 400 kPa respectively to c.1.6m depth, which is considered to represent engineered made ground. Below to a depth of c.4m the cone and sleeve resistance levels falls to c.2.5 MPa and c.27 kPa respectively, this material being defined as high strength to very high strength silt. Below the cone and sleeve resistance increases to c.14 MPa, and 300 kPa respectively, the material being

defined as medium dense gravelly sand, with probehole refusal at 5.03m.

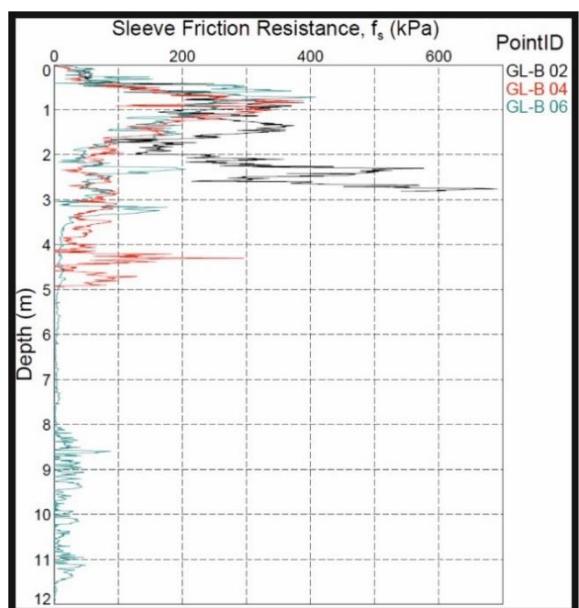
Figure 7. Examples of sleeve friction resistance responses within probeholes along section line GL-B, outside the fissure (02, black), within the spalled zone (04, red) and within the fissure (06, grey).

Location 6 (within the fissure) - High cone and sleeve friction resistance values are again recorded to c.1.6m depth (engineered made ground). Below to a depth of c.3.4m, the cone resistance falls to between c.2 and 6 MPa and the sleeve friction resistance to between c.9 and 216 kPa, the material being defined as high to very high strength silt. The materials to 8.2m comprise extremely low to very low strength fine grained soils, which are characterised by cone and sleeve friction resistance values close to zero, indicative of the presence of a fissure. Below the cone and sleeve friction resistance increases to c.5 MPa and c.109 kPa respectively (e.g. loose gravelly sand and extremely low strength soils) to refusal at 12.0m. It is considered that where the cone and sleeve resistance values are close to zero voided ground may be present rather than very low strength soils.
