Eemdijk full-scale field test programme: ground dike and sheet pile dike failure test

H.J. Lengkeek

Delft University of Technology, Delft, The Netherlands

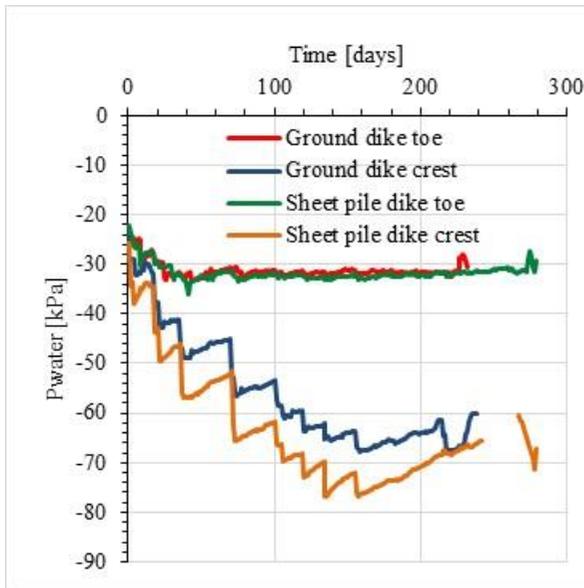
Figure 5 presents the pore pressures at the toe and below the crest of both dikes (in the middle section). Each stage is clearly visible, in particular below the crest.

Figure 5 Development of pore pressures during construction.

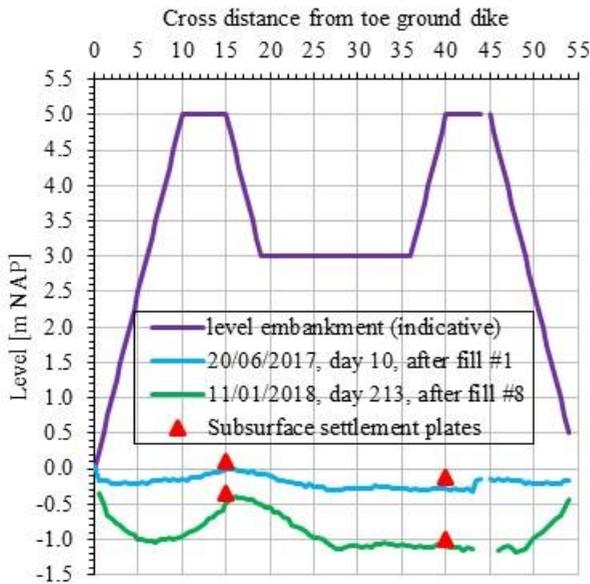
Figure 6 Settlements of the south section after the 1st and 8th fill stage.

Figure 6 presents the settlements along a cross section of the dike, after the 1st and 8th fill stage. The maximum settlement is about 1.1m. The settlement at the old berm location (located under the ground dike crest) is typically half of that due to the preloading. Also the pore pressures at the

ground dike crest are lower than at the sheet pile dike crest. The settlement at both the toes is about 0.3m. The horizontal deformations at the toe are about 0.3m at the end of construction. Deformations in the upper 2m were larger at the toe of the ground dike due to the soft silty clay (3a).

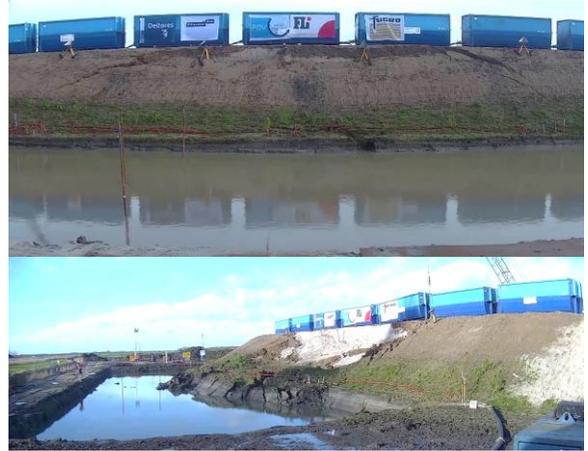
Figure 8 presents the SAAF measurements at several times. Failure of the slope continues rapidly after 0.1-0.2m horizontal displacement. The slip surface is at -2.0m NAP. Excavations performed afterwards confirm a horizontal slip surface in the soft silty clay (3a), and typically circular slip surface in the layers above.

Failure became visually clear due to large cracks developing at the transition of slope and crest, accompanied with horizontal

displacements at the toe of the dike. The failure occurred over approximately the middle 30 m of the ground dike, see figure 9a. A large part of the total deformations (several meters) developed in the first hour after the first signs of failure, and steadily increase to its final position, see figure 9b.

Figure 9 Photo's of ground during failure (a) and after failure (b).

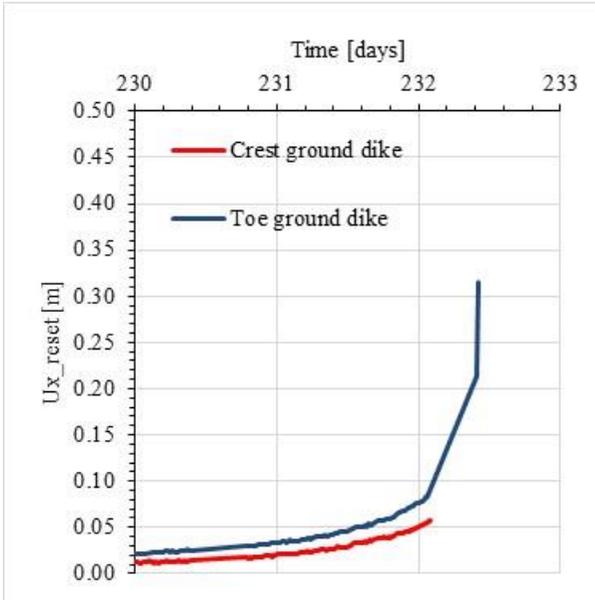
Figure 7 presents the horizontal deformations at the crest (top of the slope) and toe of the dike during the last 3 days of the ground FST. The deformations at the crest are generally 1.5 times smaller than at the toe and became clearly visible by eye one hours before failure.

Figure 7 Horizontal displacements of the Prism at the crest and toe of the ground dike.

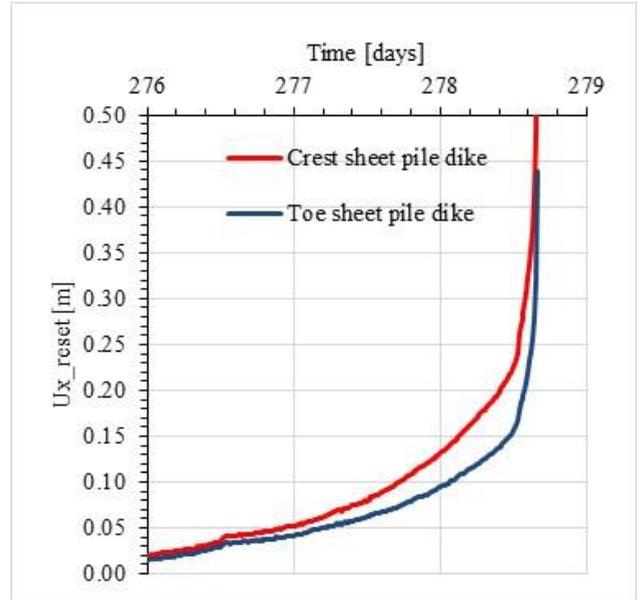
Figure 10 presents the horizontal deformations at the top of the sheet pile and toe of the dike during the last 3 days of the sheet pile FST. The deformations at the top are generally 1.5 times larger than at the toe and became clearly visible by eye one day before failure. Failure of the slope started typically at 0.1 to 0.2m displacement.

Figure 10 Horizontal displacements of the Prism at the top of the sheet pile and the toe of the ground dike.

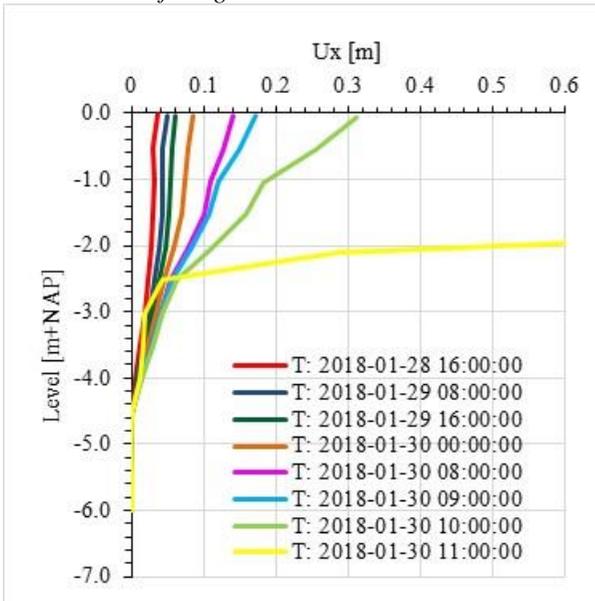
Figure 8 Horizontal displacements over depth of the SAAF at the toe, at multiple times during the ground dike FST.

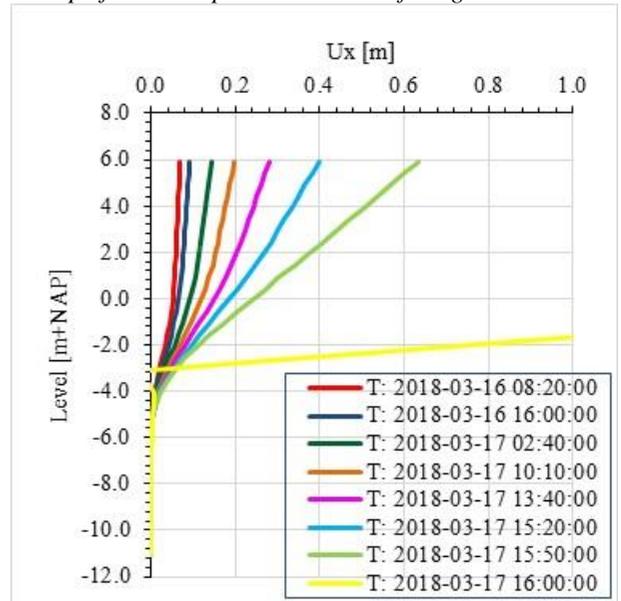
Figure 11 presents the SAAF measurements at several times. At the early stages the slope provided enough support such that the cantilever wall deflected backwards at the top. Failure of the sheet pile starts after exceeding the maximum bending moment capacity which corresponds with a displacement of typically 0.5m at the top. After failure of the sheet pile, the large deflection finally caused flooding of the FST site (see figure 12b).

Figure 11 Horizontal displacements over depth of the SAAF at the sheet pile, at multiple times during the sheet pile dike FST.

The SAAF measurements at the toe and slope indicate that the slip surface at the toe of the dike

is located at the bottom of the peat layer. Halfway the slope the slip surface is less profound and can

beter be described as a failure zone over the thickness of the peat layer. At the sheet pile there is no failure plane because all deformations are imposed by the sheet pile.

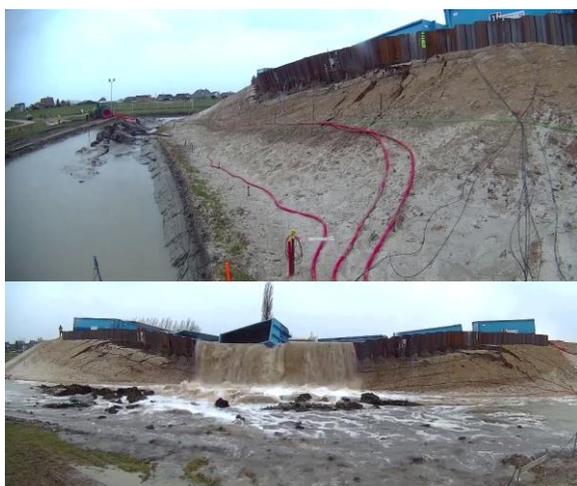
The deformations accelerated once the sheet pile failed due to local buckling. The slip surface exited in the bottom of the ditch, approximately 5m from the toe of the dike. The sliding ground mass was pushed upward even above the water level in the ditch, see figure 12a. Deformations stopped once the top of sheet pile was pushed over by 6m and down by 2m.

Figure 12 Photo's of sheet pile dike during failure, just before (a) and during (b) flooding.
