Urgent Stabilization, Reconstruction and Reinforcement Solutions of High Retaining Walls in Lisbon

C. Fartaria

JETSj, Geotecnia Lda, Lisbon, Portugal

ABSTRACT: A partial collapse of a poor reinforced concrete retaining wall, built in 1955 and overcoming a 20m high slope, in February 2017, as well as the subsequent ground sliding, led to severe structural damage of the buildings located at its base. Considering both the precarious structural condition of the buildings, as well as the possible risk of the remaining retaining walls to collapse, there was an urgent need for the execution of a definitive solution that could re-establish the local and global stability of the retaining walls. The implemented solutions aimed to rebuild and to improve the confinement of the retaining walls, while increasing the local and global safety to static, hydrostatic and dynamic loads, as well as the reconstruction of the drainage systems. The works took place between March and August 2017, covering roughly 90m of retaining walls overall extension, simultaneously with the reconstruction of damaged buildings, including their structural reinforcement.

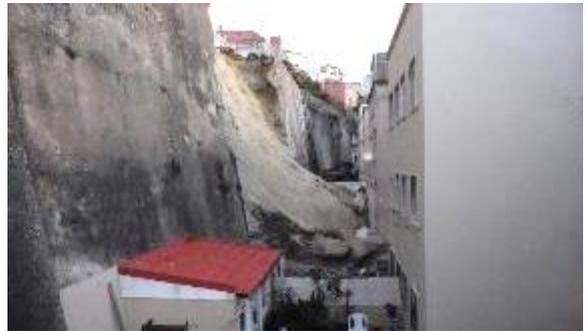
The partial collapse occurred in the central zone of this set of cantilever walls, comprising the walls located behind buildings n. ° 108 and n. °106, which experienced severe structural damages result of the walls collapse and consequent landsliding. After the incident the structural stability of the affected buildings was compromised and the overall stability of the remaining earth retaining walls was at risk of imminent collapse, thus the need of intervention was imperious (see Figure 2 and Figure 3).

Figure 2. View of earth retaining walls after its partial collapse

The information available on the earth retaining walls and the *in-situ* inspection allowed to point out the following possible causes of the incident: a) accumulation of water behind the earth retaining wall and consequent generation of a hydrostatic horizontal pressure, due to extensive irrigation of the garden and eventually water leaks from the pool located above; b) the existence of a clay layer located near the collapse section which may have block the downward percolation of water; and c) ineffectiveness of the drainage system of the walls due to lack of maintenance, simultaneously with the above stated evidences and consequent generation of a hydrostatic horizontal pressure.

The nature of cantilever wall may have eased the incident since they are more than 60 years old and are primarily composed by a low resistance

concrete, slightly reinforced, and showing severe corrosion pathologies.

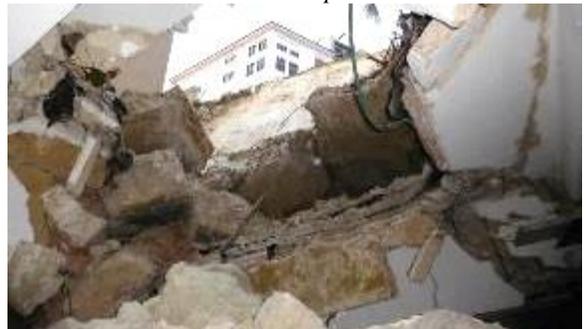
Figure 3. View from building n.°106 basement after earth retaining walls partial collapse

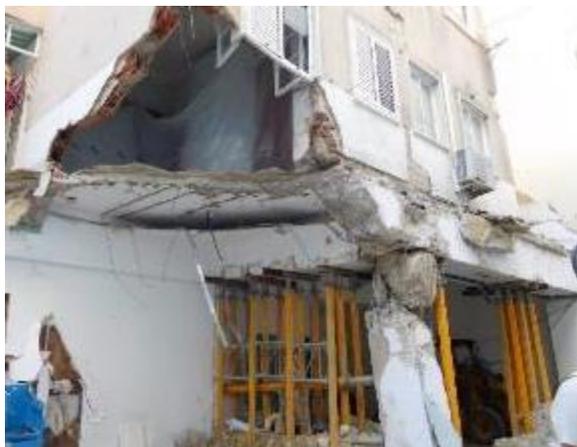
Figure 4. View of building n.º108 basement shoring

Aiming the safety restore of the area, ensuring the security of operators during the initial works the following emergency interventions were carried out: a) slope re-profiling, essentially on the top consisting of landfill materials; b) removal of potentially unstable blocks located on the surface of the slope; c) slope protection with sprayed concrete reinforced and drained. Those works were highly conditioned and they were mostly carried out with lifting equipment; and d) implementation of temporary stabilization measures on buildings such as shoring before the removal of the landslide materials and debris (see Figure 4).

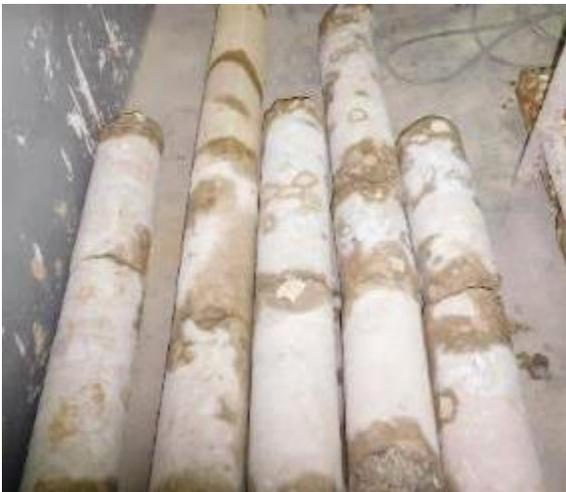
Figure 5. Concrete cantilever wall samples

The extraction of samples allowed the confirmation of the geometry indicated in project drawings and later their testing determined an average failure compression stress of 11.25MPa with a standard deviation of 3.41MPa and an elastic modulus of 17.2GPa on average, proving the low resistance of the wall.

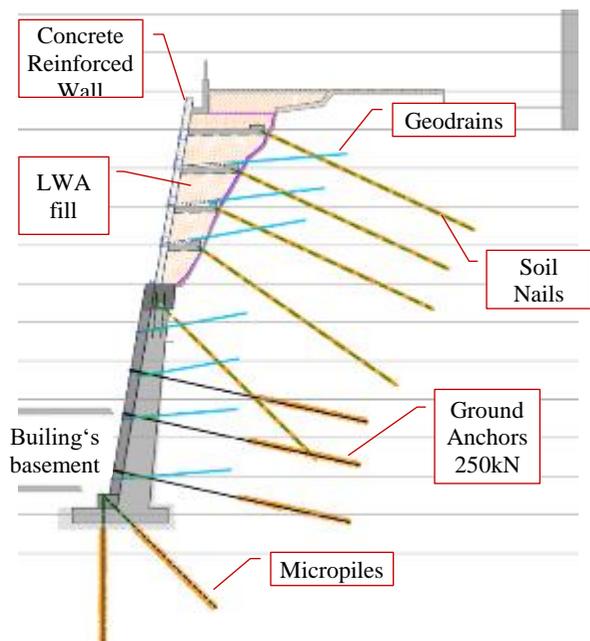
Figure 6. 'Solution A' draft - Cross section

The solution for the partially collapse walls comprised the re-confinement of the remaining walls through the execution of a 50cm thickness reinforced concrete wall connected to permanent ground anchors with low prestressed loads. Also, the walls strip foundation was reinforced using micropiles both vertical and inclined.

Above the sectioned wall level, a new reinforced concrete wall of 35cm thickness was executed and it was connected to the existing slope thorough concrete slabs and soil nails (see

Figure 6). Behind the new wall a backfill of expanded clay lightweight aggregates (LWA) was placed properly wrapped in a geotextile of filtration and separation. This solution allowed the design of the new wall for lower lateral pressures as

well as a proper drainage system since the fill material is highly permeable and the affluent water could easily be expelled through the wall drainage ducts. The drainage system was reinforced also with the installation of sub horizontal geodrain pipes.

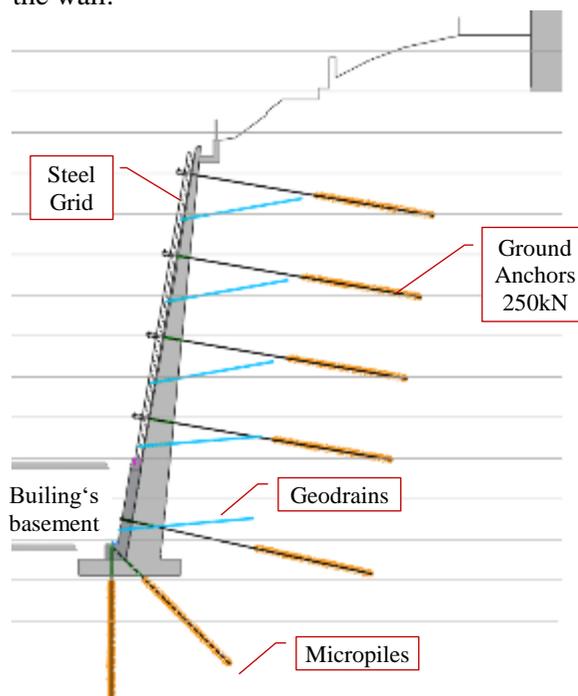
Figure 7. 'Solution B' draft - Cross section

On the non-collapsed cantilever walls permanent ground anchors with low prestressed loads were installed in order to re-confine them against the soil slope. For that purpose, a steel grid composed of steel profiles previously coated and painted against corrosion was placed on the wall face vertically supported on a 50cm reinforced concrete wall. At the level of the building's basement, the strip foundation was also reinforced through the installation of micropiles both vertical and inclined (see Figure 7).

Before the implementation of the re-confinement solutions, the existent plaster was removed from the walls face and lined with a high resistance mortar, reinforced with a carbon fibre mesh. Regarding the drainage system, multiple

sub horizontal geodrain pipes were installed in order to prevent the accumulation of water behind the wall.

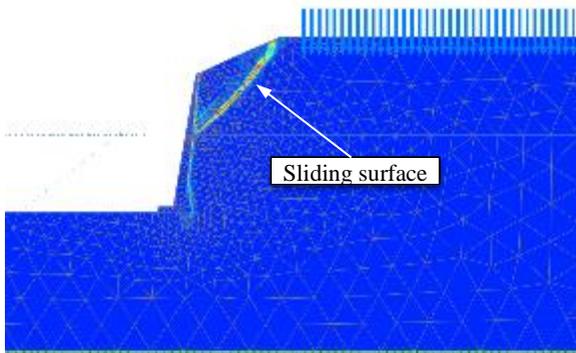
The study of the designed solutions was carried out essentially through finite element analyses. Since the problem is a fundamentally two-dimensional, plane strain analyses were performed using 2D PLAXIS software. Firstly, the geomechanics parameters were calibrated from a back analysis considering a limit stability scenario where the failure surface was the closest as possible with the observed *in-situ* (see Figure 8).

Figure 8. Back analysis - Plaxis 2D output
