Landslide risk mitigation of “São Pedro de Alcântara Viewpoint Slope” in Lisbon Historical Center

A. Pinto

JETsj, Geotecnia Lda, Lisbon, Portugal

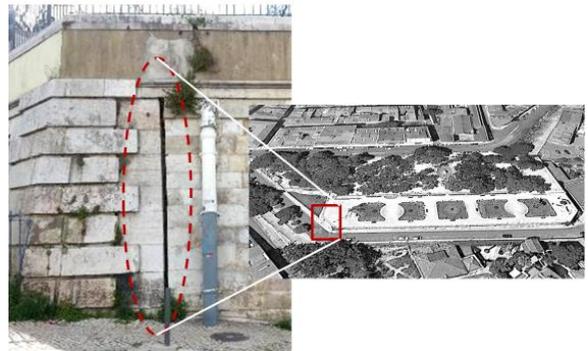
The behavior of the earth retaining structures at the SPA viewpoint, as well as the ones between São Pedro de Alcântara, Taipas / Glória Street and Fala-Só Bystreet has been monitoring and checked by several geological and geotechnical site investigations, which allowed to confirm some important ground horizontal movements. The cumulative result of those movements led to several and important cracking, mainly at the wall supporting the lower platform (see Figure 2).

Figure 2. View of cracks at the existent wall's corners.

Complementary to the slope stabilization works, additional rehabilitation works were also carried out at the lower masonry wall. The most important were: cracks sealing using cement mortars as well as the rehabilitation of the wall face wall, including a new coating after the removal of the existing vegetation.

The last structural intervention was the cleaning and rehabilitation of the lower wall, facing the Taipas Street, including the repair of existing cracks.

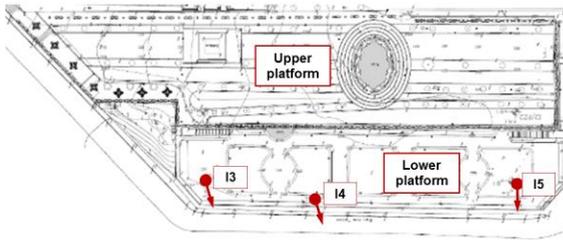
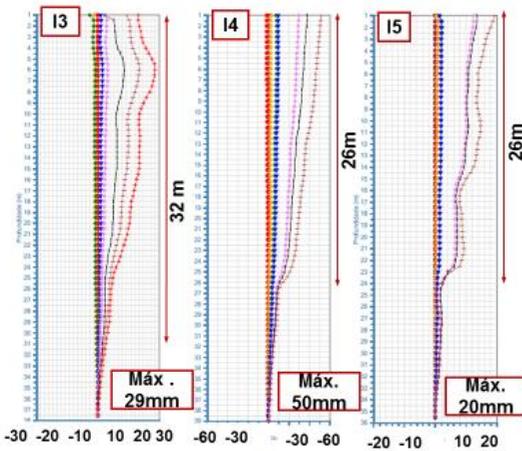
From the global appreciation of the displacements, it was possible to conclude that, during the last 5 years, horizontal movements were not negligible and showing some evolution with time. The largest displacements occurred at depths approximately coincident with the level of Taipas Street. However, displacements are recorded at lower depths, about 30m (Figure 3). These displacements indicated that a global instability phenomenon could be under development. Following this interpretation, stabilization measures would be needed.

Figure 3. Record of accumulated movements in inclinometers installed in 2011 on the lower platform.

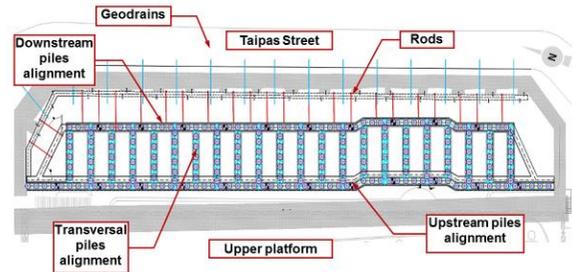
Figure 4. Plan of the adopted solutions.

The adopted stabilization solution consisted on the execution, at the SPA view point inferior platform level, of bored piles walls, Ø1000mm, spaced 0.8m, with reinforced concrete (long) or plain concrete (short), forming several rectangular buttresses, with 5m wide. The piles were capped by reinforce concrete capping beams and cover by a lightweight aggregates (LWA) fill, allowing to increase the global slope stability conditions (Figures 4, 5 and 6).

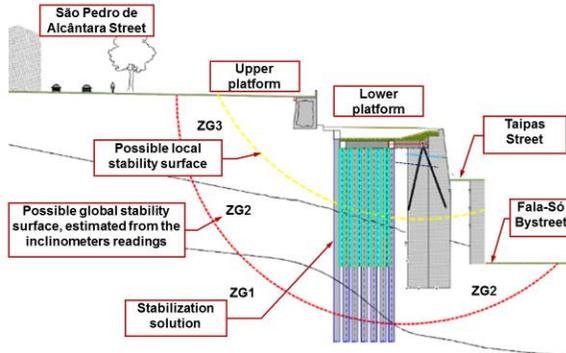
Figure 5. Cross-section of the adopted solutions.

The length of the piles was defined with the aim of ensuring not only that they will rest on a competent layer (ZG1), but also in such a way that they could intersect the previously identified sliding surfaces, based on the inclinometer's readings. For a better control of the deformations of the lower wall between the lower platform and Taipas Street, the outside piles were connected by steel tie rods to a reinforced concrete distribution beam, nailed to the wall the buttresses through sub-vertical permanent nails, Gewi Ø32mm. For a better deformation control the rods, spaced by 2m in plan, were pre-stressed.

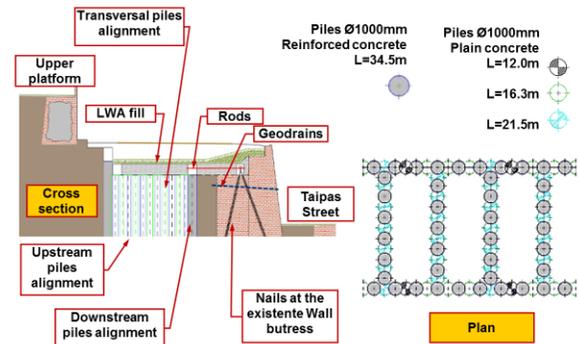
Figure 6. Details of the adopted solutions.

The piles were covered by the LWA fill, expanded clay 10-20mm size, properly confined by geotextile blankets. The use of this type of material allowed either the weight reduction at the unstable zone, increasing the safety factor of the overall slope stability, decrease of the earth pressures over the existing walls, resulting in greater control on the deformations of this structure. The use of LWA fills also allowed to increase the overall shallow drainage conditions.

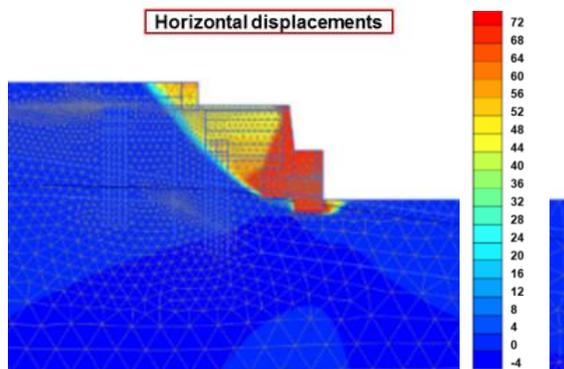
The initial design phase comprised a back analysis of both the platforms and retaining structures, assessing the overall the slope overall stability. The analysis was performed using the PLAXIS 2D finite element software. The calibration of the geological and geotechnical model was performed in order to try to reproduce the horizontal displacements recorded by the inclinometer's readings. The magnitude of the observed displacements, coincident with a calculation approach under static conditions, led to the formation of the sliding surfaces, which are indicated in Figure 7, corresponding to an overall safety factor of 1.12. The behavior of the slope was also analyzed for the seismic action, leading to a global safety factor inferior to 1.0, confirming the need to design a slope stabilization solution.

Figure 7. Numerical analysis for the evaluation of global stability to static actions [FS=1.12], horizontal displacements (cm).

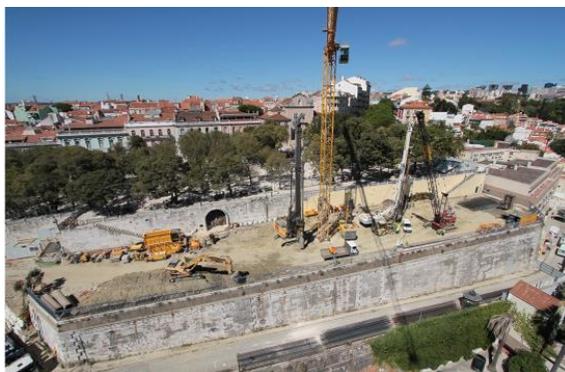
During the execution of the piles, soft materials were intersected, as well as the remains of old constructions, which determined the need to use various drilling techniques, from temporary casing to soil and rock augers (Figure 8).

Figure 8. View of the piles works.

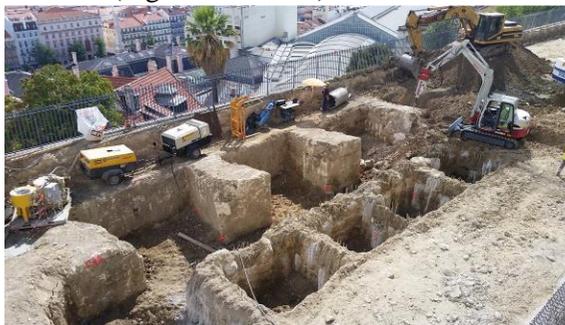
Figure 9. View of the excavation works.

Following the execution of the bored piles, the remaining work was carried out with lower restraints, mainly the capping beams, the rods and the nails (Figures 9 and 10).

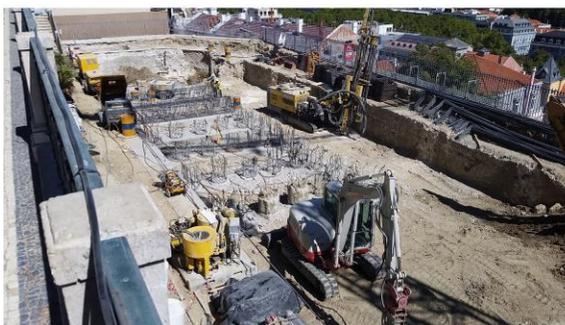
Figure 10. View of the nail's execution.

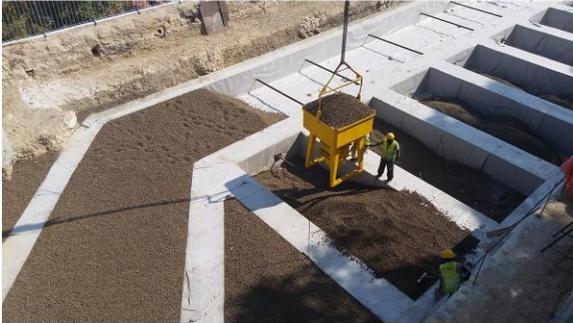
Figure 11. View of the lightweight aggregates

At the end the LWA was installed (Figure 11) over a waterproofing membrane, in order to drive the water to the drainage systems, mainly longitudinal drains and geodrains. At this moment,

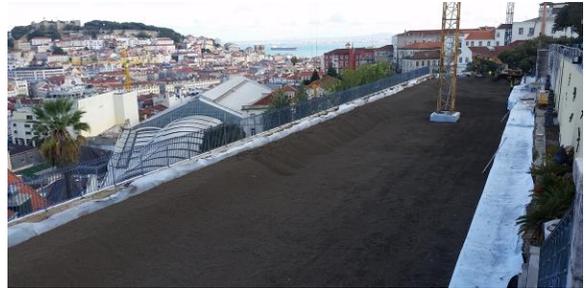
According to the monitoring results, about 1.5 years after the completion of the stabilizations and drainage works it was possible to confirm the stable behavior of the SPA viewpoint slope (Figure 12).

Figure 12. View of the final works
