Hegramo quick clay area – stability analysis and stabilisation work

P. A. Wangen

Rambøll Norge AS, Trondheim, Norway

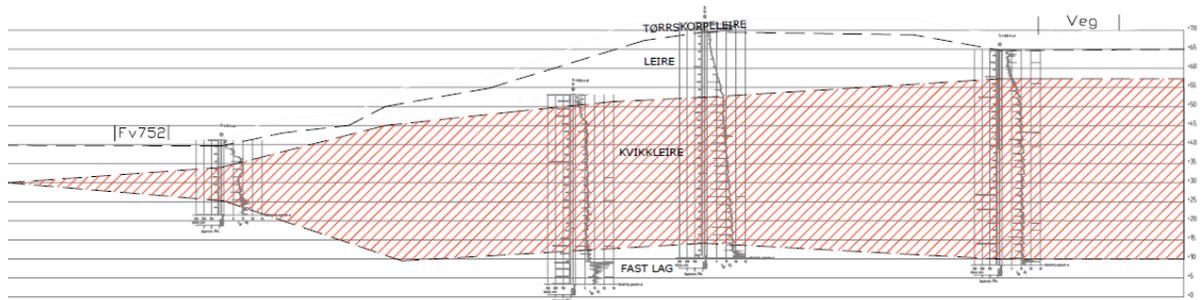
Figure 4. The most critical slope near the site (Slope A). The new primary school is planned to the left in the figure. Hatching shows the thickness of the quick clay.

The preliminary soil investigations indicated that the ground conditions on the site itself was suitable for the structure and that there was no quick clay on the site itself (ref. fig.4). However, the results from one borehole situated on top of slope A, borehole 5, indicated possible quick clay in the

ground. This was further investigated by sampling, laboratory testing and analysis that confirmed the suspicion. The suitability of the site was therefore uncertain, and a need for further soil investigations as basis for more detailed stability analysis and evaluations arose.

uously adjusted according to the registrations obtained. The results showed that slope A contained large volumes of highly sensitive quick clay.

The results of undrained calculations indicated that the factor of safety for slope A was slightly above or equal to 1,0. That is, the state of the slope is close to labile. Drained calculations showed satisfying safety factor, indicating that the safety of the slope at its natural condition is acceptable. However, the low factor of safety obtained in the undrained analysis indicates that even small changes in slope geometry, caused by human actions or natural processes such as erosion, may lead to a disastrous landslide event.

In autumn 2016, the focus is to do the necessary stabilizations works to prepare for a relocation of the primary school. The factor of safety for slope A must be increased to an acceptable level. Several possible ways of increasing the factor of safety have been discussed, however it is concluded that the most reasonable and efficient method to achieve the required factor of safety is by reducing the height of the slope. This either by levelling down the top of the slope, or by introducing a counter filling at its foot. The use of mass stabilisation is not widely investigated for this project, but traditionally it is found to be expensive, and to achieve the necessary effect, the extent of the mass stabilisation must involve a large volume of quick clay. Additionally, in established residential areas, the necessary area for such work is rarely available. Mass stabilisation was therefore excluded as an opportunity early in this process.

In this case, a counter filling will conflict with a local road located close to the foot of slope A as well as several private properties and houses. An excavation on top of the slope will conflict with private properties and houses. In an overall assessment, it was concluded that the levelling down of the slope would be the least inconvenient and most efficient solution. The extent of the top of slope A is relatively small compared to its foot and the effect of lowering it down will be more beneficial and involve less mass transportation than a counter filling. In addition, less private houses and properties are involved and, a local elevation of the road close to the foot of the slope would cause repercussions involving a need for adjusting the road several 100 metres away from the counter filling area.

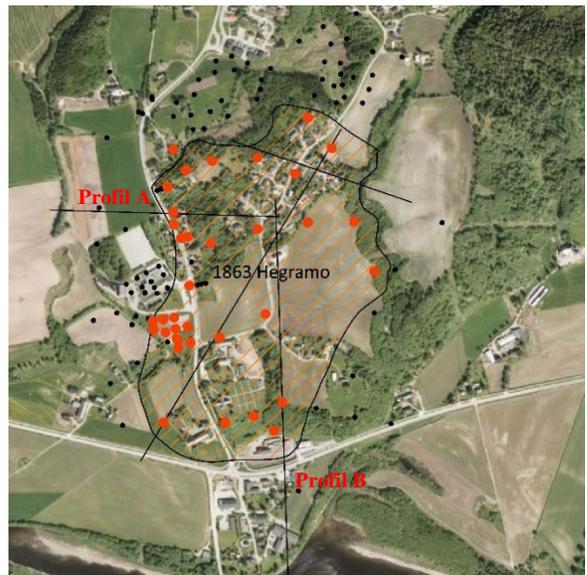
Fig. 5. The total extent of the quick clay area and the slopes analysed concerning level of safety.

Because of these findings the extent of the investigations and the stability analysis were expanded. The NVE financially supported the necessary works to map the total extent of the quick clay deposit and determine the factor of safety for several slopes of relevance.

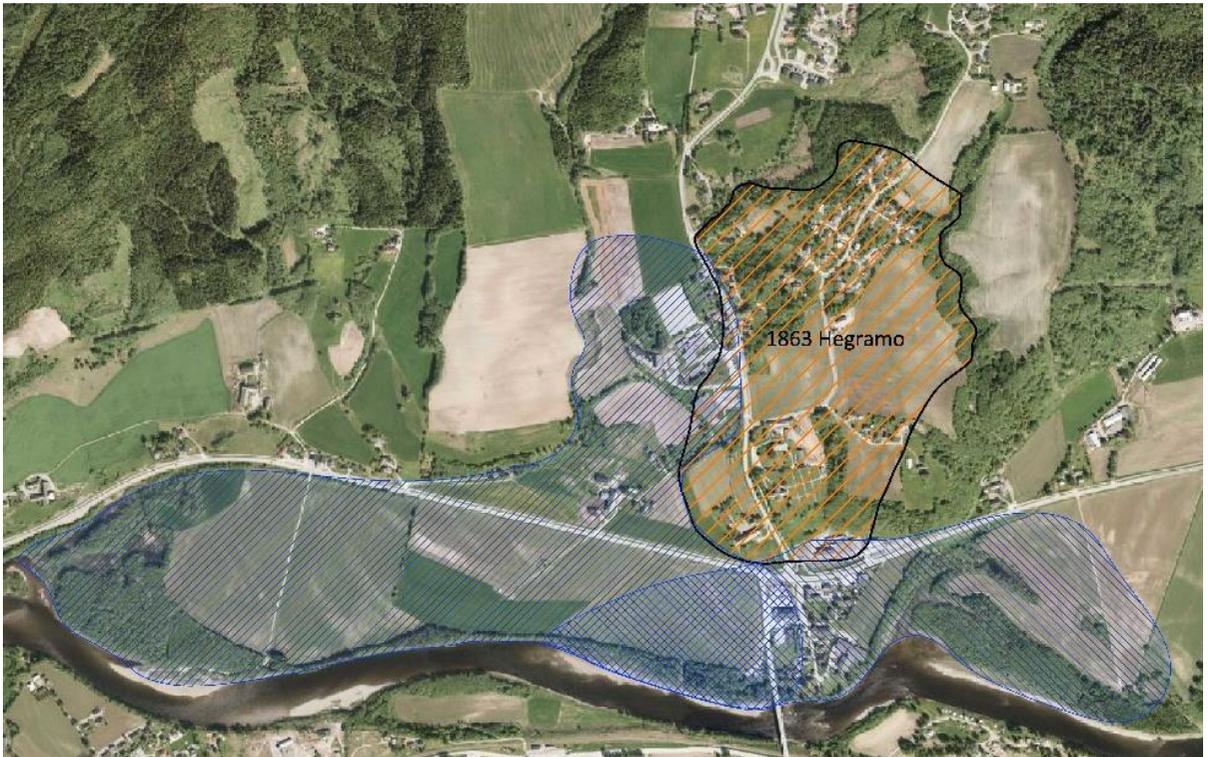
Figure 6. The total extent of the quick clay area and areas were debris from the two most critical slopes might represent risk.

Further works also included analysis to determine the total extent of run-out from the two most critical slopes and the possible debris flow direc-

tions based on empirical data and studies of topography in the area downstream the critical slopes.
