# Failure of a massive geosynthetic-reinforced clay dyke for a waste disposal plant: investigation of the causes

P. Ruggeri

**ABSTRACT:** To increase the capacity of a waste disposal plant located in a hilly site in central Italy, a new 25 m high barrage has been built to bound a valley and create a new waste storage over the upstream area. To minimize environmental risks, a geosynthetic-reinforced clay dyke has been designed for the plant. Just after the completion of the works and before entering into operation, clear signs of instability appeared at the upstream side of the dyke. To prevent the growth of such mechanism the dyke was immediately re-profiled by lowering the crest. A thorough ground investigations and monitoring were carried out to understand the causes of the instability; three main causes have been identified: unfavorable local geological conditions; inhomogeneity of the foundation soil; development of high pore pressures in the dam and in the subsoil. This case history turned out to be again an example of the importance of details for design and construction of geotechnical works particularly if of great impact for the environment.

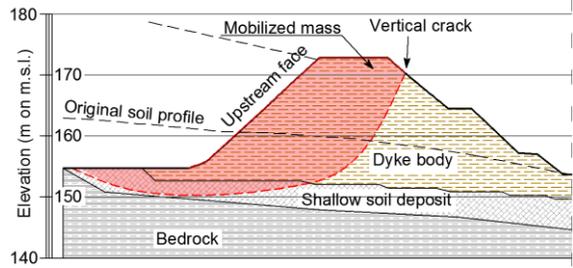
After the end of construction signs of sufferance of the embankment began to appear. First the unexpected rupture of a drainage pipe crossing the dyke, then the opening of a crack at crest on the downstream face and finally the settlement of an entire segment of the top road were occurring in sequence. The phenomenon became evidently a "mass movement" when a bulge of the ground appeared at the base of the upstream side. Therefore contingency measures were promptly activated: the lowering of the dyke and a ground fill over the bulge. Finally, at the removal of 7 m of soil from the crest for 60 m along the embankment, the paroxysmal movement came to a stop. Figure 2 shows the cross section of the dyke with a sketch of the mobilized mass.

Figure 2. Trace of the observed failure surface

Displacements were substantially vertical at the crest. The failure surface appears not regular,

being the boundary of a block compound phenomenon, and is formed by a steeper segment in the upper part and a sub-horizontal one in the lower portion. The described geometry of the failure is however a simplification of reality, as the observed displacements at the upper part of the dyke show some rotational components that suggest compatibility with a log-spiral failure surface.

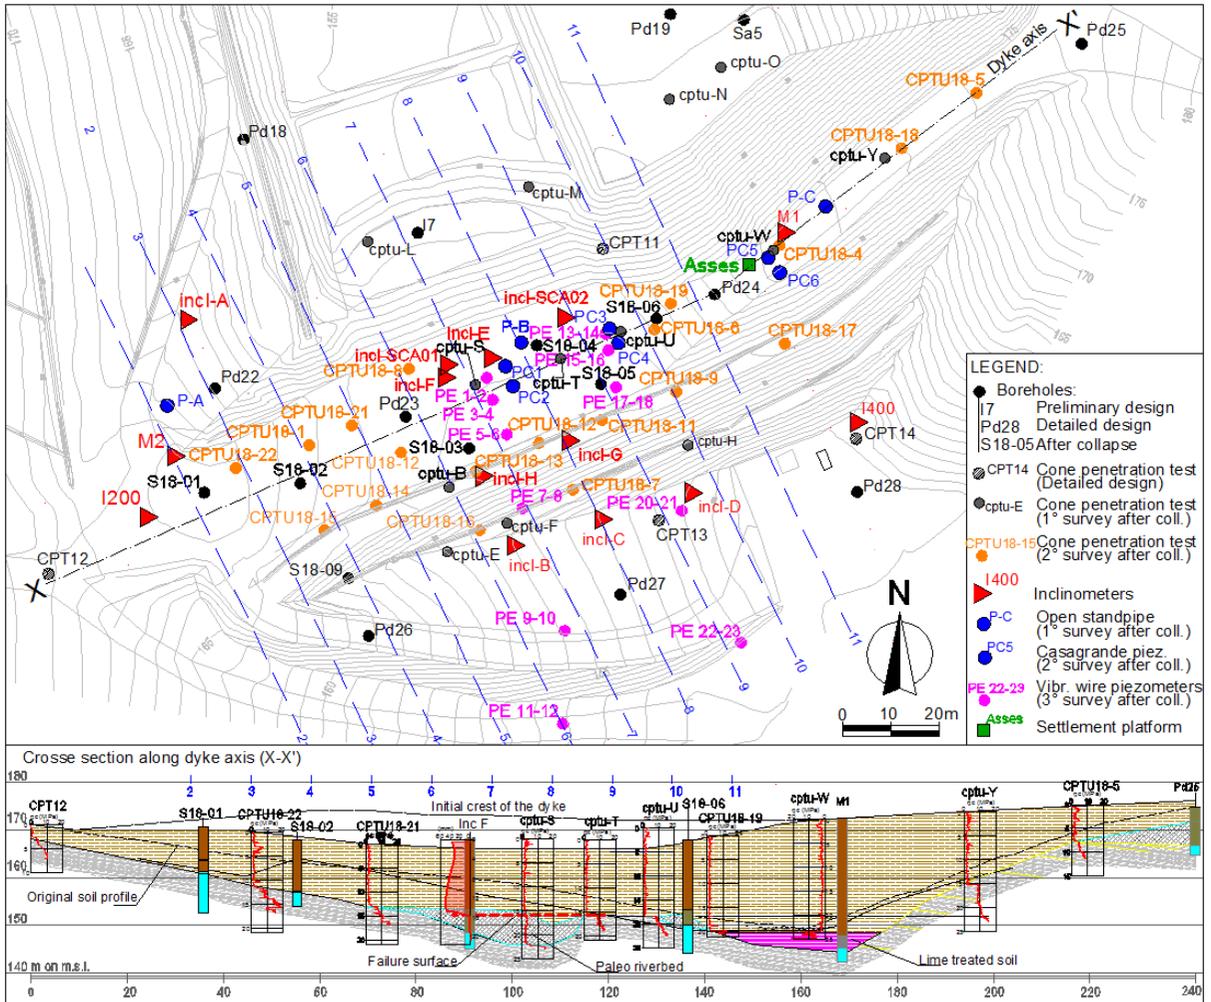
Figure 3. Layout of the site, investigations and resulting geotechnical model along cross section X-X'

The dyke body and the boundaries of the soft soil, of the lime treatment and of the bedrock can be distinguished. Figure 4 shows contours of the altitude of the interface between bedrock and the soft surficial soil.

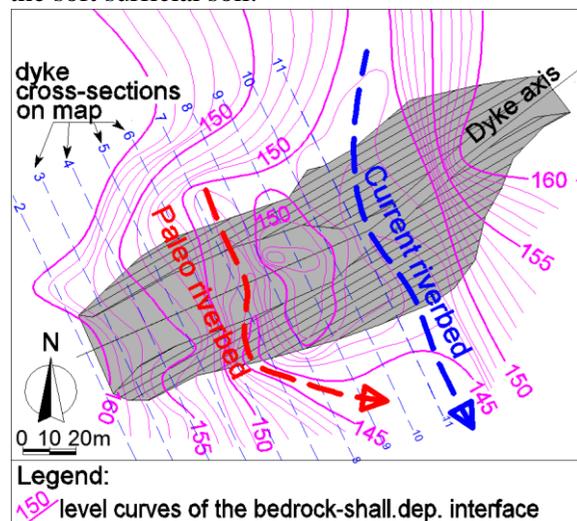
Figure 4. Level contours for the interface between bedrock and the shallow deposits

It is worth noting the displacement of the riverbed towards East and the consequent increase of the thickness of the soft soil filling. Such a displacement of the riverbed is linked to the immersion towards North-East of the bedrock and is the cause of the better geotechnical conditions of the left flank of the valley with respect to the right one. However the presence of a rather thick deposit of soft soil filling the paleo riverbed was not properly considered by designers and this posed the premises to the localization of a failure surface right in this zone of the dyke.

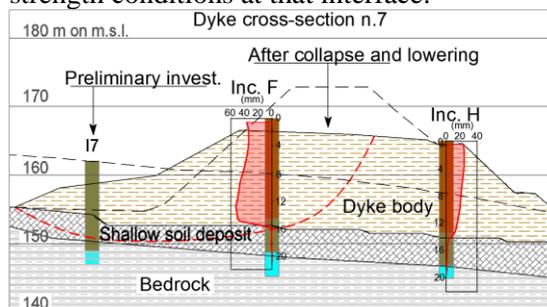
Figure 5 shows the cross section n.7 of the dyke (see Figure 3 for the trace of the sections), just where the instability occurred, with the relevant inclinometer profiles being shown. Note that inclinometer readings refer to the period after the paroxysmal event. The profiles show quite clearly that deformations are localized at the contact between the base of the dyke and the top of the shallow deposit. Moving upstream the failure surface deepens and localizes at the contact between the shallow deposit and the bedrock. Such geometry of the failure is very likely conditioned by the occurrence of residual strength conditions at that interface.

Figure 5. After collapse inclinometer profiles and resulting geometry of the failure surface

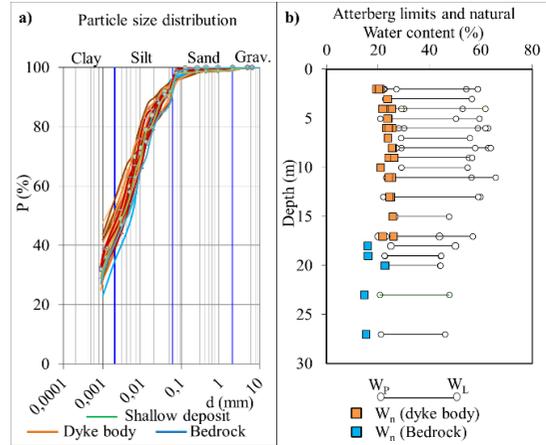
The geotechnical characterization of the soil deposits was obtained both through site, i.e. CPT's, and laboratory testing of undisturbed samples. Such testing addressed the dyke constituent materials and the foundation soil deposits, the shallow layer and the bedrock. Figure 6a shows the particle size distributions for all soils; a uniform composition made of 50-60% of silt and 40-50% of clay resulted from the tests. At-

terberg limits indicate that the soil of the embankment and the soil from the shallow deposit, as expected, have the same index properties: in both cases the clay classifies of high activity (CH). On the other hand, activity of the clay from the bedrock is low (CL). In Figure 6b index properties are compared with values of the natural water content: water content of soil samples taken from the dyke is close to the respective values of plastic limit while, for bedrock samples, water content is lower than the plastic limit.

Figure 6. a) Particle size distributions; b) Soil index properties and natural water content

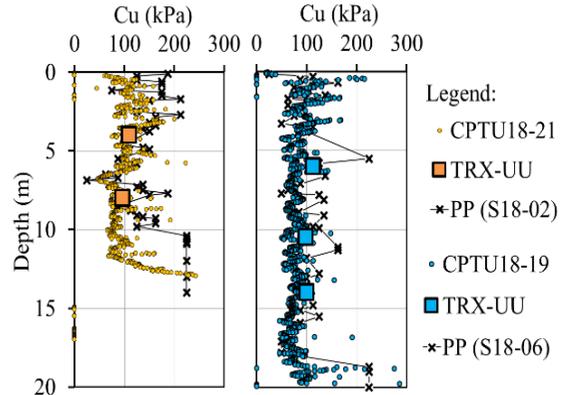
Shear strengths were then investigated. Undrained shear strength profiles have been estimated from CPT's through well-known correlations checked against undrained unconsolidated triaxial test (TRX-UU in Figure 7).

The samples taken from the body of the dyke show an undrained cohesion ranging from 80 to 100 kPa, independently of depth. Only occasionally, small values as little as 50 kPa have been registered. The same figure holds for the soil from the shallow deposit. Bedrock samples instead show undrained cohesion values ranging from 300 to 600 kPa.

Figure 7. Undrained shear strength profiles: derived values from CPT's, pocket penetrometer (PP) and Undrained Triaxial tests (UU)

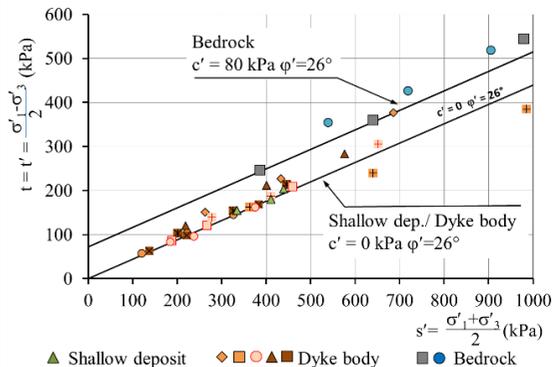
Effective shear strength have been evaluated by drained (TRX-CD) and undrained (TRX-CU) triaxial tests. Figure 8 shows the results of the tests in the plane of invariants. The estimated failure envelope for both the soils from the dyke and the shallow deposit can be described with a negligible effective cohesion and a friction angle of 26°. For the bedrock, the failure envelope gives an effective cohesion of 80 kPa and a friction angle of 26°. Such values well compare with the typical figures of this soil formation (e.g. Segato et al., 2015; Ruggeri et al., 2016). The residual shear strength was estimated by shear testing, either direct or ring shear. Samples from shallow deposit exhibit a failure envelope with a negligible effective cohesion and a friction angle ranging from 14 to 18°. Failure envelope for bedrock shows again negligible cohesion but a friction angle of 18°. This difference reflects those of the index properties between the two soils.

Figure 8. Failure envelopes from Triaxial Tests

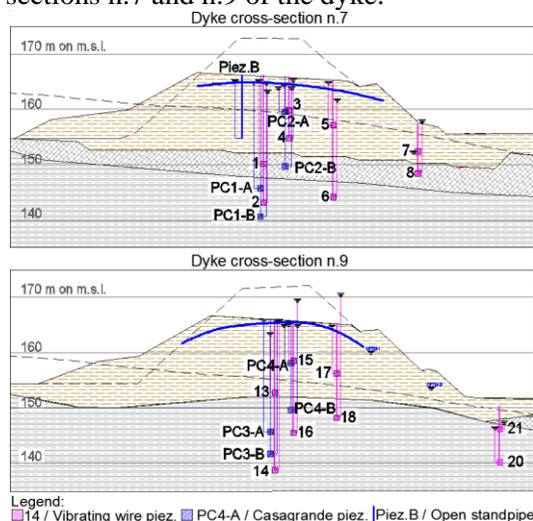
Figure 9. After collapse piezometric heads along cross sections n.7 and n.9 in Figure 4

The embankment is today fully saturated, and pore-pressures are significant both in the lower part of the dyke and in the ground. It is worth noting that two piezometers indicate that the piezometric level is well above the current crest.
