On the nexus of engineering failures in the ground

David M. Tonks, Ian M. Nettleton, Eugene M. Gallagher
Coffey Geotechnics Ltd, a Tetra Tech company, Manchester, UK

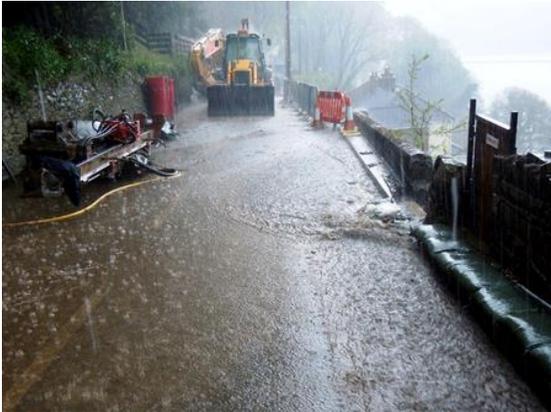
- there continue to be many incidents due to natural or climatic conditions, notably high antecedent and / or short duration high intensity rainfall. Cases continue to occur when surface and groundwater drainage needed to be better understood and managed both during construction and operation (Photo 1);

Photo 1. Surface water flooding above metastable slopes (Photo courtesy of Ms. S. Marsh).

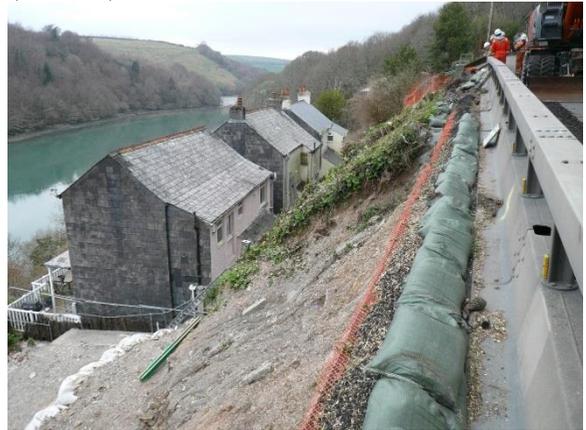
A tragic recent fatal landslide inquest brought together a nexus of multi-hazard issues including surface water; metastable slopes, and increasing demands on aging infrastructure (Photo 2).

Photo 2. Fatal landslide of metastable slope.

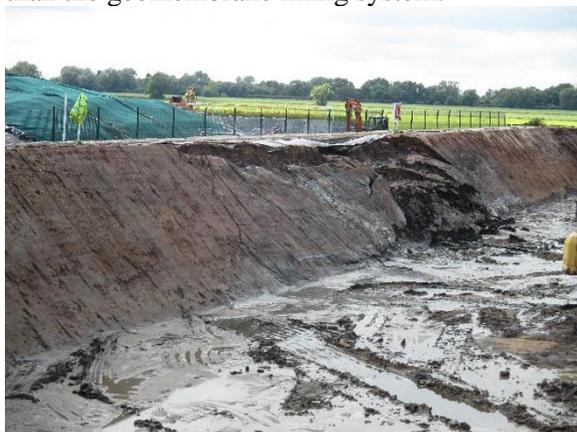
In recent years we have investigated several failures of relatively small facilities for agricultural or other wastes including lagoons for anaerobic digester plants. One such lagoon was formed of geomembrane-lined earthen bunds of about 4.5 m height constructed at slopes of 1V:1H. Several failures occurred during construction (Photo 3), in the earthworks rather than the geomembrane lining system.

Photo 3. Slope failure in oversteep soil bund (exposed after removal of overlying geomembrane).

- inadequate ground investigation and soil characterisation;
- oversteep slope angles for the soils used (predominantly sandy silty clays);
- cursory/inadequate geotechnical design;
- lack of suitable earthworks specifications; supervision or construction quality assurance (CQA) of the earthworks;
- lack of adequate compaction;
- slope failures during construction were reconstructed with unsuitable fill;
- higher-than-anticipated groundwater levels and slope seepages were addressed by localised drainage; and
- apparently no recognition of the warning signs during construction leading to a systemic review of the design.

Creating 1:1 slopes of this height would require lime/cement stabilisation of the soils or geosynthetic reinforcement. Opportunities to
