Assessment of peat slides and failure mechanism of blanket peat at Flughland, Ireland

P. Jennings & G Kane

Fehily Timoney & Company, Bagenalstown, Ireland. Formerly Applied Ground Engineering Consultants Ltd (AGEC), Bagenalstown, Ireland

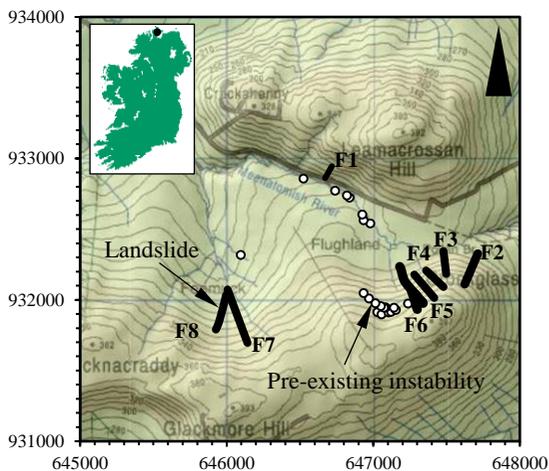
Landslides occurred on the relatively steep slopes surrounding the valley floor to the north and south and effected the public road and local electricity services. A number of the landslides originated in the headwater areas of these streams, with other landslides occurring within relatively open slopes.

Figure 1. Topographical location of site showing landslide locations (base GSI, 2018)

There were no previous landslides recorded in the area (GSI, 2018). Nevertheless, inspection of the site showed pre-existing instability, such as pre-existing tension cracks, slumps, partially displaced peat likely representing re-activated relict failures (Figure 1).

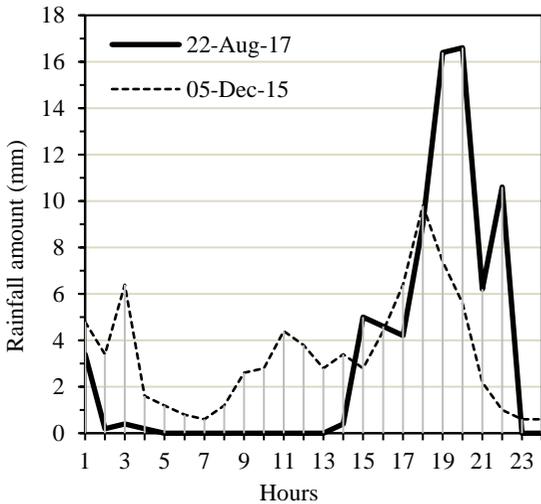
A comparison with the highest daily recorded rainfall at the station (80.6mm on 5 December 2015 during storm Desmond), in which no landslides were recorded in the area, is shown in Figure 2. The comparison shows that the hourly rainfall intensity on 22 August 2017 was notably

greater than that recorded on the day of the highest rainfall.

On 22 August, about 50mm fell in a 4-hour period. The hourly rates from 19 to 20:00 hours of 16.4 and 16.6mm/hr were the highest recorded at the station (since hourly records started in 1988) with the next highest falling a few days before on 17 August 2017. Clearly, the short-duration rainfall intensity was significant in initiating landsliding.

Figure 2. Hourly rainfall data (Met Eireann, 2018)

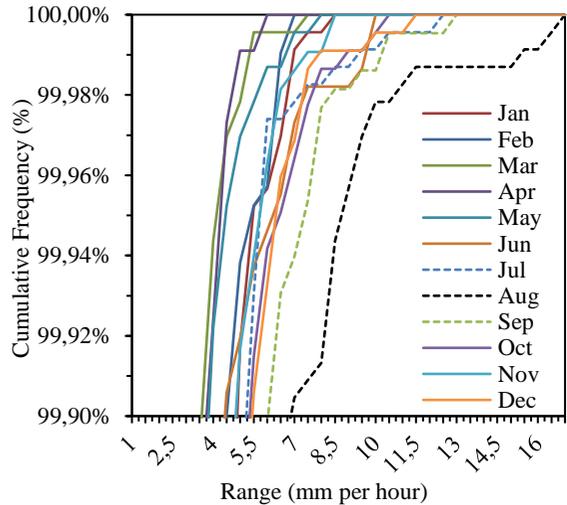
In north Co. Donegal the monthly rainfall averages vary from about 60 to 120mm, with broadly more rainfall occurring in the months October to January. However, rainfall intensity (mm/hr) is greatest from July to September. The higher intensity hourly rainfall amounts per month over about a 30-year period are shown in Figure 3, which clearly shows that August has a notably greater intensity of hourly rainfall; though the probability of such rainfall intensity is very low.

Figure 3. Hourly rainfall intensity for each month for 30-year period (Met Eireann, 2018)

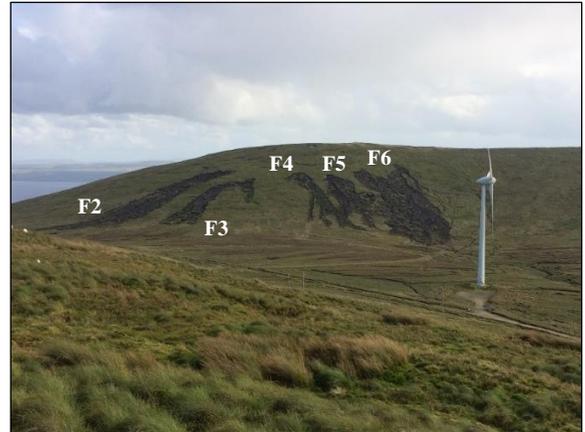
The landslides were clustered, and in some cases, there was little intact ground between

landslides (F2 to F6) see Figure 4. Landslide F1 blocked the local road, the remaining landslides occurred in open country and had no impact on infrastructure.

Figure 4 General view of landslides F2 to F6

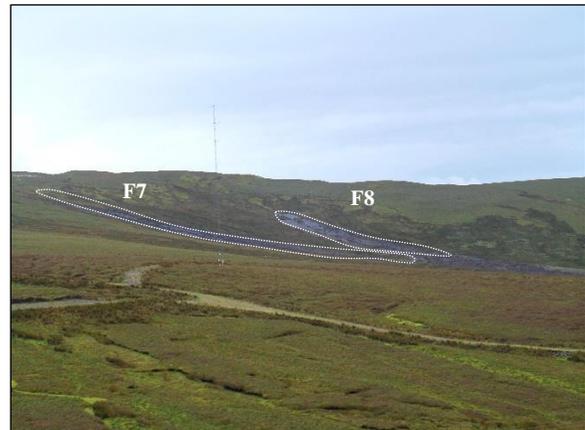
F7 and F8 occurred in the headwaters of streams within notably open and relatively uniform slopes with gentle gradients (less than about 10 degrees), see Figure 5.

Figure 5 General view of landslides F7 to F8)

- (6) Beyond the areas of recent landsliding there were signs of partial reactivation of pre-existing instability, such as multiple tension cracks (Figures 1 and 5). The failure mechanism that initiated this instability was undoubtedly similar to the above, but there was insufficient destabilising forces to cause full mobilisation of the peat. It is uncertain to what extent this relict instability existed prior to the recent rainfall event. In the face of a similar rainfall event, the presence of particularly pre-existing tension cracks could facilitate slope drainage and mitigate against potential build-up of excess groundwater, which could act to reduce the occurrence of similar rainfall-induced landslides. The presence of tension cracks though could increase erosion of the blanket peat.

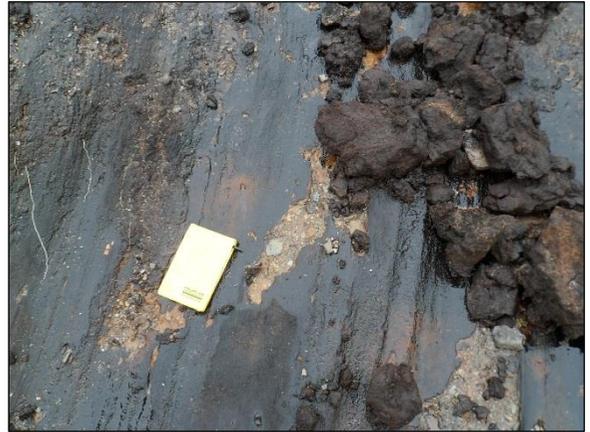
At a number of the landslides, the basal surface comprised a discrete black hard pan layer at the interface of the peat and underlying glacial soil (Figure 6). This layer was likely an accumulation of soluble humic colloids leached over time from the peat above and cemented to the underlying soil. The layer provided a discrete plane of sliding

and was essentially impervious and acted as an aquiclude. A similar hard pan was noted at the site of rain-induced peat slides at Polltomish in 2003 (Boylan et al, 2008).

Figure 6. Black hard pan below failed peat (F2)
