# Investigation into the likely cause of peat failure at Ballincollig Hill Wind Farm, Ireland

G. Kane<sup>+</sup>\*, R. Grennan\* & P. Jennings<sup>+</sup>\*

<sup>+</sup>*Fehily Timoney & Company, Bagenalstown, Ireland*

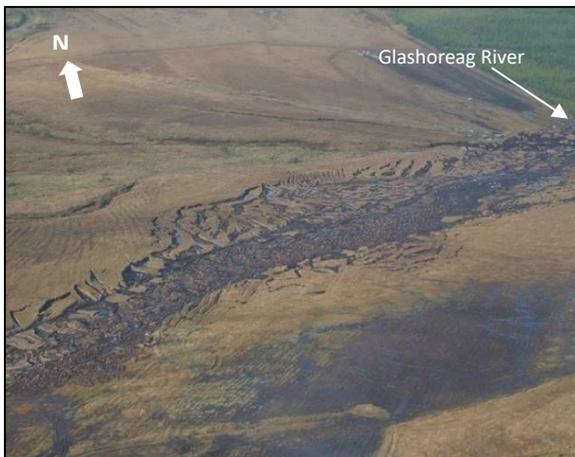
As a result of the failure a considerable volume of peat was displaced downslope (Figure 1) and entered the Glashoreag River.

Figure 1. Movement of peat towards the Glashoreag River

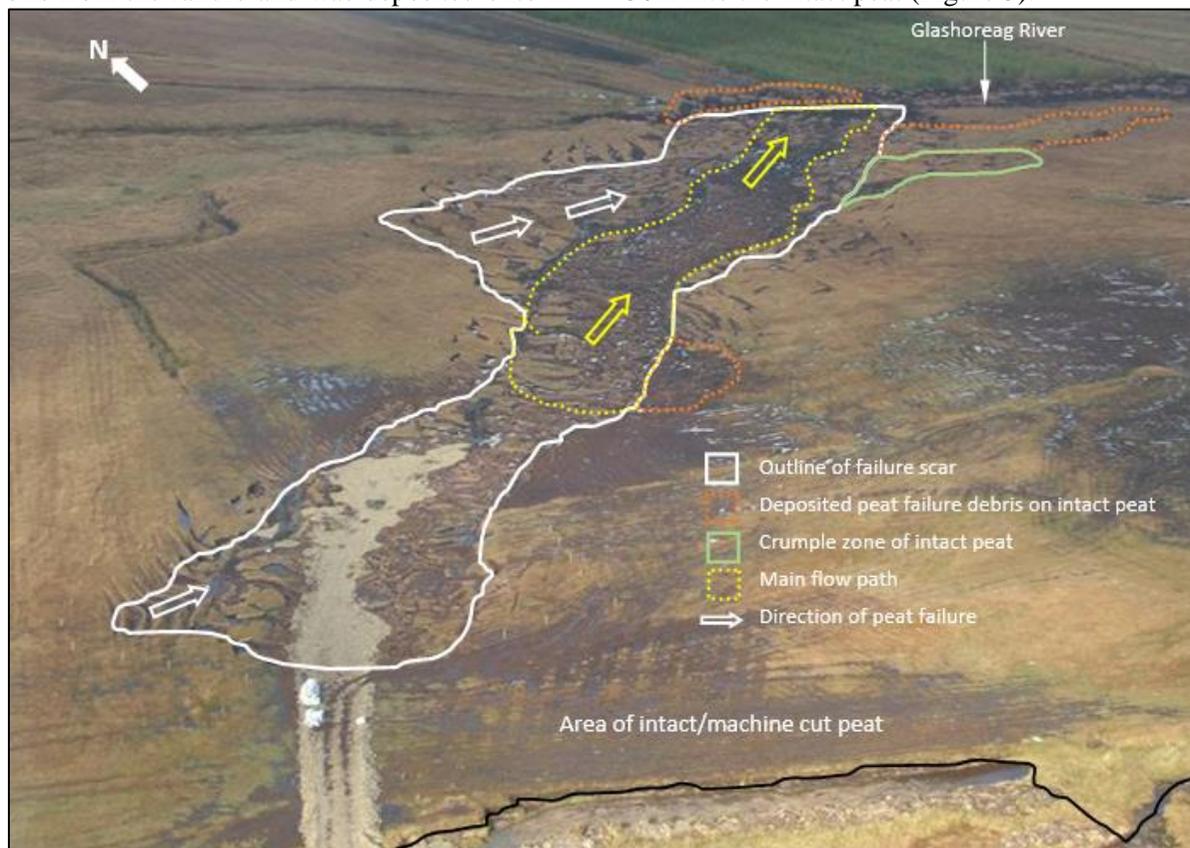
tact peat along the perimeter of the failure, including where the scar meets the Glashoreag River. On the southern side of the failure, upslope from an elongated debris deposit, there was a crumpled zone extending approximately 30m into the intact peat (Figure 3).

Figure 3. Morphological elements of the Ballincollig Hill failure

The crumpled zone represents the pressure or impact of the peat debris during the failure event.

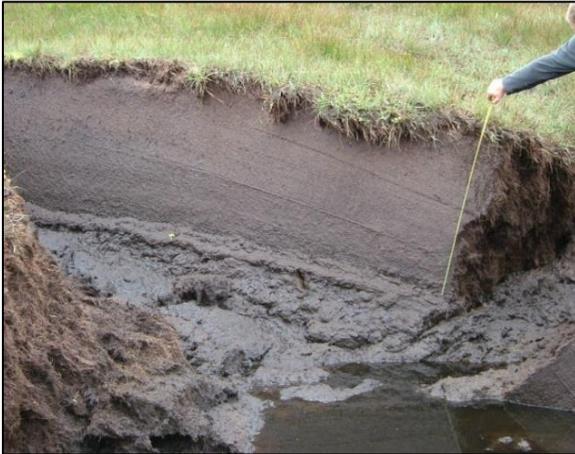
From examination of exposures, the failure appeared to have occurred about 100 to 200mm above the base of the peat and not at the peat/mineral soil interface or within the mineral soil. Following inspection of the site around the failure scar the thickness of peat varied from about 2.5 to 3m, the upper 1 to 1.5m consisted of fibrous peat (acrotelm) overlying humified peat (catotelm) (Figure 4). Typically, the in-situ undrained shear strength of the acrotelm varied

between 5 to 40kPa, while the catotelm undrained shear strength varied between 2.5 and 6kPa. It should be noted that in-situ field vane testing of peat, particularly within fibrous peat, can give an overestimated strength (Dykes and Jennings, 2008).

Figure 4. Typical composition of peat viewed from detached peat strips

The blanket peat was described as very soft to soft fibrous in the upper 1.5m grading to amorphous peat with an increase in depth (Figure 4). At the location of the failure the thickness of peat varied from about 2.5 to 3m. To the south of the failure scar the peat deposits were between 1 and 4.5m thick. The Von Post humification grading for the upper 1.5m of peat was relatively fibrous (humification of H3 to H5) with decreasing fibre content with depth (humification up to H8).

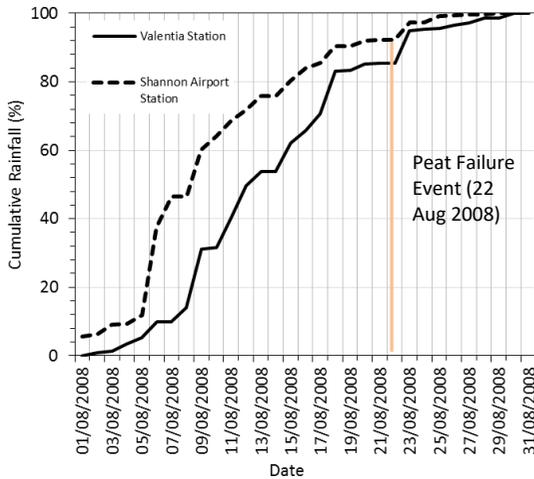
The antecedent rainfall during the first 21 days of August corresponded to about 90% of the total rainfall for the month and significantly occurred prior to the peat failure. This is highlighted in Figure 6 which shows the cumulative rainfall from both weather stations for the month of August in 2008. The significant rainfall before the peat failure would have resulted in a

significant amount of water being retained within the mechanical cuts made during the peat harvesting operations.

Figure 6. Rainfall records for the month of August 2008 (Met Éireann, 2018)
