Assessment of slope failure and engineering behaviour of raised marine deposits of the River Clyde, Scotland

P. Jennings⁺* & R. Grennan*

⁺*Fehily Timoney & Company, Bagenalstown, Ireland*

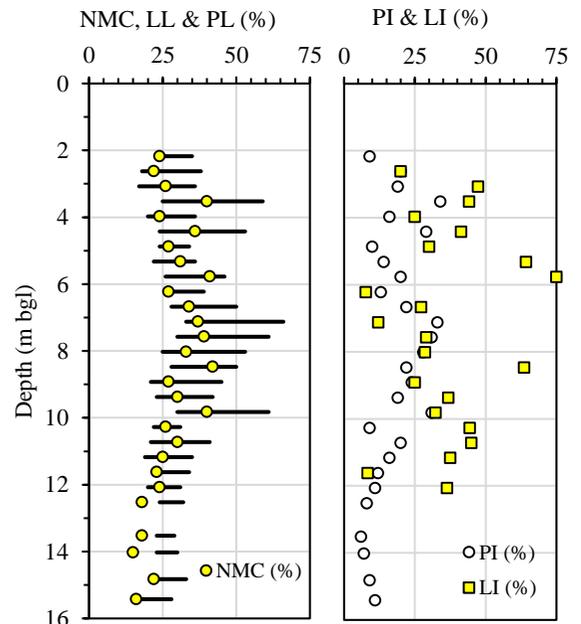
Figure 3. RMD index results with depth

Figure 3 shows index test results (natural moisture content (NMC), liquid limit (LL), plasticity index (PI) and liquidity index (LI)) with depth. The results indicate that above 12m depth the RMD comprises a more recent slightly over-consolidated deposit with plasticity of range from generally intermediate to high. Below 12m depth the RMD appears to be an older over-consolidated deposit with low plasticity.

The liquidity index (LI), which is a measure of relative moisture content of the soil, provides an indication of soil strength and sensitivity. Higher LI would indicate greater sensitivity and lower strength. LI is notably high between depths from about 5 to 6m, and locally at 8.5m depth.

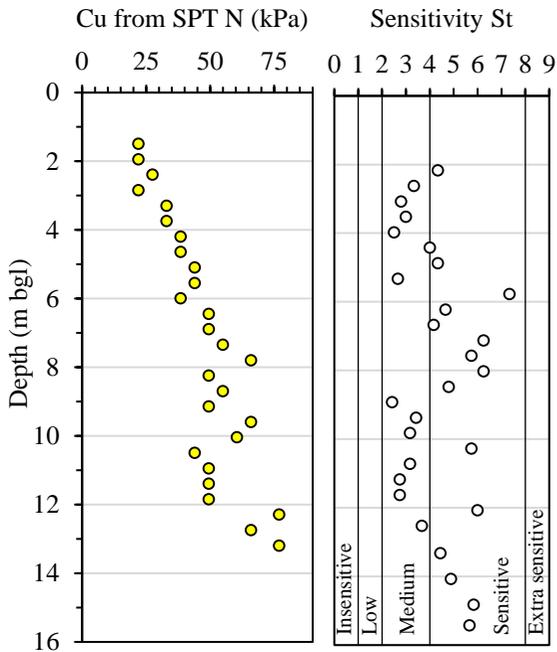
Figure 4. RMD strength (SPT N in c_u) and sensitivity with depth

Strength was determined both by insitu and laboratory testing, with the latter providing notably low values with no discernible trend with depth which is considered to be related to samples failing along laminations. Figure 4 shows the insitu strength with depth.

Hand vane results were also used to determine the sensitivity (S_t) of the RMD (ratio of peak to remoulded undrained shear strength). The average sensitivity was 4.3 (range 2.4 to 7.3). A sensitive soil would have a sensitivity of 4 to 8 (Skempton and Northey, 1952). Results show (Figure 4) a higher sensitivity from 6 to 8m depth and at greater depth below the toe of the slope.

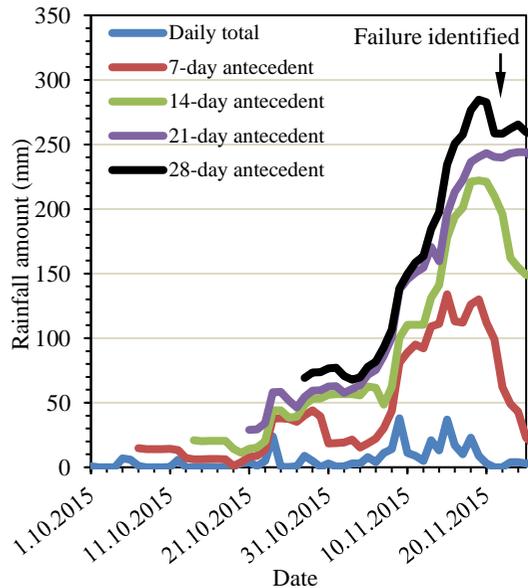
Figure 5. Antecedent rainfall prior to failure

Preceding the failure the rainfall amount in November was significantly high, with elevated rainfall amounts occurring from 9 to 18 November (Figure 5). From the beginning of the month up to 20 November about 240mm of rainfall had occurred which was about 180% of the long-term average monthly total rainfall of 131mm for November.

The antecedent rainfall amounts (for 7, 14, 21 and 28-day periods) were also examined, see Figure 5. This showed a significant rise in antecedent rainfall amounts from about 9 November onwards with a peak on 19 November 2015, a day before the failure was identified.

- (10) Prior to the failure, the rainfall was significant, with antecedent rainfall peaking the day before the failure was identified (Figure 5). The coincidence of a significant period of rainfall, approaching record levels, and the occurrence of the slope failure are considered to be related.

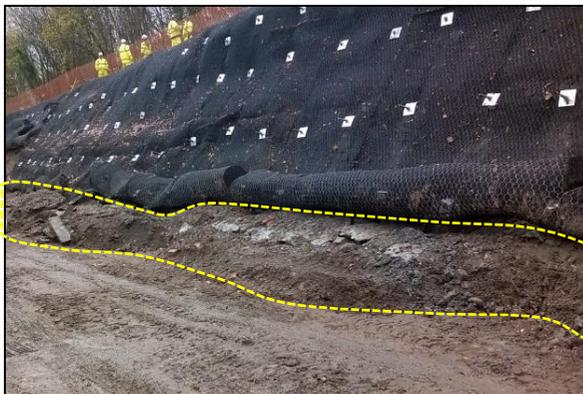
Figure 6. Bulging at slope toe (inside dashed line) indicating onset of slope failure

The initial indications of slope failure were bulging around a number of the lower rows of soil nail heads and particularly bulging and heave at the toe of the nailed slope (Figure 6).

The geometry of the back-scarp suggested a predominantly deep rotational failure. The failure surface appeared to pass below the soil nail block and daylight at the toe of the nailed slope. It was likely the failure surface essentially passed around the soil block and daylighted below the lower row of nails. This coincided with the observation of bulging at the toe of the nailed slope (Figure 6).

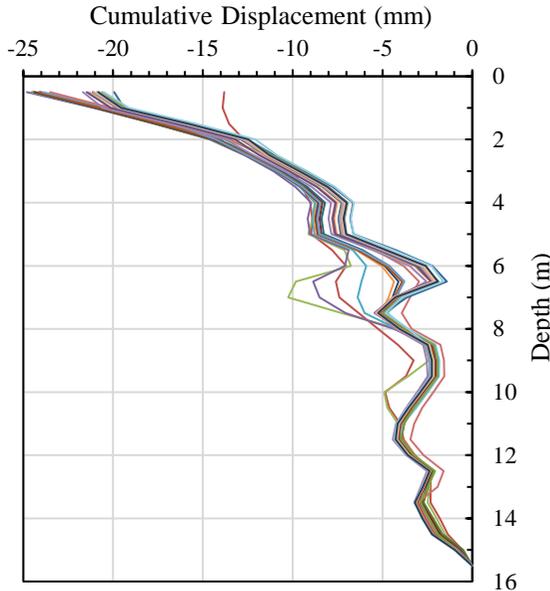
Figure 7. Displacement with depth from inclinometer readings (Dec 2015 to Mar 2016)

Ground displacement profiles with depth from inclinometers installed shortly after the failure showed there was a reasonably consistent ground displacement above about 6m depth. From below about 6m bgl the ground showed little displacement. Based on these readings, the basal shear surface was assumed at 6m depth at the inclinometer location, and confirmed the deep-seated nature of the failure (Figure 7).

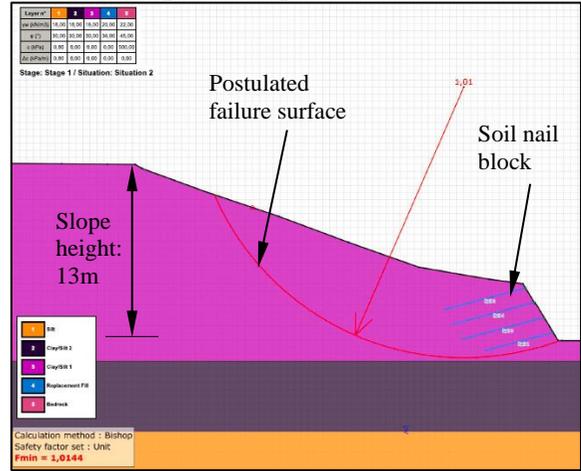
Figure 8. Slope geometry and stability analysis (peak $\phi' = 30^\circ$ and r_u 0.4)

The drained analysis was carried out for a typical range of soil friction values (ϕ') and a range of r_u (Figures 8 and 9). The drained analysis results showed that for failure to occur at peak strength ($\phi' = 30^\circ$) then a notable groundwater level ($r_u = 0.4$) was required in the slope. The actual recorded groundwater level in the slope was relatively low. As such, for failure to occur the operating soil strength in the slope would

have had to be notably lower than peak strength. The analysis suggests the presence of a weaker soil in the slope was required to cause the failure.

Using the back-calculated operational strength from the above analysis a remedial design was carried out. The failed slope was remediated using a cantilevered contiguous piled wall prior to the removal of the temporary slope support.

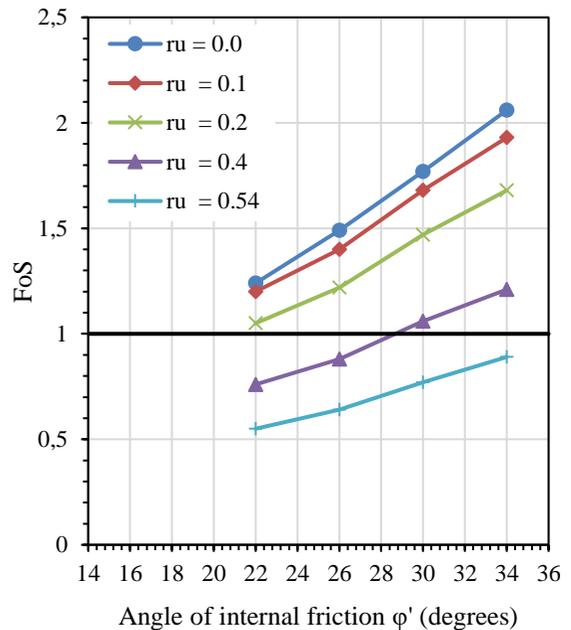
Figure 9. Slope FoS versus internal friction angle (ϕ') for a range of r_u

Based on the results of the stability analysis, for failure to occur the operational soil strength in the slope was notably less than that determined from ground investigation. The weaker soil in the slope was likely due to the presence of a previous part failure surface in the slope, or possibly long-term slope movement resulting in localised strain softening (reduction in strength) over time, leading to progressive failure.
