Damage assessment within the Kathmandu valley's World Heritage Monument Zones after 2015 Gorkha Earthquake

Evaluation des dommages dans les zones des monuments du
patrimoine mondial de la vallée de Kathmandu après le tremblement
de terre de Gorkha de 2015

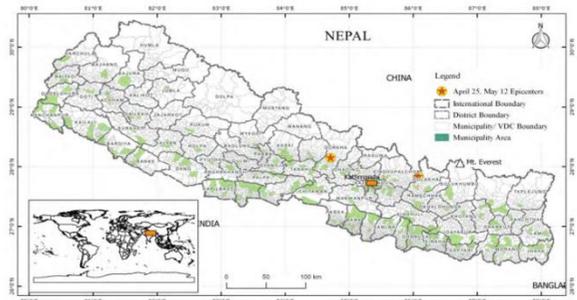
inset map of Nepal's location on a world map (source: NSET, 2015)

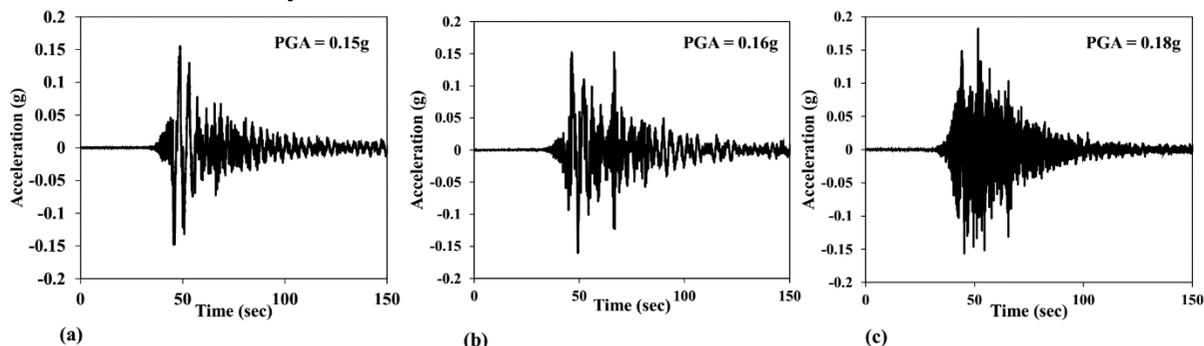
Fig. 2. Acceleration-time history record of 2015 Gorkha Earthquake mainshock event recorded at Kantipath Station in Kathmandu (27.71235N 85.31561E) (Data from: <https://strongmotioncenter.org/>)

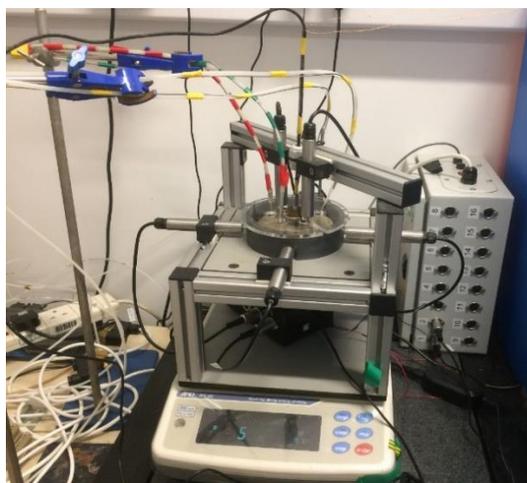
Figure 5. The Durham water retention frame

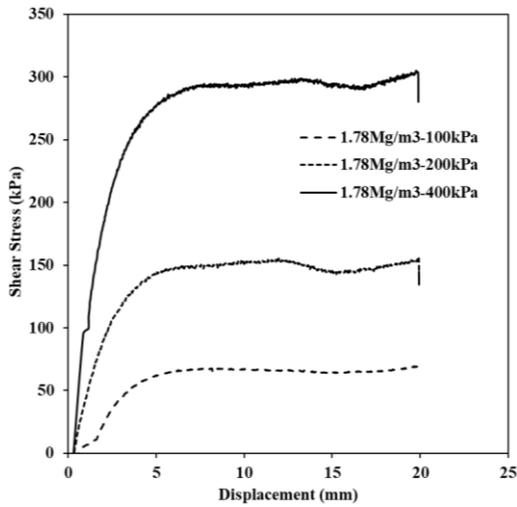
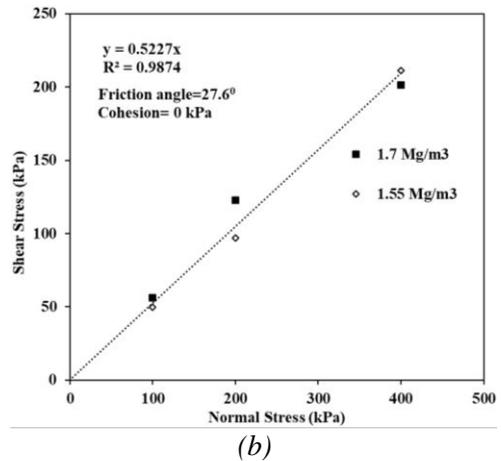
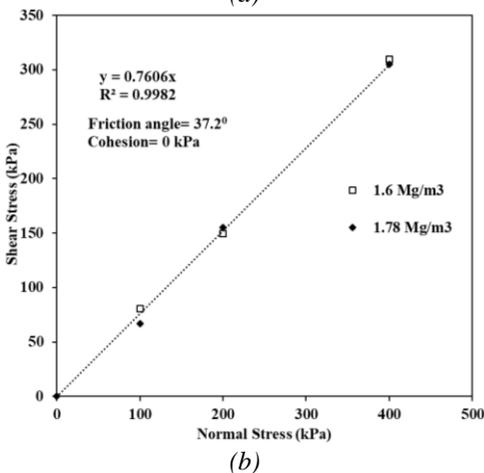
Figure 7. Pashupati soil response (a) shear stress-displacement (b) shear stress-normal stress

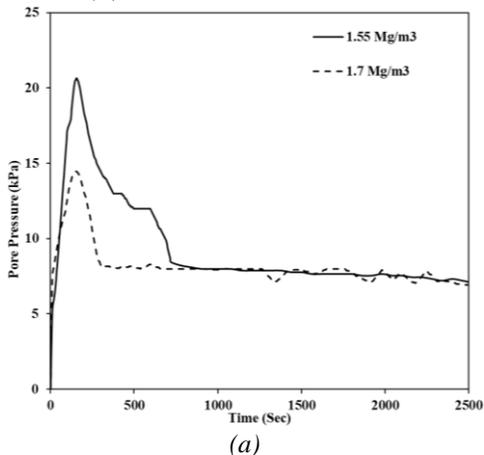
Fig. 8. Changu Narayan Soil sample (a) Pore-pressure response during consolidation (b) Shear stress-normal stress

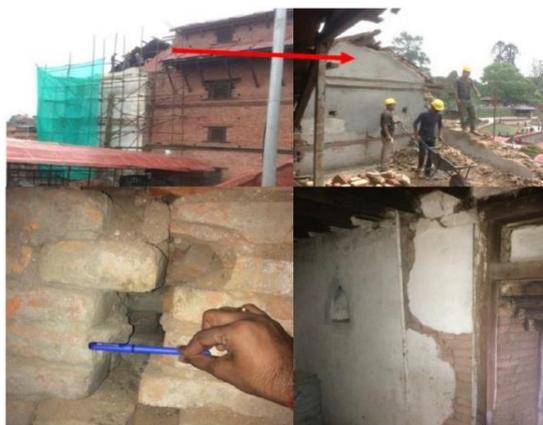
Figure 10 View of the collapsed portion of the courtyard building

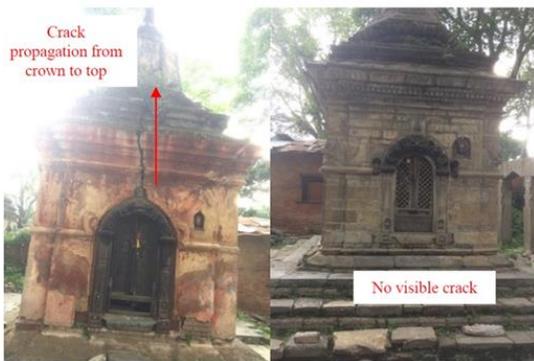
Figure 11 View of visible crack in a temple made of brick masonry and no such crack in a stone temple.
