# Scour, Settlement & Stabilisation of Linton Bridge

A. Willoner

*Mott MacDonald, Sheffield, UK*

**ABSTRACT:** On Boxing Day 2015 Storm Eva peaked flooding large parts of North Yorkshire and damaging over a hundred bridges. Scour of the river bed at Linton Bridge resulted in sudden settlement of the south pier and severe damage including loss of thrust to the south arch. The bridge, a grade II listed structure which connects the villages of Collingham and Linton, was deemed to be in a dangerous condition and immediately closed. This paper highlights risks associated with old multi-span masonry river bridges on spread footings which may be perceived as being stable following serviceable life well in excess of 120 years. It describes the key design decisions and complex works carried out to safely assess the damage, provide stabilisation measures and design and construct a new reinforced concrete structure hidden within the bridge's original fabric. Experiences are documented from several challenges including designing a new deck within the limited depth between the crown of arches and carriageway, boring through strong slender piers with restricted weight plant to form stiff pile

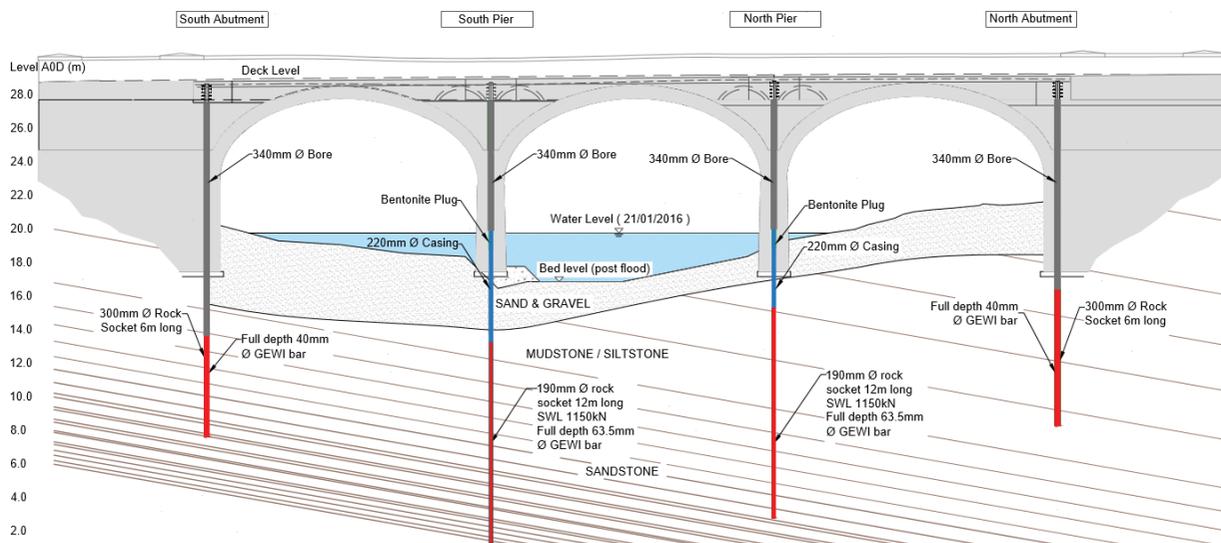
Figure 2. Geotechnical long section

The most significant geotechnical information regarding scour risk was the discovery that the south pier was founded on 2.75m of granular alluvium and the north pier on or close to rockhead (Figure 2).

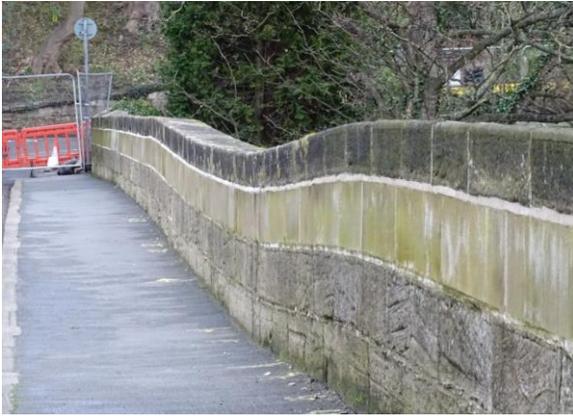
Figure 3. Sunken parapet above the south pier

Figure 3 illustrates the deformation of the sunken parapets following settlement of the south pier. The point cloud survey confirmed the crack through the south arch barrel to be 30mm wide and the crack through the central arch barrel to be 10mm wide. This survey also highlighted a 35mm horizontal displacement of the south pier towards the center of the channel, 29mm further settlement at the upstream end of the pier relative to the downstream and a rotation of the south pier towards the center of the channel of 0.4 to 0.5°.

The central section of the south arch, approximately 5m in length, was left supported by tension within the mortar joints and the 2007 concrete saddle. Masonry is very poor in tension and collapse can be sudden and without any warning. If the mortar failed it was expected that this 150t section would drop out and result in a domino failure of the entire bridge into the river as illustrated by the Eastham Bridge collapse in May 2016.

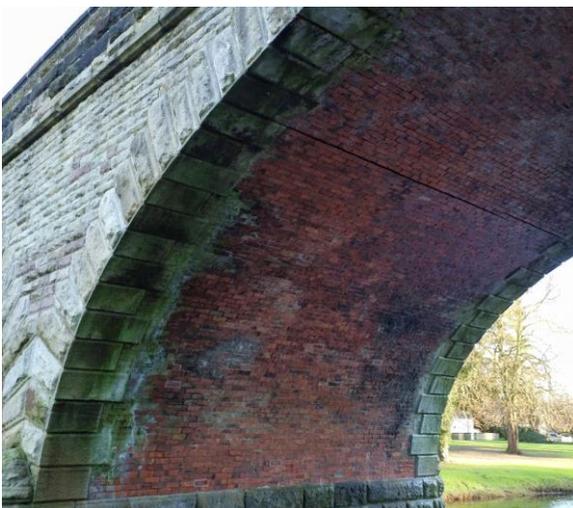
Figure 4. Transverse crack through south barrel and intrados

Transverse cracks were clearly visible running through the entire length of each arch barrel adjacent to the south pier and up through the intrados (Figure 4).

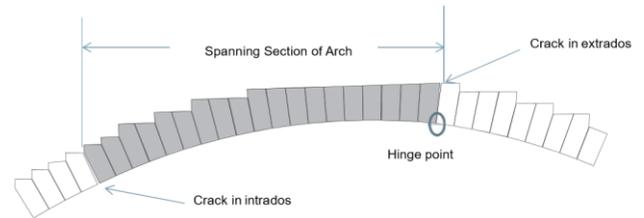
Figure 5. Diagram illustrating flattening of arch

Figure 5 illustrates the longitudinal deformation of the south span using data from point cloud survey and a simplified diagram.

The shaded voussoirs have rotated around a hinge point in the intrados at the south end. The settlement of the south pier to the left of the grey blocks opened up the transverse crack across the arch. The cracks in the intrados and extrados indicates that compression in the arch is lost. The assessment assumed that there would be reflective cracks on the extrados of the arches and this was confirmed when the south and central arches were exposed. Two large transverse cracks on the extrados of the central arch and small cracks on the south arch were observed beneath the carriage. Due to the twisting nature of the deformation, the south arch closed up on the extrados whilst the central arch opened. Some immediate support was provided to the south span for the following reasons:
