# Slope stability aspects for municipal waste landfills. Case studies and numerical modelling

L. Batali

*Technical University of Civil Engineering Bucharest, Romania*

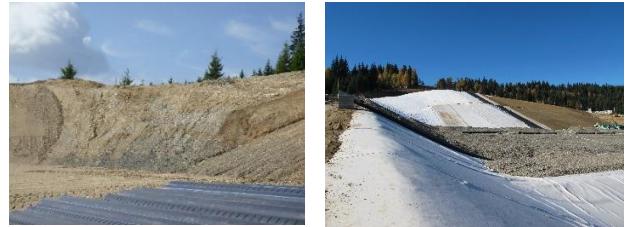
Figure 2 (left) shows the case of a new landfill, under construction at the time the photo has been taken, with too steep slope for the cells, of 2:3 (V:H), for 28 m in height and 60 m slope length. A simple stability analysis for the drainage layer on this slope showed the following:

- for dry conditions the safety factor was  $F_s = 1.22$ ,
- for horizontal seepage,  $F_s = 0.92$ , unstable
- for seismic conditions,  $F_s = 0.96$ , unstable
- for construction equipment up slope in dry conditions,  $F_s = 1.22$ ,
- for equipment up slope + horizontal seepage,  $F_s = 0.95$ , unstable

- for equipment down the slope,  $F_s = 1.16$ .

Figure 2. Example 2 – new landfill – improper design of the side slopes without geotechnical calculations – before (left) and after remodelling (right)

Also, the geocomposite clay liner to be installed on this slope was tensioned with 85 kN/m, above its tensile strength. Therefore, the slope was remodelled to a less steep inclination (1:3 V:H) and by introducing a berm and a veneer reinforcement by geogrid in the drainage layer (Figure 2 - right).

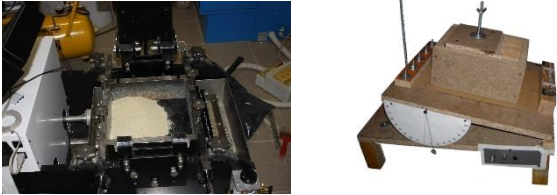
Shear tests have been performed at the interface between the various materials in contact (shear box and inclined plane – Figure 4), the results showing that the friction angles varied between  $14^\circ$  and  $19^\circ$  (for  $18^\circ$  slope inclination). The tensile force to be overtaken by the drainage geocomposite (108 kN/m) was far

beyond its strength, leading to the observed rupture. But also, it has been found that the geomembrane was textured on only one face and had very heterogeneous roughness and that the drainage geocomposite has a too low peel strength and non-homogeneous bonding between the components (Figure 5).

Figure 4. Example 3 – shear tests at interface (Batali et al, 2014)

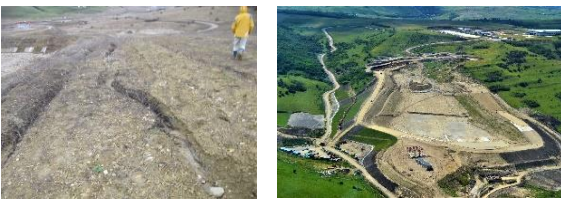
Figure 6 (left) shows another example of improper design, but also improper execution, this time for the dikes of a new landfill, which have been built using inadequate materials (local clays) and without proper compaction, which eventually led to failure of the dikes. The dikes had to be demolished and re-built using the local soil improved by mixing with hydraulic binders (fly ash and lime) (Figure 6 right).

Figure 6. Example 4 – new landfill – improper design and execution of the dikes (left), after reconstruction (right)

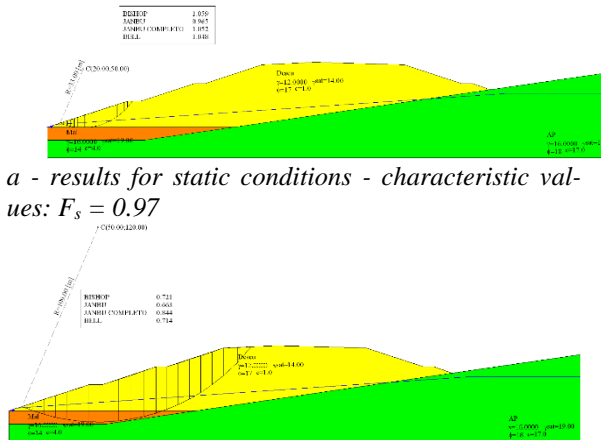
The forensic analysis carried out showed that the geotechnical investigation consisted of only a couple of boreholes of max. 6 m deep and disposed around the site, therefore no knowledge about the geotechnical characteristics of the site below the waste, no hydrogeological data and no slope stability analysis. Also, the landfill had no drainage system, thus the leachate accumulated within the waste mass, leading to the instability phenomenon. A new, proper, geotechnical investigation allow to carry out slope stability analysis. The waste geotechnical characteristics ( $\phi = 17^\circ$ ,  $c = 0$  kPa) have been chosen based on literature and by back – calculation such as obtaining a safety factor slightly less than 1 for the actual conditions. Figure 8 shows the LEM results for the actual situation in static and seismic conditions.

To be noted that the technical regulations recommend to check the stability also by superposing a high level of water and the seismic action. Also, to be noted that the failure surface in static conditions is in the waste mass, which corresponds to the observations on site after the landslide occurred, while for seismic conditions the critical failure surface is deeper caused by the presence of a muddy layer (deposited waste from waste water treatment plant) discovered during the final geotechnical investigation.

a - results for static conditions - characteristic values:  $F_s = 0.97$

b - results for seismic conditions - characteristic values:  $F_s = 0.67$

Figure 8. Example 5 – old landfill – results of LEM stability analyses with characteristic values

The stability analyses showed that the rise of the leachate level in absence of a drainage system, combined with an overcharge at the slope crest by an additional waste mass were the cause of this phenomenon. But, in fact, the lack of design and investigation can be considered to be the real cause. The landfill is now under consolidation works including pile retaining structure and a gabion retaining wall and drainage system.

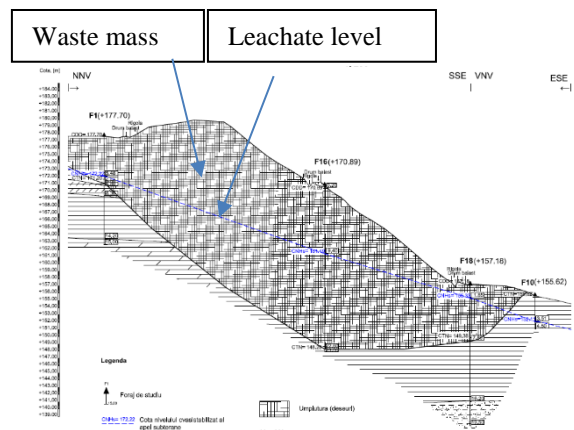
No geotechnical investigation has been carried out before the design of the closure, while the design was a typical one, according to the “recipe”, with no stability analysis. Geotechnical and hydro-geological investigations performed after the events on site showed that the waste layer was thicker than expected (up to 19.60 m) and an old man-made excavation filled with waste, having a maximum thickness of 19.6 m, was emphasized. The ground beneath the waste was a clay, sometimes silty, in saturated state, soft to stiff consistency. Figure 10 is showing a cross-section.

Figure 10. Case study – old landfill – cross-section

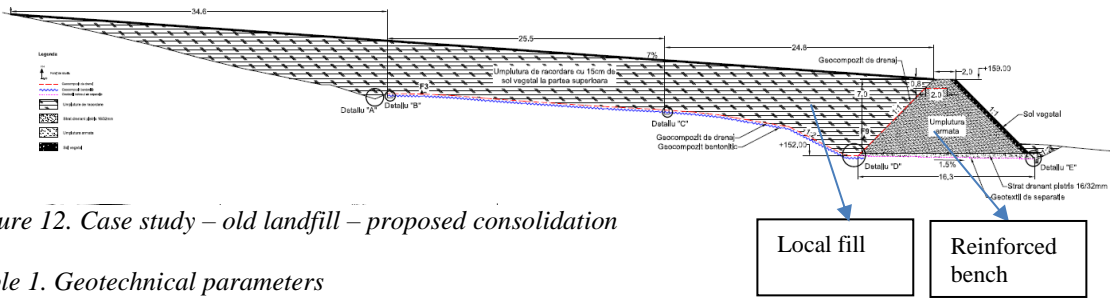
The conventional LEM stability analyses showed that the bench increases the stability of the landfill in seismic conditions to a safety factor slightly above the limit ( $F_{smin} = 1.04$ ). Calculations have been carried out according to EN 1997-1 (Eurocode 7).

Figure 12. Case study – old landfill – proposed consolidation

Thus, it was proposed to consolidate the landfill in 2 main stages:

1. a drainage system - 6 vertical wells and 3 lines of drainage trenches - for lowering the leachate level to approx. +1.50 m above the ground level, level to be maintained min. 270 days, while monitoring the landfill settlements.

2. a mechanical consolidation for ensuring the required safety margin against failure in seismic conditions – a geosynthetic - reinforced soil bench disposed at slope toe (Figure 12).
