Geological-geotechnical characterization of a deep-seated landslide affecting a road-bridge in Alcoy (southeastern Spain)

J.L. Pastor, R. Tomás, A. Riquelme, M. Cano
University of Alicante, Alicante, Spain

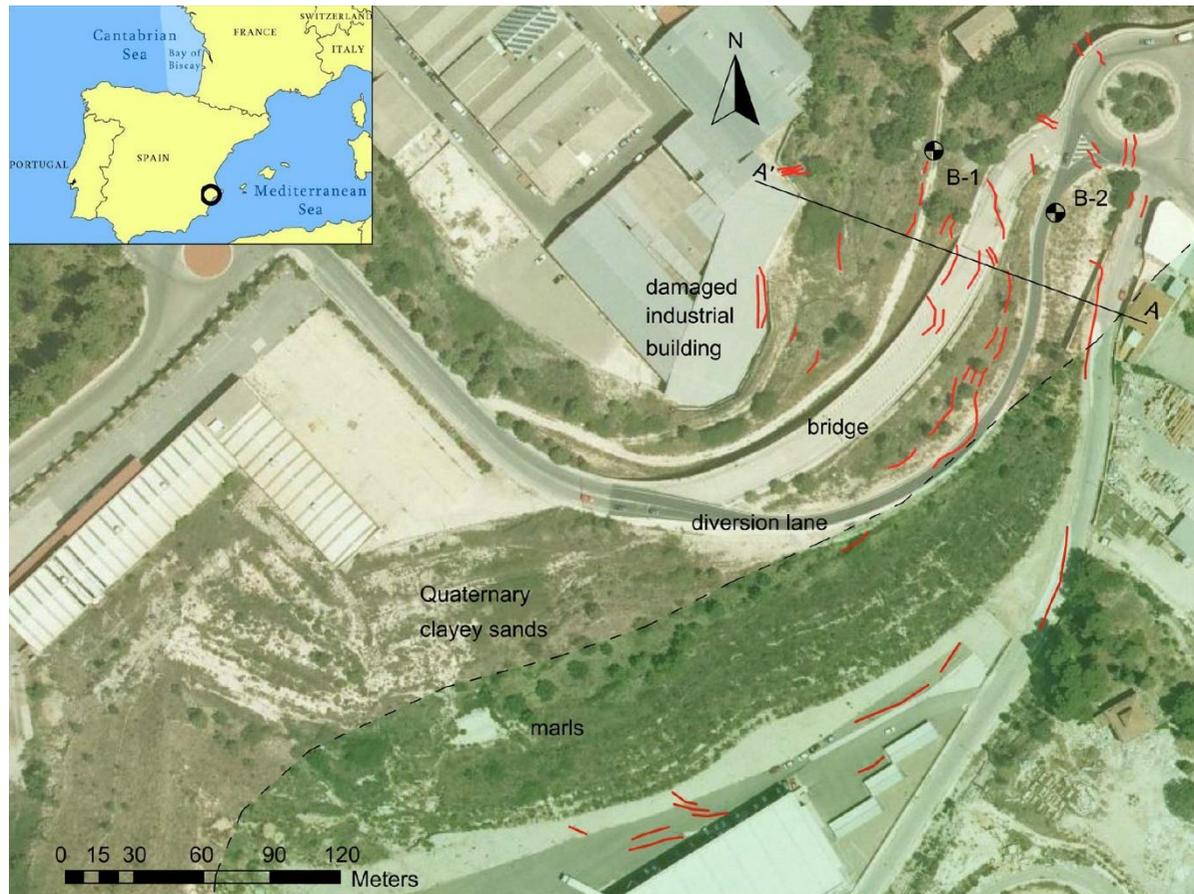
The spatial distribution of these layers is shown in Figure 1. It can be seen that the Quaternary deposits are located from the toe to the centre of the slope, whilst the marls are located from the centre to the top.

Figure 1. Geological and crack's distribution map of the study area and location of boreholes B-1 and B-2.

The tension cracks observed during the visual inspections of the slope and the nearby area are shown in Figure 1. A large number of tension cracks were detected near the north abutment of the bridge and between the bridge and the diversion line built after the damage caused by the landslide. Some cracks were also observed at the toe of the slope, by the damage industrial building, and at the top, on the edge of the access road to the industrial building located at the bottom of Figure 1.

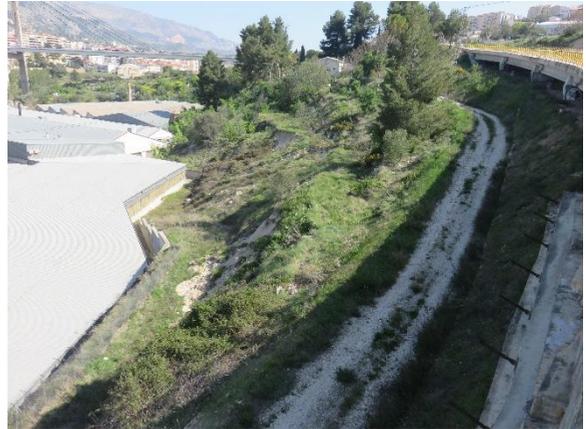
Figure 3 shows a general view of the damaged industrial building located at the toe of the slope (bottom left of the figure) and the bridge (top right of the figure) from the left side of the slope.

Figure 3. General view of the slope.

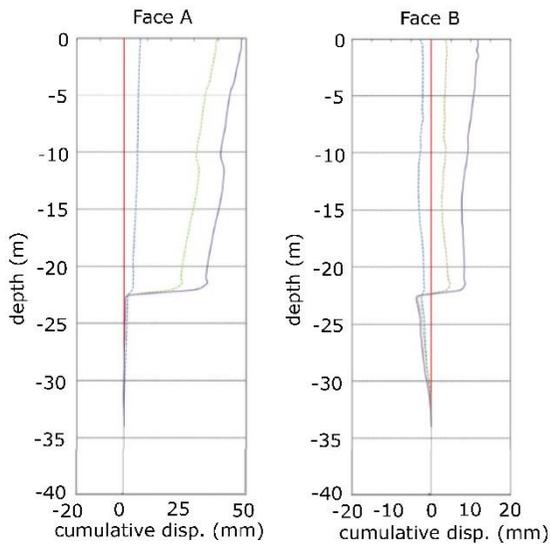
According to the information provided by the two inclinometers, the sliding surface is located at a depth of 23 m in the inclinometer 1 and of 7 m in the inclinometer 2. The location of the inclinometer is shown in Figure 1. The recorded displacements of the inclinometer 1 from November 2012 to February 2013 are depicted in Figure 2.

Figure 2. Profile of the Inclinator 1.

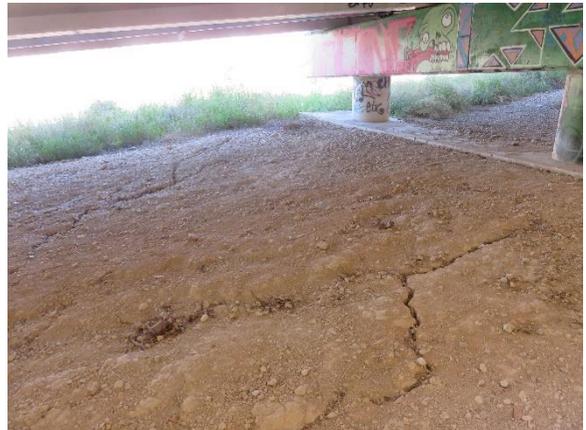
Two tension cracks located near the north abutment on the soil surface below the bridge are shown in Figure 4. The landslide has affected the bridge in such an extent that some of the precast beams have been displaced out from its elastomeric bearing pads. The displacements of the outside precast beams have broken the seismic shear keys of the bridge, Figure 5. All this damage alongside the active instability has ended in rendering the bridge unusable.

Figure 4. Tension cracks on the soil surface below the bridge

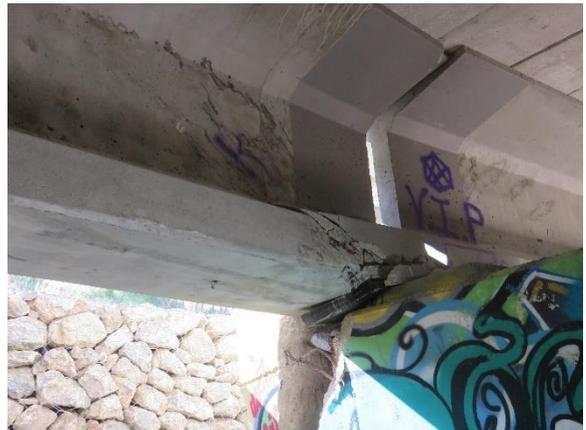
Figure 5. Damaged precast beam. Note the state of the neoprene bearing pad.

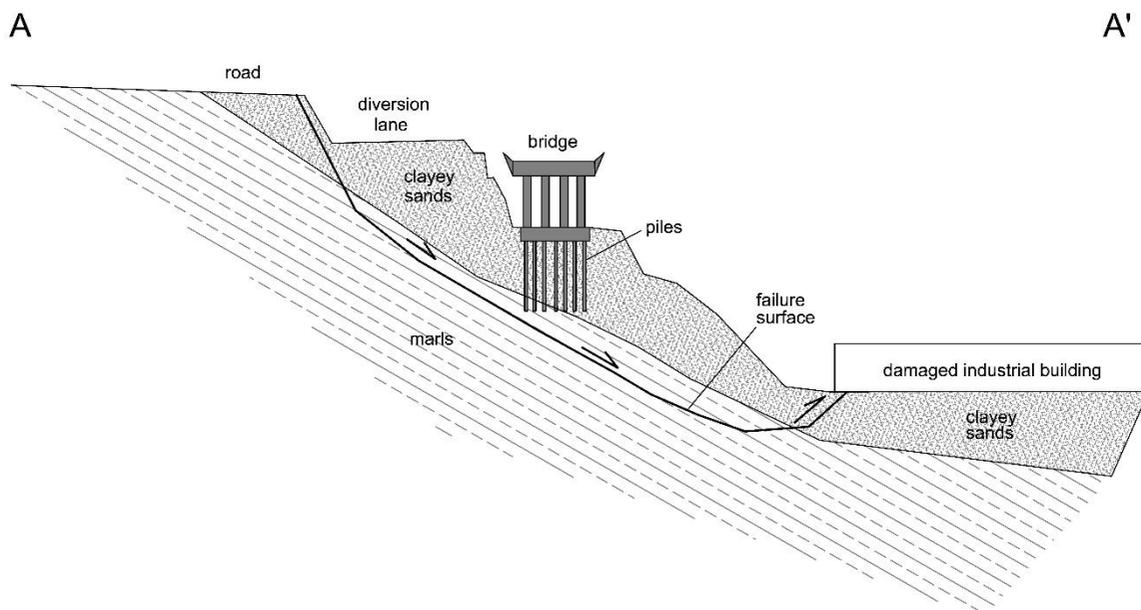
The information provided by the geophysical investigation along with the information obtained from the inclinometers have allowed to define the failure surface of this deep-seated rotational landslide, which is shown in figure 6.

Figure 6. Cross section AA' with the estimated failure surface.
