# Scour and foundation damage at the Vespucci Bridge on the Arno River in Florence (Italy)

R. Bardotti, J. Facciorusso, C. Madiati & G. Vannucchi

**ABSTRACT:** The Amerigo Vespucci Bridge on the Arno River in Florence (Italy) was built in the 50's of the last century. The bridge has three spans and a total length of 155.5 m. The deck is in pre-stressed reinforced concrete, the piers, the abutments and the foundations are in reinforced concrete. The foundations of the piers consist of caissons supported by bored piles, with diameter 0.40 m and length 15 m. The piles are weakly reinforced only in the first 3 m from its head. At the time of the construction of the bridge, the subsoil stratigraphy consisted of a surficial alluvial layer of sand and gravel with a thickness of 10-12 m overlying a deep layer of overconsolidated clay. The bridge is located immediately downstream of a hydraulic weir which is heavily inclined with respect to the water flow direction. Such inclination causes a deviation of the water flow and situations that can be very different from each other even within a few tens of meters of distance. In particular, the right pier of the bridge is affected by a conspic

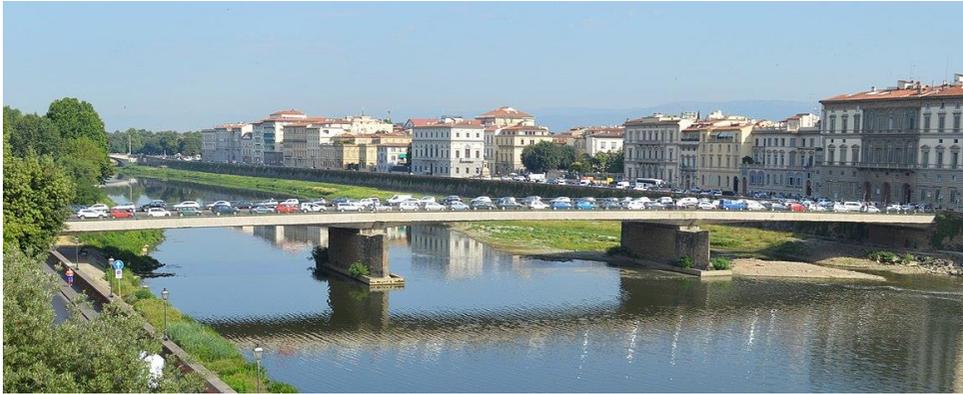
Figure 1. The Amerigo Vespucci bridge in Florence. View from a point upstream.

The Amerigo Vespucci Bridge was built in the 50's of the last century. The bridge has three spans with width 22.0 m and total length 155.5 m (Figure 1). The deck is in pre-stressed reinforced concrete, the piers, the abutments and the foundations are in reinforced concrete. The static scheme of the structure is rather complex, since it consists of a sequence of three independent portals. Each upright is obtained by coupling a tie rod and a strut, that is obtained with the ribbing of the pier and (Figure 2).

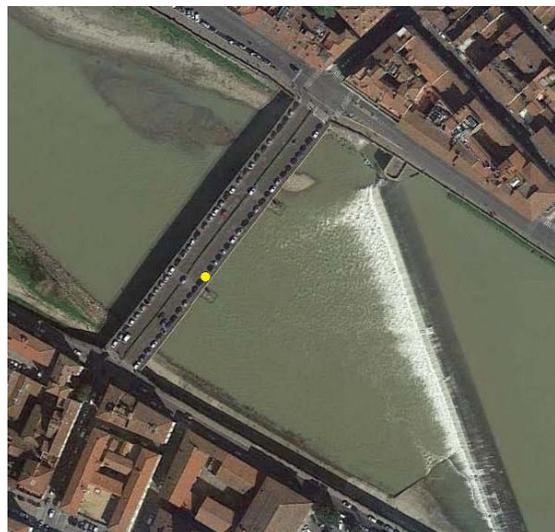
Figure 8. Aerial view of the Amerigo Vespucci bridge and of the Santa Rosa weir

The study on the morphological evolution of the Arno River in the period 1960-2015 showed a generalized lowering of the riverbed in the urban stretch of about 3.0 m, due to several causes. They include extractive activity, construction of dams and changes in land use. However, at the left pier of the Vespucci Bridge, the erosion depth is much greater due to a localized phenomenon attributable to a weir, called “Pescaia di Santa Rosa”, located immediately upstream of the bridge (Figure 8). The sharp inclination of the weir (its axis has an inclination of  $55^\circ$  with respect to the axis of the bridge) caused a deviation of the streamflow, which caused very different localized situations even within a few tens of meters. In particular, the right pier of the bridge is affected by a significant deposition phenomenon while the riverbed has lowered at the left pier, causing sapping at the base of the pier itself. The plan of the foundation piles of the left pier of the Vespucci bridge and their state of consistency are shown in Figure 9.

In 2017 a new geotechnical borehole, whose position is indicated by the yellow dot in Figure 8, was performed. From the stratigraphic profile, the riverbed resulted at + 29.15 m above sea level. Thus, the thickness of the upper layer of gravel and sand was reduced to 3.70 m.
