A geosynthetic reinforced steep slope 60.0 m high for the stabilisation of the Valpola landslide in Northern Italy

Daniele Cazzuffi

Piergiorgio Recalcati

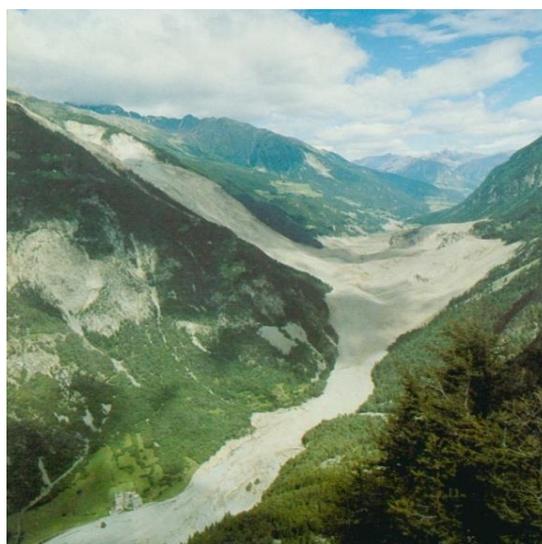
Figure 1 Aerial view of the area before and after the landslide

village of S. Antonio Morignone. In the immediate aftermath, the river opened a breach in the natural dam and the waters subsided, reducing the lake surface up to about 15 ha. In the meantime, the process of violent erosion channeled along the Pola continued and rockfall and small landslides were observed. On July 28, 1987 at 7.23 a rock avalanche of 3545 million cubic meters collapsed from mount Zandila, falling down into the river 1200 m below and running up about 300 m on the opposite side of the valley (Figure 1), causing 28 casualties.

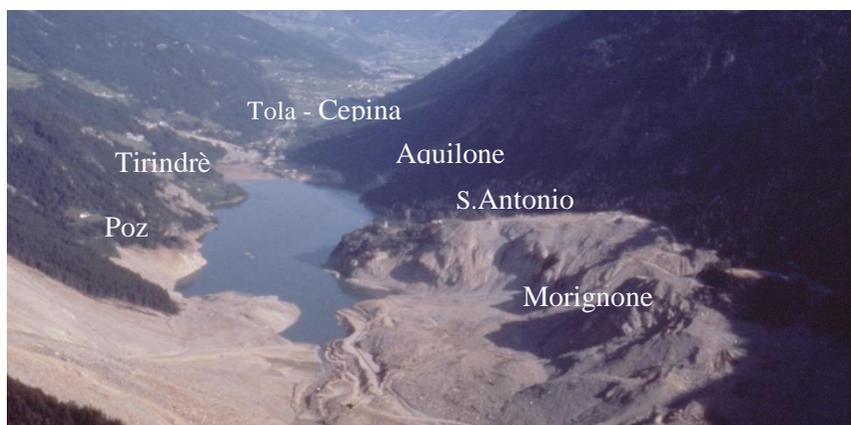
Figure 2 The lake and the position of the villages destroyed by the landslide

The main rockslide body, detached between the crown located at 2360 m a.s.l. and the toe of the rupture surface at 1750 m a.s.l., fell down in just 30 seconds destroying the villages of Morignone, S. Antonio, Poz, Tirindrè, S. Martino and Aquilone; most of the villages (S. Antonio, Poz, Tirindrè and Aquilone) have not been directly invested by the landslide mass but by a catastrophic wave of water and debris caused by the impact of the rock mass into the lake formed in the previous days (Figure 2).

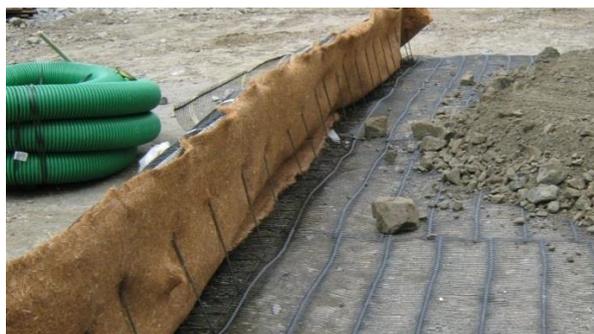
Placement of biomats on the internal side of the geogrids. Taking into account the altitude of the job, the fact that construction was taking place in two years time and that during winter due to the snow the work could be stopped for some weeks or months, a heavy straw mat was used (Figure 5).

Figure 5 Installation: from the left, steel mesh formwork, geogrid, straw mat, and fill material.

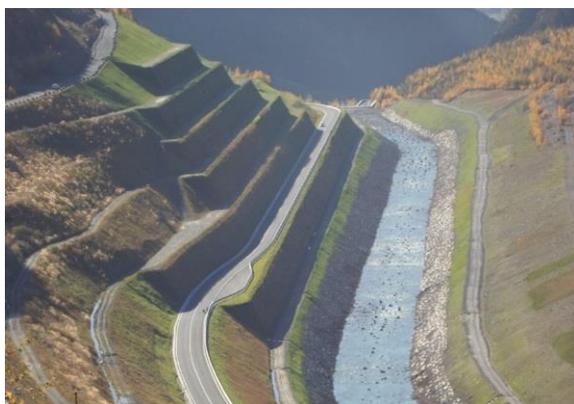
Figure 6 The finished job.

Repeat the phase 1-5 until completion of the work (Figure 6).

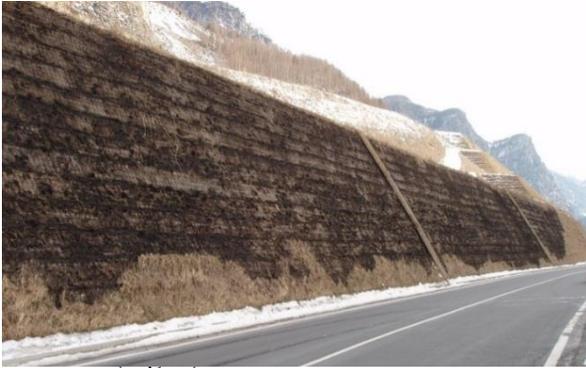
One year after the end of construction, the reinforced structure was attacked by fire (Fig. 7); a prompt inspection of the site was confirming the job was not suffering any serious damage (Cazzuffi et al., 2014).

Figure 7 The reinforced structure after the fire event

It is important to remember that the structural reinforcing elements (geogrids laid horizontally within the soil) are never affected by the flames, as oxygen is not present. A thorough inspection to assess the integrity of the works has been done, considering the banks from the top to the bottom.

Samples of geogrid excavated from an area that was interested by the fire were subjected to mechanical tests, and the results obtained were demonstrating that the fire itself was not directly affecting the resistance of the geogrid. In conclusion, such a structure, once vegetated, has then demonstrated to be resistant even to the fire.

The sample of geogrid exhumed was delivered to an accredited laboratory for geosynthetics, where it was subjected to a wide width tensile test according to the EN ISO 10319, as described by Cazzuffi (1996). The test results have provided values of residual strength equal to 85% of the nominal value of the geogrid. These values were due to the damage suffered during installation but especially during the exhumation, and are in no way attributable to the fire, since the geogrid in the portion removed did not show any trace of fusion, burn or change to its geometry due to heat.
