Results from ground improvement with lime-cement columns in quick and sensitive clay on the E6 Trondheim-Melhus

E. S. Juvik / primary author

Norwegian Public Roads Administration, Trondheim, Norway

Keywords: Ground improvement; Lime and cement; Quick clay; Bridge foundations; Slope stability

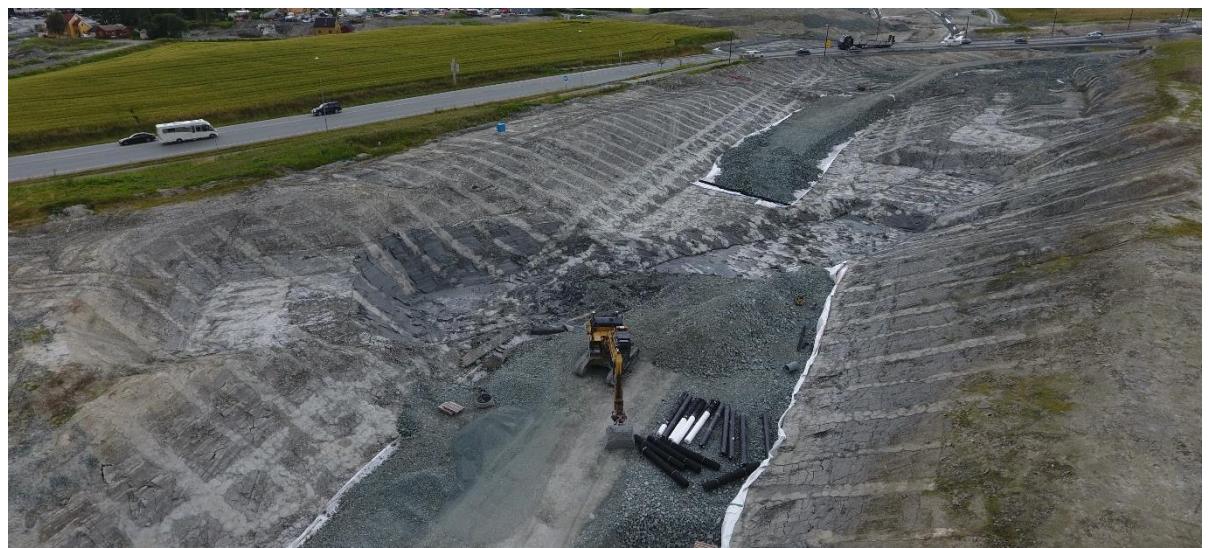
Figure 1. The area of Sørnypan after excavation. The panels that ensures the stability in the cuttings are visible on the sides. The grid pattern that reinforce the road-bed can be seen in the middle. At each side of the road-bed is the longitudinal panels that supports the water supply and sewage ditches. Also, 5 of the blocks that serves as foundation for the overpass bridge Leinstrandbrua are visible. (Photo: NPRA)

The stability of the cuttings are ensured with single and doubles panels, as seen in Figure 1. Distance between centres is 3.5 m. The heighth difference at Sørnypan is 12 m and the inclination of the excavated slopes are 1:2. The length of the lime and cement columns were originally 25 m. Before the stabilzation works began, the terrain was unloaded with 3 m. Hence the real column length became 22 m. The disadvantage of unloading and removing the dry crust before, is that the bearing capacity for the machinery is severely reduced. Measures has to be taken so that the machinery can move around in the area.

Where the road-bed is situated in quick and sensitive clay, it is reinforced with two different patterns. The road-bed for the motorway under the overpass bridge is stabilized with a grid pattern with centre distance 3.5 m in both lonitudinal and transversal direction, as seen in Figure 1. The grid consists of two columns in each row. Outside the overpass bridge the road-bed is stabilized with transversal columns which is an extension from the panels in the cuttings. The length of the columns are 25 m. 15 to 24 m of the columns remains under the road-bed after the excavation.

foundations are 11.5 m. The blocks are shown in Figure 1.

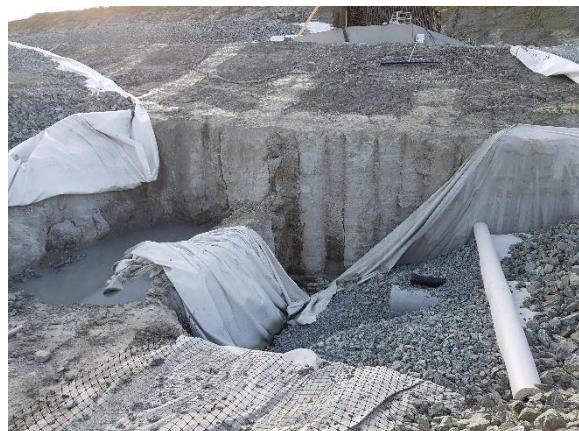
Figure 2. Longitudinal double panels serve as retaining walls for the water supply and sewage ditches. The trans-versal panel serves as a wall in the longitudinal direction. Because of the risk of reducing the stability in a larger area, the pipes were installed section by section. (Photo: Eivind S. Juvik)

even deeper. This was solved by installing double longitudinal columns on both sides of the ditches, which served as retaining walls. Furthermore we installed transversal columns at regular intervals to ensure the stability in the longitudinal direction. See Figure 2.
