# Safety assessment of existing retaining structures

M. J. Rebhan

*Institute of Soil Mechanics, Foundation Engineering and Computational Geotechnics / Graz  
University of Technology, Graz, Austria*

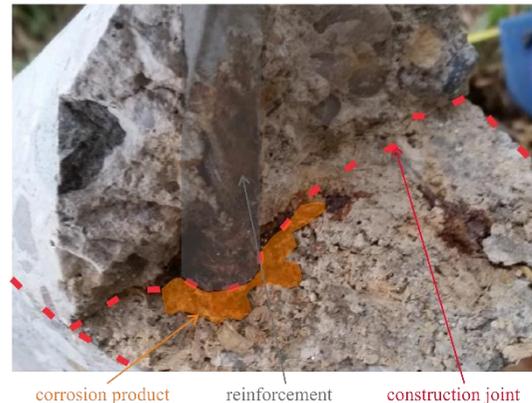
Figure 1: Damage due to corrosion at the construction joint of a cantilever wall

Corrosion describes a chemical process in which metal and steel material oxidises under the presence of oxygen and an electrolyte. The reaction product of this process is colloquial referred to as rust. The process of corrosion can only be stopped by removing one of the reaction partners (e.g. oxygen or the electrolyte) or the passivation of the surface. The presence of salt results in an increasing conductivity of water (as part of the electrolyte) which leads to an enhancement of the ion transport within the electrolyte and therefore to a significant acceleration of the corrosion process. This damage symptom can especially be found next to roads where salt and chloride is used as a de-icing agent for winter maintenance. Figure 1 (Rebhan et. al., 2017) shows the effects of corrosion on the reinforcement of a retaining structure. It can clearly be seen, that due to the

construction joint of the wall (as exemplary shown in Figure 4), a depassivation of the reinforcement took place and the corrosion process was able to start. Additionally, this process has been accelerated by salt and chloride, leading to a significant reduction of the reinforcement and therefore to a deficiency in serviceability and usability of the structure.

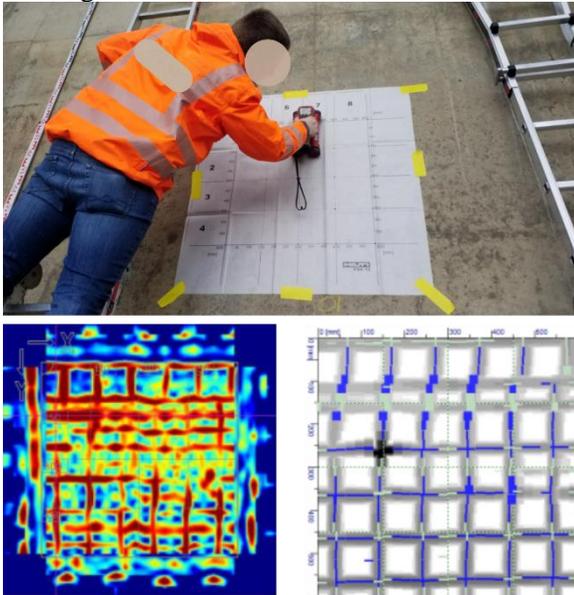
Figure 2: Non-destructive testing methods used for the reinforcement detection of a cantilever wall

Due to the fact that most of these methods are based on wave-propagation, the measurement of the potential or the resistivity between the reinforcement and the concrete the use of non- or minor-destructive methods on retaining structures (as exemplary shown in Figure 2) is often limited to near surface detection. Consequently, these methods are limited by a certain range (max. 40 cm wall thickness). Additionally, the most critical areas to be observed are on the (inaccessible) backside of the wall. Nevertheless, in combination with destructive methods, non- or minor destructive methods can lead to an improvement of the assessment methods and an enhancement of the knowledge about the structure.

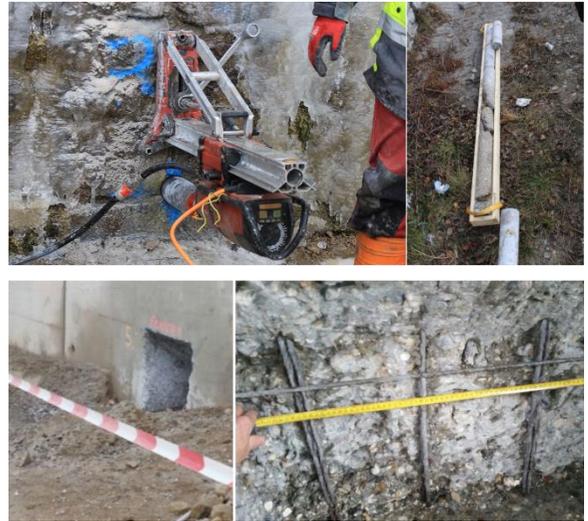
Figure 3: Core drilling used to determine the thickness of a wall and to gather a material sample (top), subsequently installed inspection hatch using high-pressure water jetting (bottom)

Common destructive methods used for the investigation of retaining structures are core drillings (Figure 3 top) and the subsequent installation of

an inspection hatch using high-pressure water jetting (Figure 3 bottom).

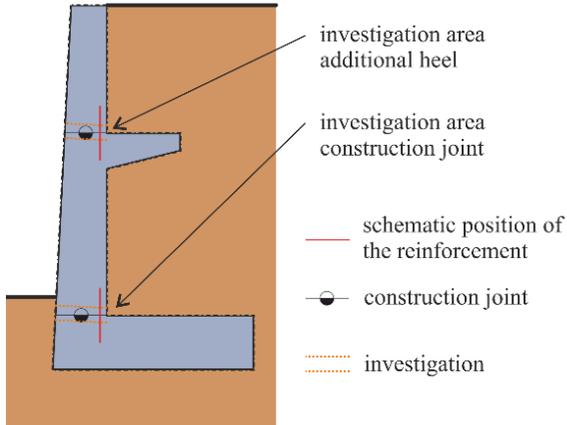
Figure 4: Cross-section of a cantilever wall with additional heel, representation of the possibly performed investigations

Corrosion of the reinforcement leads to a reduction of the bearing capacity of structures. Quite often the highly loaded regions of cantilever walls overlap with sensitive areas such as the construction joint between the foundation slab and the vertical wall. Figure 4 shows a cross section of a typical cantilever wall, and some examples for these highly stressed and vulnerable regions. The reinforcement in these critical areas of the structure is not only necessary for the durability and serviceability of the structure, it is also essential for the internal bearing capacity. Corrosion in this region of a structure is a common problem, which results from the weak points (construction joints) of this type of retaining structure.

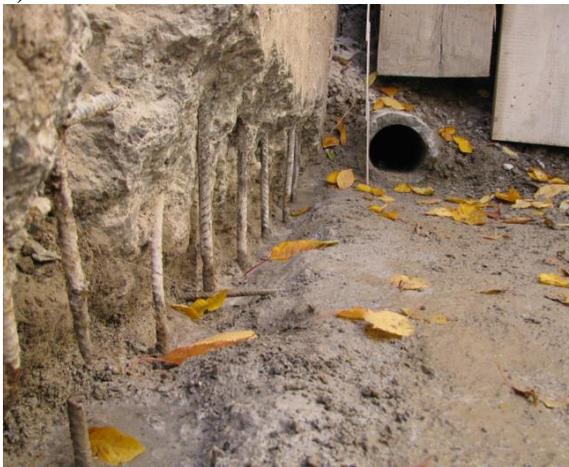
Figure 5: Visual inspection of the reinforcement on the backside of a cantilever wall due to the installation of a manhole (Vollenweider, 2014)

Certainty on the results can only be achieved by spreading the investigation area. This is in general only possible by installing a manhole (Figure 5) on the back side of the wall.

This type of inspection method can only be performed on structures which offer the required space for the installation. Additionally, this process leads to high costs and often the necessity of a road blockade or a detour.

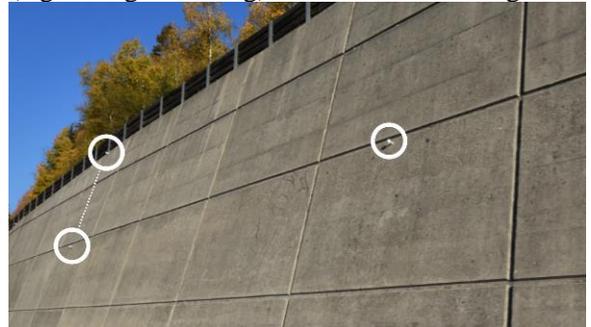
Figure 6: Geodetical targets installed on a retaining structure

To ensure the safety and the usability of roads, railways and other infrastructures an observation (monitoring) of geotechnical structures is performed. The installation of geodetical targets (Figure 6) or the installation of tilt sensors is state of the art for such a monitoring task. This kind of observation allows the detection of rotational and transversal deformations of a structure. But in many cases it is not possible to quantify between different failure mechanisms or deformation sources such as geotechnical failure mechanisms (e.g. tilting or sliding) and corrosion damage.

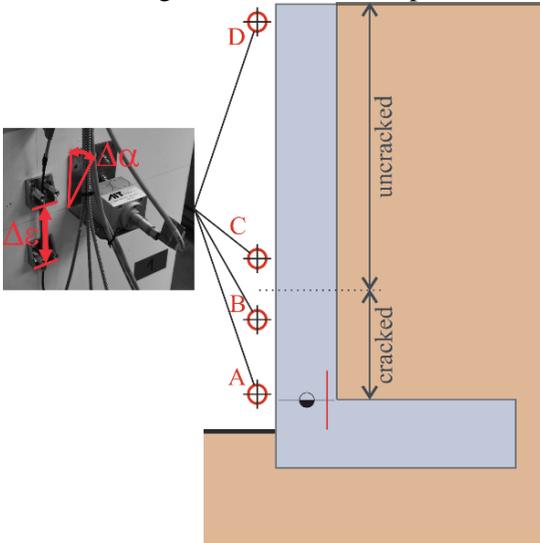
Figure 7: Monitoring system for the observation of corrosion defects on cantilever walls

Therefore, a new monitoring system for corroded retaining structures (especially cantilever walls) is proposed. This system uses the combination of classic tilt sensors and combines these measurement results with measured concrete strains on the frontside of the wall, whereby it is important to get these data on several levels of the cross section. The combination of data from these two sensor types for different levels of the wall could offer the possibility to distinguish between effects related to load changes, temperatur effects and an increasing corrosion damage of the reinforcement. As one can see in Figure 7, a number of tilt sensors ( $\Delta\alpha$ ) and strain sensors

( $\Delta\varepsilon$ ) is placed along a vertical section of the wall. When measuring wall deformations over time with the combination of the results from the tilt and the strain sensors, a distinction between the different damage sources should be possible.

Table 1 shows the concept behind the different sensor positions and the possible interpretation of the results given by changes in the values for the different sensor positions (Figure 7 A – D) and the two types of sensors (tilt and strain).

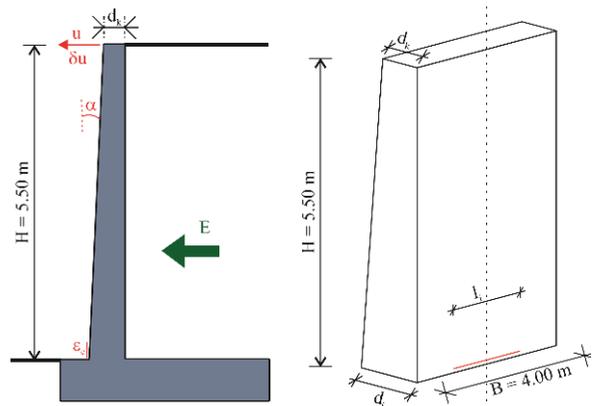
Figure 8: Schematic figure of the investigated cantilever wall (Rebhan et. al.)

To come up with the measurement concept described in chapter 2.3 a cantilever wall with corrosion damage (Figure 8) has been numerically modelled (Rebhan et. al., 2017) and parameter studies have been performed. Finite Element Analysis were performed to simulate corrosion effects to evaluate the influences on the ductility of the system. Different wall configurations and varying earth pressures acting on the wall have been investigated to determine the possibilities for an identification of corrosion induced damage.

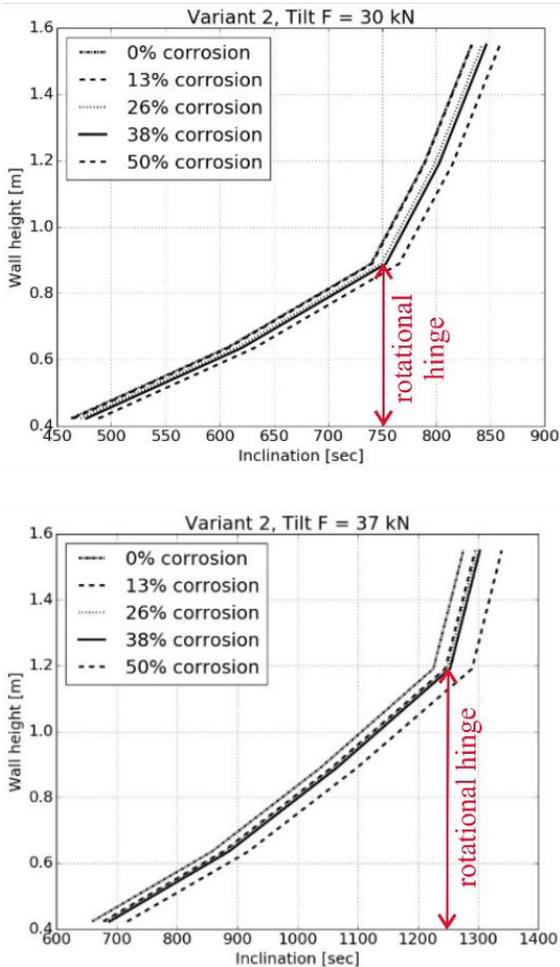
Figure 9: Results of nonlinear FEM- investigation of different corrosion stages under different load levels

have shown, that a classical monitoring of the inclination of the wall solely does not offer the possibility to distinguish between an increase in the load level of the structure, temperature effects or the effects given by an increasing corrosion process. Further advanced nonlinear FEM studies were performed as a basis for the experimental studies on cantilever walls. Figure 9 demonstrates results from these numerical studies, which demonstrate that the inclination of the cantilever wall is more sensitive to the change of loads than to different corrosion stages. Also, the position of the rotation point is moving upwards with an increasing load level, while an increase in corrosion has a minor influence.

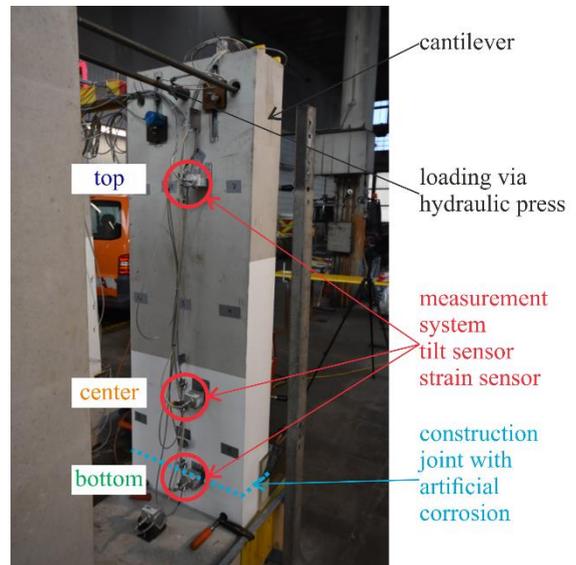
Figure 10: Mock-up for the validation of a monitoring system for corroded cantilever walls

Experimental studies to verify the monitoring system described above and to validate the numerical simulations have been conducted. A picture of the mock-up is shown in Figure 10.

The test setup represents the lower third of a 5.50 m high cantilever wall with a thickness of

25 cm. As one can see in Figure 10 the tilt and the strain sensors have been placed along a vertical line on the test body, which represents the front side of a cantilever wall. The sensor positions have been chosen in the uncracked area (top), the cracked region of the structure (center) and the area which is cracked and influenced by an artificial corrosion damage (bottom) of the cantilever. In addition to the sensors shown in Figure 10 further measurement equipment has been installed to verify the system behavior during the test. The cantilever has been loaded by a hydraulic press using a load distribution unit at the top of the wall. This loading point represents 1/3 of the height of the 5.50 m high structure, the rest of the structure has not been modelled in the mock-up. First results of this tests are illustrated in Figure 11. The x-axis schematically represents the time to conduct the test and to reach a corrosion level of 50 % of the reinforcement area. On the left y-axis the concrete strains on the front side of the wall (compression) are shown. The right y-axis represents the measured changes in the inclination (tilt) of the structure.

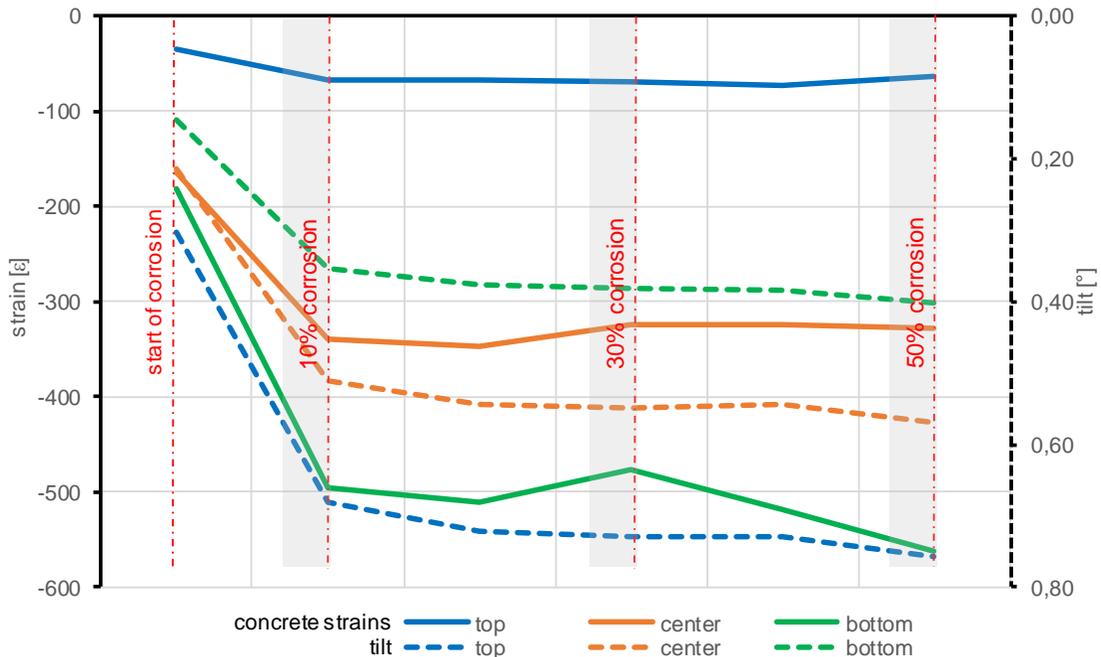
Figure 11: Measurement results of an artificial corrosion damage induced to the test setup

The measurement results show:

- (1) A sufficient corrosion causes a rotational hinge in the lower wall section.
- (2) The changes in tilt show the same trend along the wall height during the increase of corrosion.
- (3) The cracked and uncracked areas of the structure can clearly be identified.
- (4) Despite the differences in the concrete strains for the different areas of the structure, the influence of the corrosion joint on the strains can be identified.
