Search for hidden construction shafts within the Welsh railway tunnels

P. Taylor

JNPGROUP, Sheffield, United Kingdom

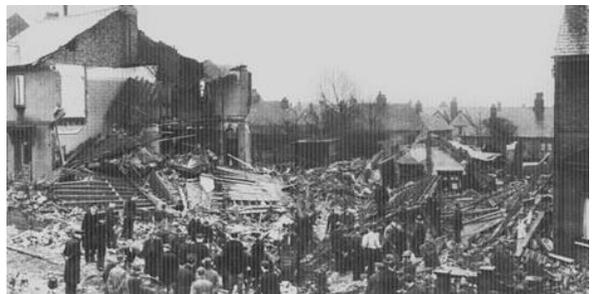
On the 28th April 1953 at Clifton Hall Tunnel near Manchester the brick lining of the tunnel collapsed in the early hours of the morning beneath what turned out to be a hidden construction shaft (Figure 1). The contents of the shaft spilled out onto the railway line and caused a crater to appear at surface, approximately 20 feet deep. Unfortunately, the area above the tunnel was occupied by a number of semi detached properties; a pair of which collapsed into the crater killing five of the occupants (Ministry of Transport 1954).

Figure 1 Clifton Hall Tunnel Shaft Collapse (Salford Voice 2017)

This incident and the resultant investigation highlighted the danger posed by these abandoned construction shafts and as such works have commenced sporadically since the 1960's to try to identify and locate any such hidden construction shafts.

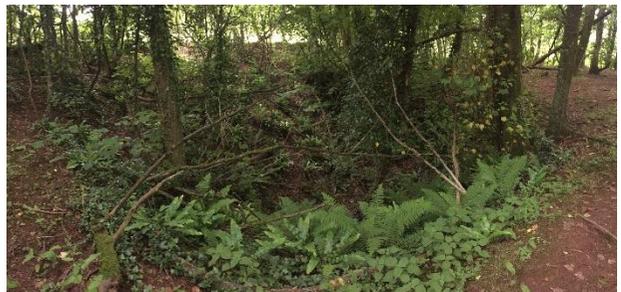
Figure 3 Surface depression at Pembroke Tunnel with mature trees growing within.

In addition to the archive data, a site visit was made at each tunnel to walkthrough and over the tunnels. During the tunnel walkthrough, features which may potentially indicate the presence of a hidden shaft, were measured from both tunnel portals and recorded. This included areas of significant water ingress, bulging of brick work and large areas of brick repairs. As part of the tunnel walkover, features such as depressions (figure 3) and spoil mounds (figure 4) were recorded utilising hand held GPS.

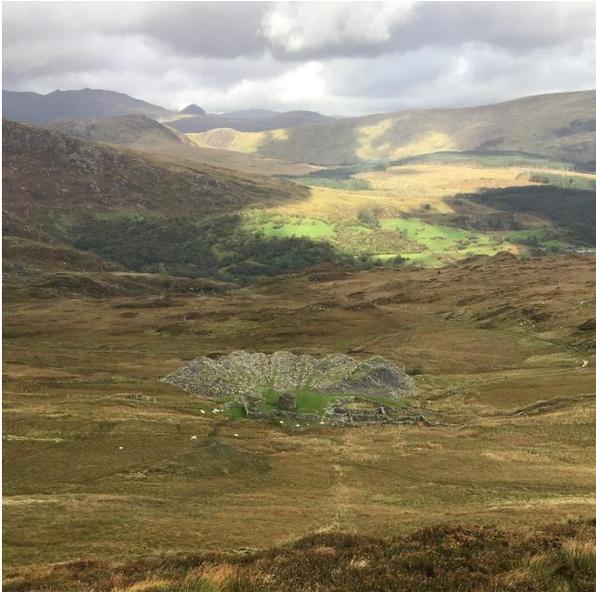
Figure 4 Radial spoil mound adjacent to an air shaft at Ffestiniog tunnel..

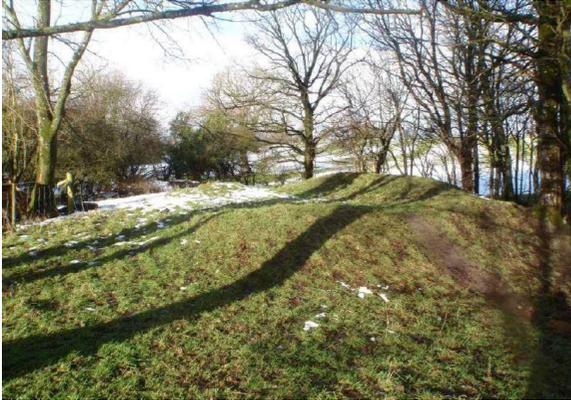
Figure 5 - Spoil Mound Investigated Following Walkover Survey in South Wales (AMEY)

Recommendations were made within the desk based reports with regards to various intrusive investigation methodologies. These recommendations were based on experience gained undertaking similar investigations on other rail routes and inline with well established methodologies for investigating abandoned mine shafts. Figures 5 – 7 show various investigation techniques undertaken.

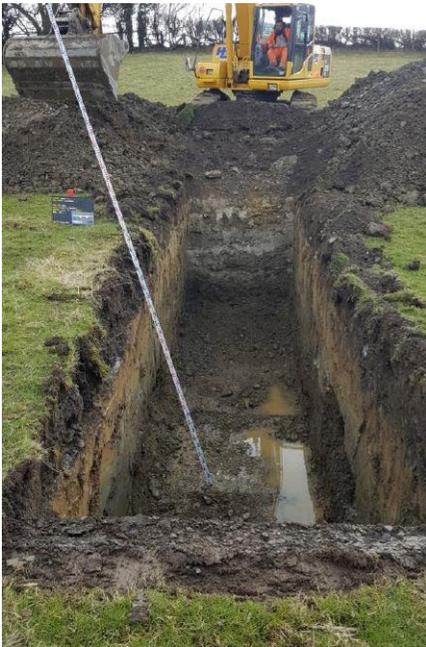
Wherever possible, the first option was to undertake a trial trenching investigation from the surface, targeting spoil mounds or depressions. This was deemed to be the only possible way to positively determine if a shaft cap was in place.

Figure 6 – Trial Trenching investigation (AMEY)

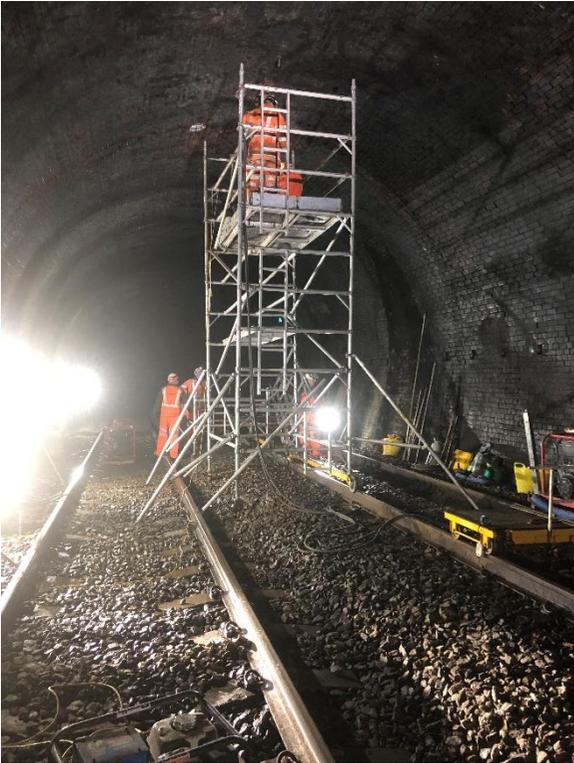
The first technique involved the use of a traditional coring rig similar to that which would be found on most investigation sites for undertaking concrete coring. In this instance, the contractor installed bolts at 1m centres into the roof of the tunnel, which allowed the rig to be bolted to the roof. The holes were then drilled utilising a 32mm core barrel with various extension rods used to achieve the required depth. Whilst this method was more time consuming, the equipment used was relatively mobile and could be moved to site on track trollies with the work area accessed via tower scaffold. In addition, multiple teams were able to work in close proximity to each other.

Figure 7 – Drilling coreholes into the tunnel roof of Lonlas Tunnel

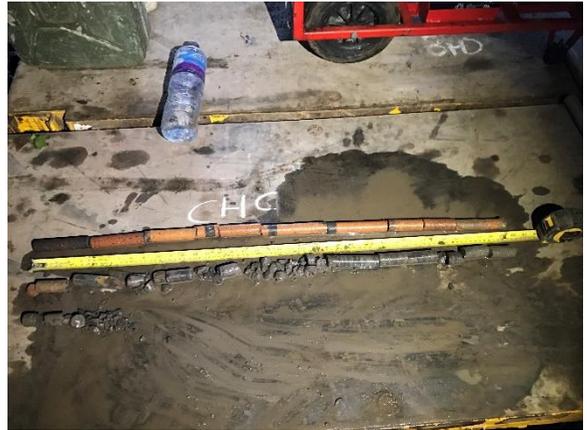
Figure 8 – Example of core recovery from Lonlas Tunnel

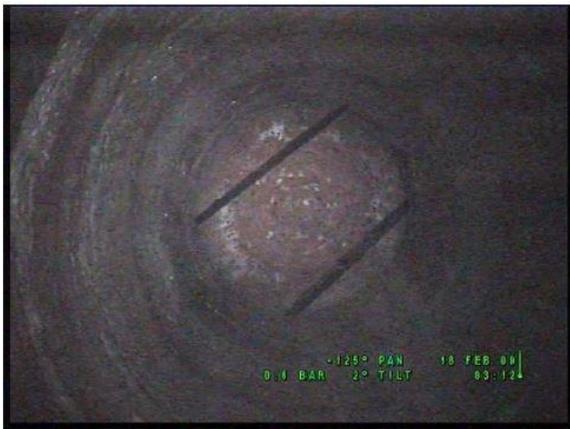
Figure 10 – CCTV inside Hidden Shaft on LNW Route
