Geotechnical issues on the access of the Ojo Guareña karst complex

González-Gallego, Javier

CEDEX/Laboratorio de Geotecnia/Madrid/Spain

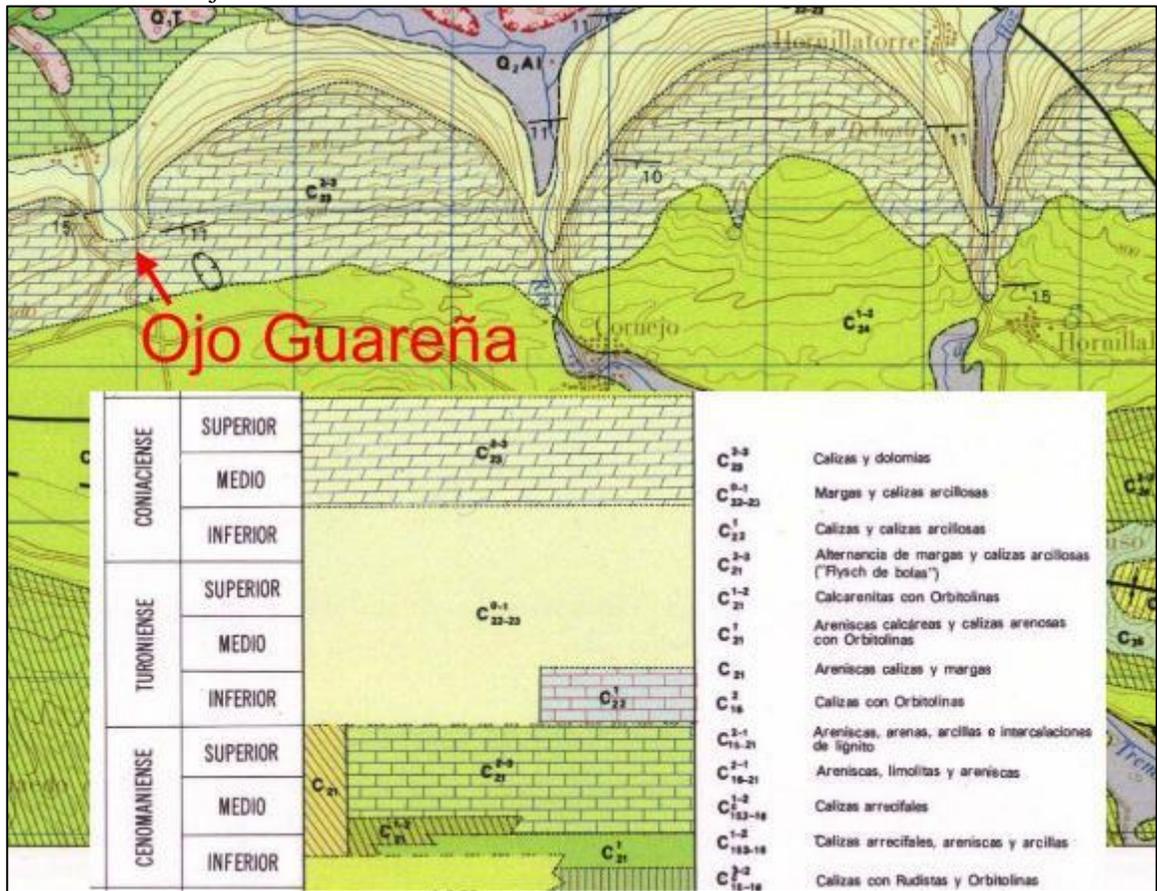
Figure 2 Geological setting (MAGNA 84 IGME)

The figure 2 shows the geological setting and the location of the Ojo Guareña's main entrance.

The limestone formation containing the system is approximately 130 metres thick and sits on a massive water-resistant layer of marl and clayey limestones.

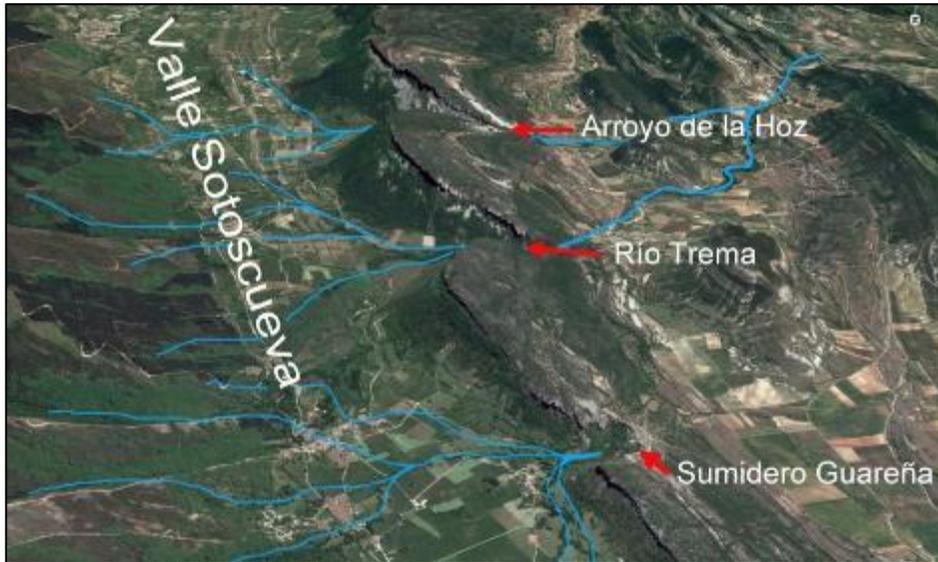
Figure 3 Sotoscueva valley and the three rivers crossing it.

Figure 3 shows a view where it is possible to see the Sotoscueva valley and the three rivers crossing the valley to find the barrier of limestones.

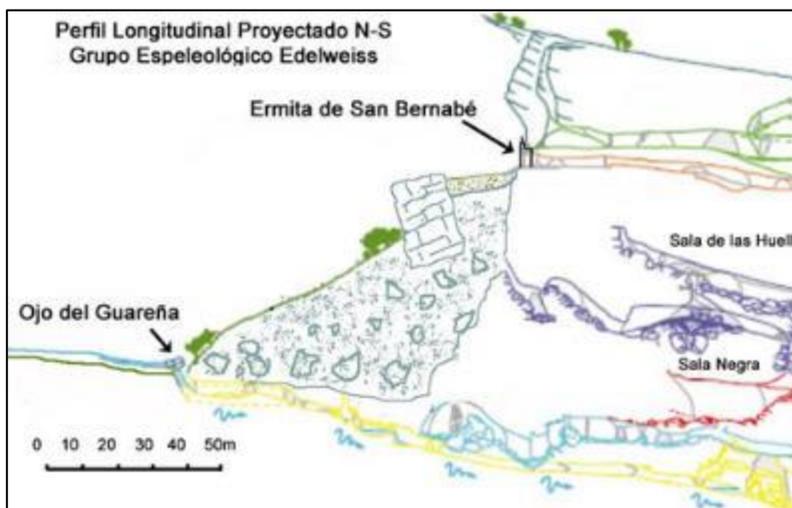
Figure 4. Cross-section: sink of Guareña and hermitage

Figure 4 shows a cross-section in which the esplanade and the hermitage can be seen on top of the slope. Also shows the different levels of galleries, the colluvial deposit and the Guareña sink.

The Guareña river runs through the lower galleries for most of the year, although during flood season it may not have enough drainage capacity and therefore the water rises to enter the higher galleries.

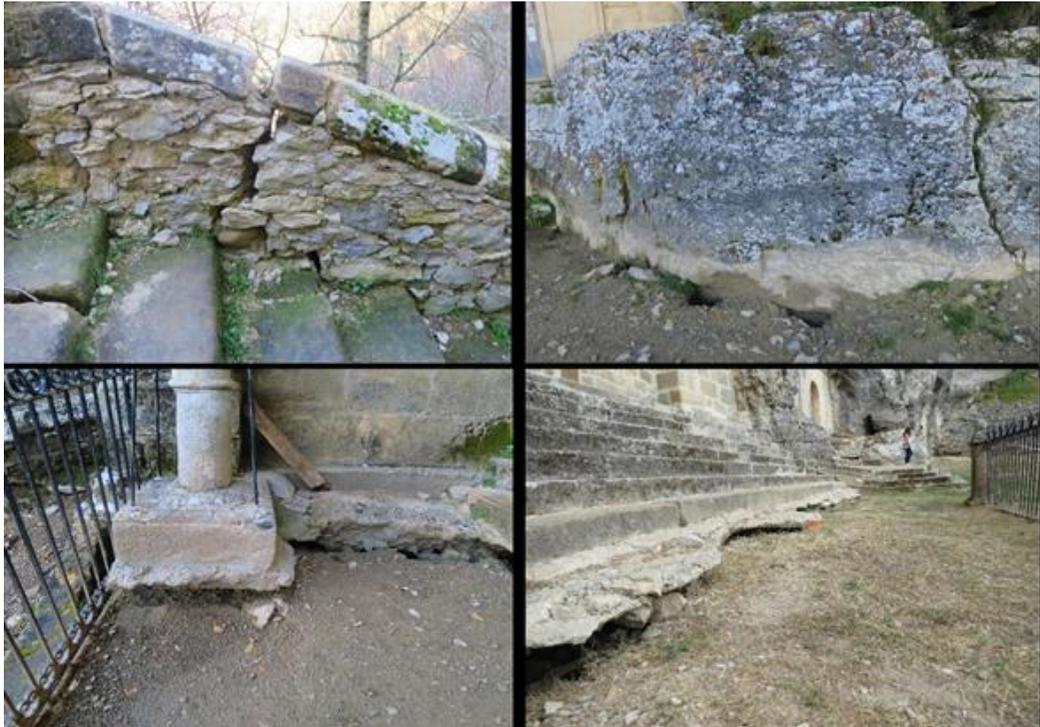
Figure 5. Damages and settlements around the esplanade

In winter 2015 the settlements on the esplanade were unusually pronounced. In some

areas up to 20 cm of settlement have been measured and are well marked in the structural components (stairs, masonry walls, etc).

Figure 5 shows pictures of different areas with important settlements.

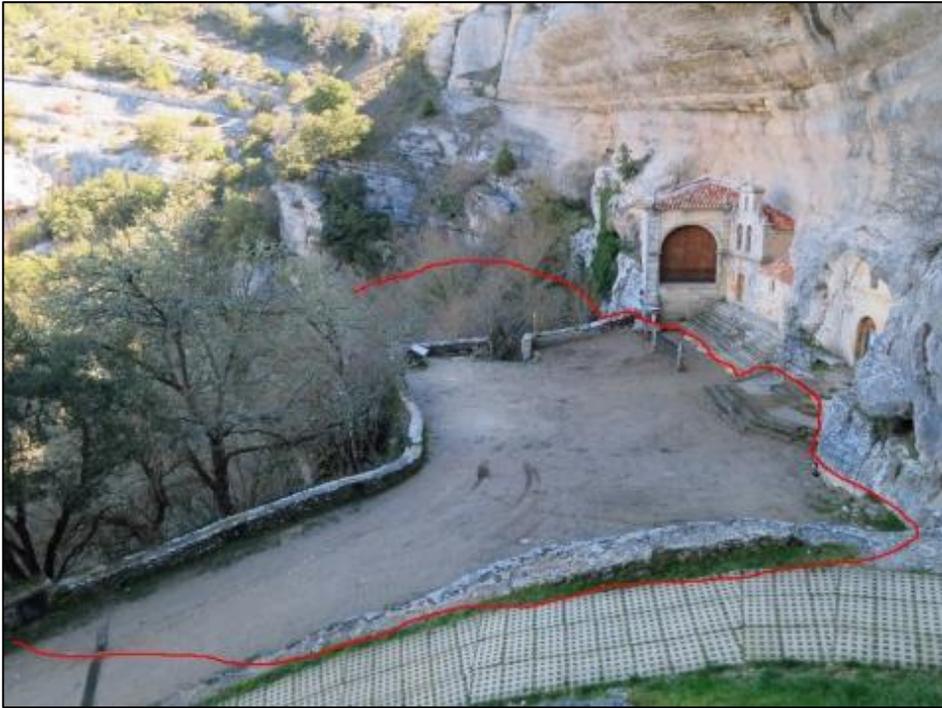
Figure 6. Upper limit of the settlements on the esplanade

Figure 6 shows with a red line the upper limit of the settlements on the esplanade and on the slope next to it.

During the in situ investigation it has been proved that settlements not only appear on the esplanade but also on the slope next to it. Furthermore the magnitude of settlement is very similar on the slope and esplanade.

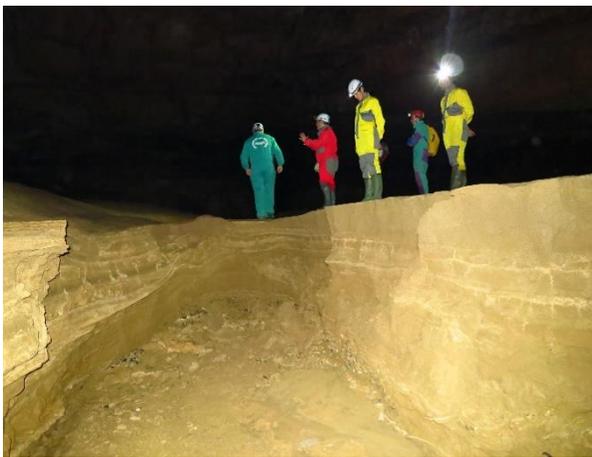
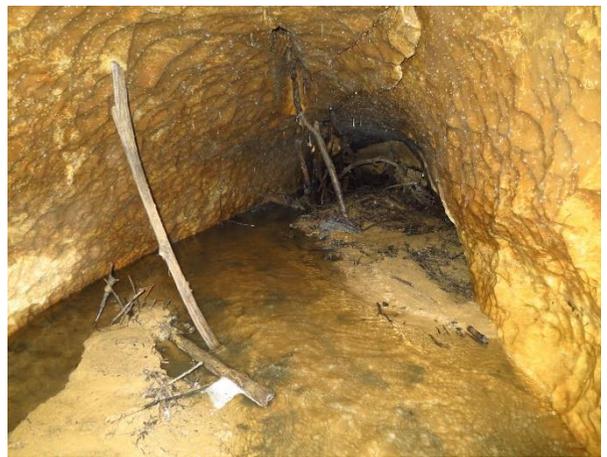
Figure 7. Recent erosion and the inside of the sink of Guareña River

Figure 7 shows two pictures with a recent erosion in old deposits and a view of the sink almost clogged.

At the same time in the higher galleries important geomorphological modifications have been found, that indicates a change in the karst hydrological behavior. This occurrence has not

Speleo Club Edelweiss which has been exploring the cave since the fifties has observed that some important morphological changes has been produced into the sink.

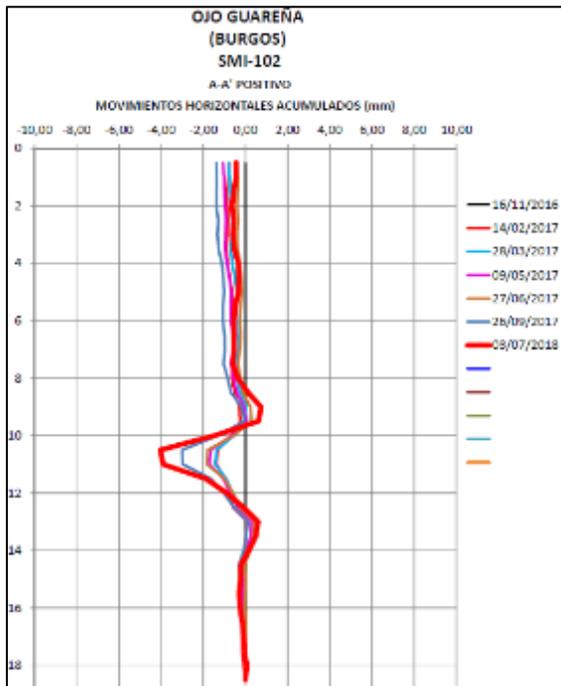
Figure 9. Inclinometer SMI-102

Only in the S102 borehole a small deformation has been detected at 12 m deep wich could be confirmed by next measures (Figure 9).

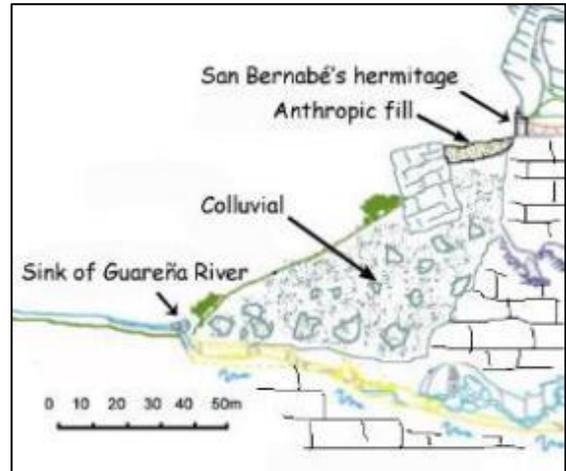
Figure 10. Geotechnical cross-section

Figure 4 shows the geotechnical cross-section made with the results obtained. The anthropic fill is 8 m deep. Under this fill there is a colluvial deposit down to 50m deep formed by limestone blocks with very different sizes and a matrix made by clay, sand and gravel.

Small caves, with a maximum section of 1,5 m, have been found in the colluvial deposit.
