# Validation of drilled shafts for a new bridge in Denmark, by means of a holistic approach, CSL testing and pile coring

*Rob Demeersman, Besix Denmark,*

*Christophe Bauduin, Engineering Department Besix, & Department of civil engineering, KU Leuven Belgium*

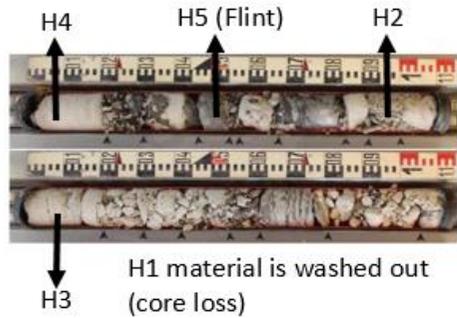
Figure 2: Illustration of limestone induration

The investigation campaign consists of one or two borings up to 65m deep at each pier and 725m of core samples from the limestone. A set of 850 strength tests (Unconfined Compression Strength, UCS, & Point load Test, PLT) of the in situ limestone has been gathered. The measured compressive strengths of all 850 samples are linked to its geological hardness (or induration) category ranging from H1 (very soft) to H5 (flint, very hard). The variation in hardness categories in a core sample is illustrated in figure 2.

The variation in rock induration as illustrated above is captured by a variation in strength characteristics as defined in table 1. Table 1 gives the average strength value from the testing campaign as well as the selected characteristic value.

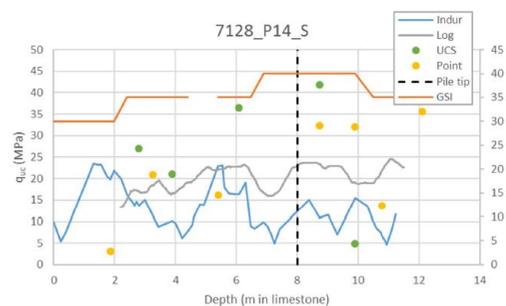
The relation between UCS and hardness is being observed on a quite continuous way on the rock corings, allowing for a continuous mapping of the rock. A rock strength profile as shown as the blue line figure 3 can be created at the location of each pier. The figure also plots the measured UCS or PLT results at the core taken, as well as the variation in GSI.

Figure 3: Strength profile at location of test pile 1

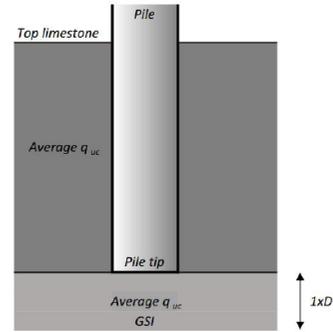
Figure 4: Pile design parameters

- Locally low and high rock strengths are averaged over the length of the shaft,
- A quite small volume of rock is involved in the pile tip compression resistance, therefore a local value is considered over a depth corresponding to 1 pile diameter under the pile tip.

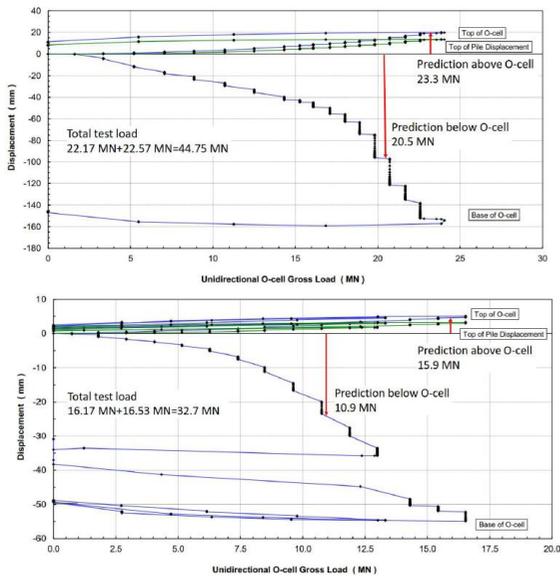
Figure 5: load displacement curves above and below O-cell and comparison with predicted ultimate resistances

The load settlement curve of the lower part indicates that a large part of the end bearing has been mobilised during the test, while the load-displacement curve of the upper part shows a lower degree of mobilisation of the ultimate shaft resistance. Both load tests validate the predicted ultimate tip and shaft resistance.

Those values are to be demonstrated by means of the load test. Figure 5 shows the load displacement curve for both piles, including the targeted load mobilization.

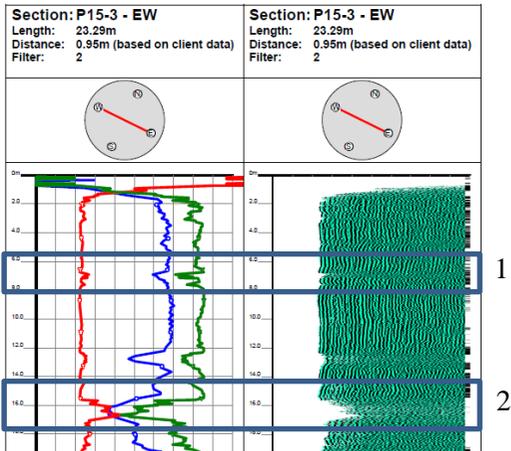
In figure 6, a CSL test result for 1 profile is shown. The profile contains two anomalies in energy and wave speed.

Figure 6: Integrity test with anomalies

- First arrival time (FAT) (red in Fig. 6),
- Apparent wave speed (shown in green)
- The recorded relative energy (blue)
- Sequential arrival of the sonic impulses in a waterfall diagram (right side of figure 6).

The sonic profile of the concerned pile, as shown in figure 6, seems to primarily show the impurity at the transition between the mortar and the concrete and not the extent of the mortar inclusion. This same observation was made in another pile coring. It is therefore important to consider the entire pile integrity when concrete segregation is observed.

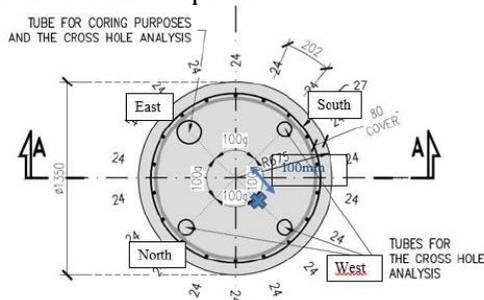
To investigate the anomalies a core (D100mm) from the pile was retrieved. The location of the core is defined by selecting the most onerous area from the 6 CSL test profiles.

Figure 7: Selected location for pile coring

The pile tip grouting, performed to validate pile tip contact is done through the reservations made for the sonic testing (see also figure 7).

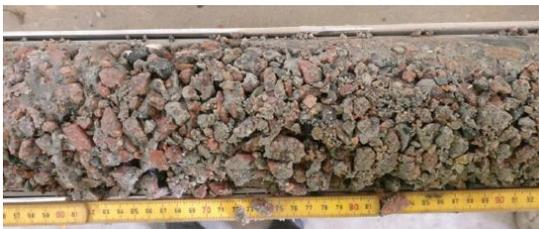
The coring shows important (>50cm) concrete segregation 16m to 18m below top of pile, marked as area 2 in figure 6, as show in figure 8. Hence confirming the CSL effectively identified the deviation of pile integrity.

Figure 8: Core picture of gravel nests

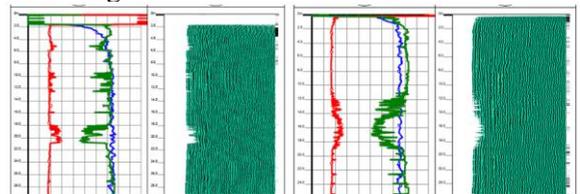
Further on, in other piles, locations have been found where the apparent wave speed was reduced by more than 20%. 2 Of those events are shown in figure 10.

Figure 10: Variations not confirmed to be an anomaly

Those locations have been investigated by means of coring and no anomaly was found in the pile. The reduced apparent wave speed could be a result of not recorded first impulses.

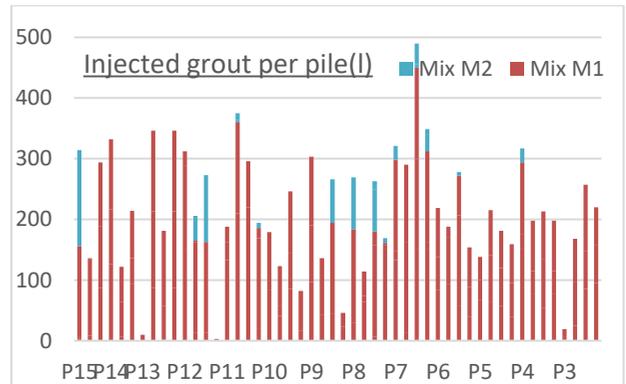
The pile tip grouting is validated if a pressure of 10 bar is reached at each of the 3 injection points per pile. The injected volumes of grout per pile are illustrated in figure 11.

Figure 11: Injected grout volume per pile

In average, each of the 3 injection points per pile were injected by 65 liters, resulting in 204l grout/pile. The volume cored prior to the injection and required to be filled by grout amounts to 6.8l/pile.

Only in 19 of the 150 injection points, injection with more viscos M2 mix was needed in order to reach the pressure of 10bars. Only in 1 pile, the threshold of 150l injection was exceeded at all 3 injection points. This indicates that the rock was more porous at that exact location.

At 25 points, none or negligible injection was possible with the pre-defined pressure limit. Overall the injected grout quantities can be seen as relatively small.
