Full scale load test on historic quay wall in Antwerp

Gerrit Feremans

SBE nv, Sint-Niklaas, Belgium

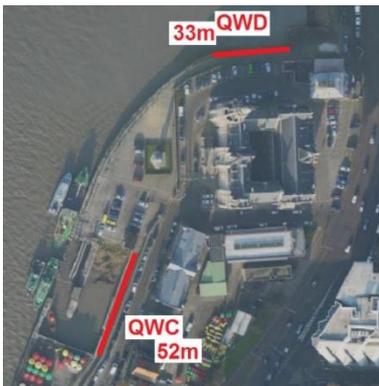
Figure 1: Project location

The two quay walls are situated near the Marguerie dock and are named Quay Wall C (QWC) and Quay Wall D (QWD), as shown in Figure 1.

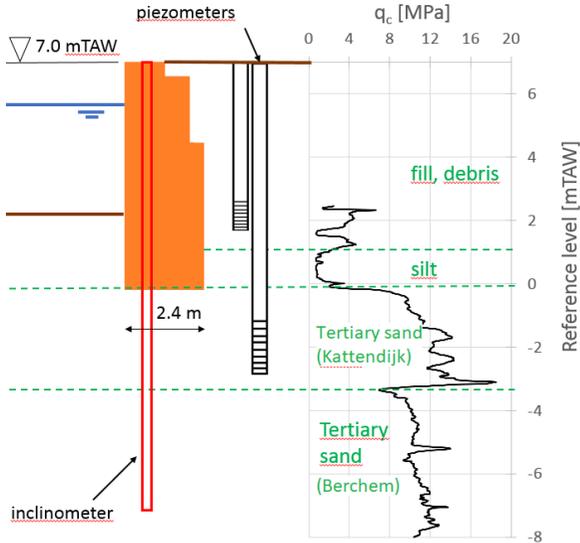
Figure 2: Cross section Quay wall C

Based on this information, conservative assumptions are made on the cross section of the quay wall, as shown in Figure 2. The wall is constructed with masonry. Since no indication of a pile foundation is present and given the fact that the encountered foundation level is at the top of a medium dense sand layer, a gravity wall is assumed.

2) Water level measurements: Behind the quay wall piezometers are installed in the different aquifers (cfr. Figure 2 and Figure 3). Water levels of the river Scheldt are measured in a nearby gaging station.

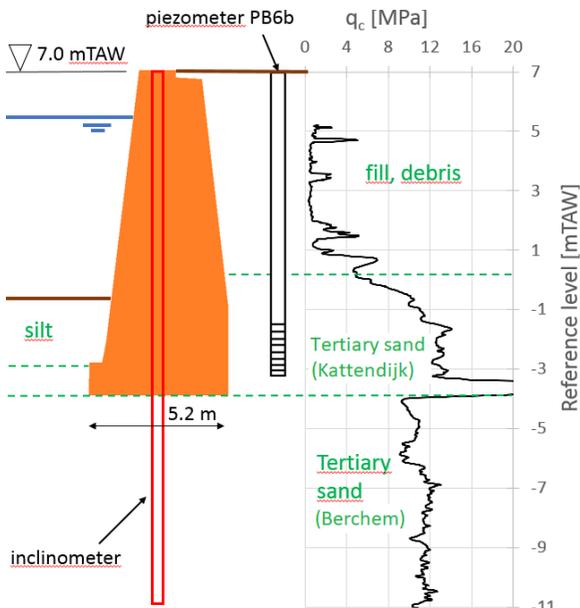
Figure 3: Cross section Quay wall D

An old cross section found in the city archive shows a gravity wall constructed of masonry with a height of about 11 meters. To verify this information, the same amount of determination and geotechnical survey tests as for QWC are conducted. No severe structural damage is found, only esthetical damage is identified. The drill holes confirm the foundation level of the old cross section. Based on all available information, conservative assumptions on the geometry of the quay wall are set, as shown in Figure 3. The thickness of the wall is taken from the old cross

section. The occurrence of counterfort walls - found in other archive documents - is neglected as no evidence of their presence in the conducted tests is available.

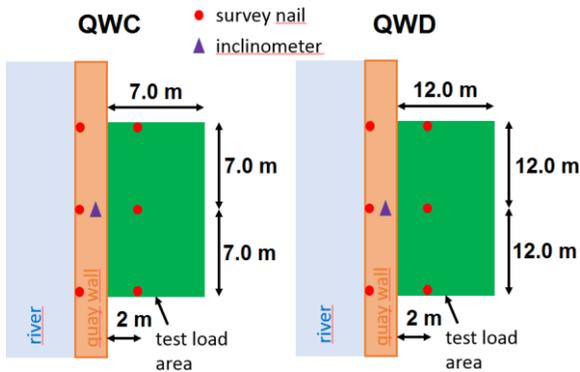
Figure 4: Load test configurations - plan view

3) Most unfavourable surcharge load: For gravity walls founded in a dense sand layer, the governing failure mechanisms are sliding and/or tilting of the wall rather than bearing resistance or deep sliding plane failure. For these first mechanisms the most unfavourable load situation is one with no load on top of the wall and the area behind the wall fully loaded. The footprint of the loaded area has a width $W = H$ and a length $L = 2H$ with H the height of the retaining wall as shown in Figure 4. The test load is equal to 30 kN/m^2 ($\gamma_Q=1.5$).

1) Deformation measurements (cfr. Figure 4): At each test location, 6 survey nails are fixed and an inclinometer casing is installed through the quay wall. The bottom of the casing is situated 7 meters below the foundation of the quay wall to accomplish a fixed point.

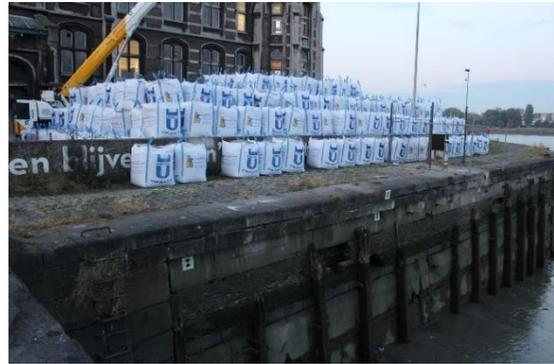
Figure 5: Load test at QWD.

Big bags filled with sand are used to realise the test load as can be seen in Figure 5.

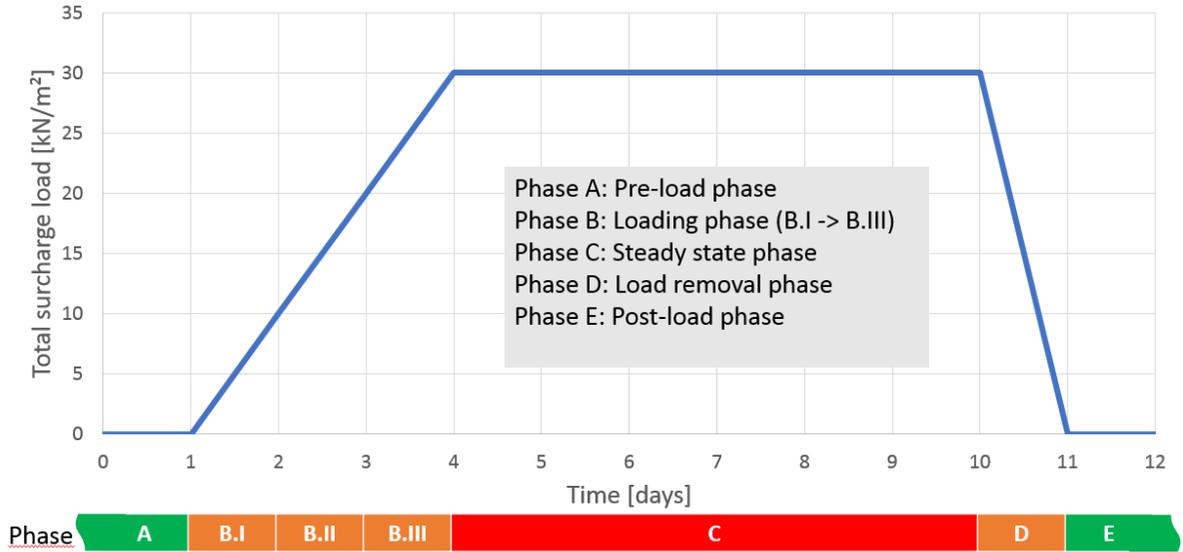
Figure 6: Load program

Loads are applied according to the load program shown in Figure 6. In the loading phase, an additional load of 10 kN/m^2 is applied every day.

The maximum test load persists for 7 days. The additional loads are put in place at the moment just before low water so the mobile crane is still staffed in case of necessary emergency unloading.

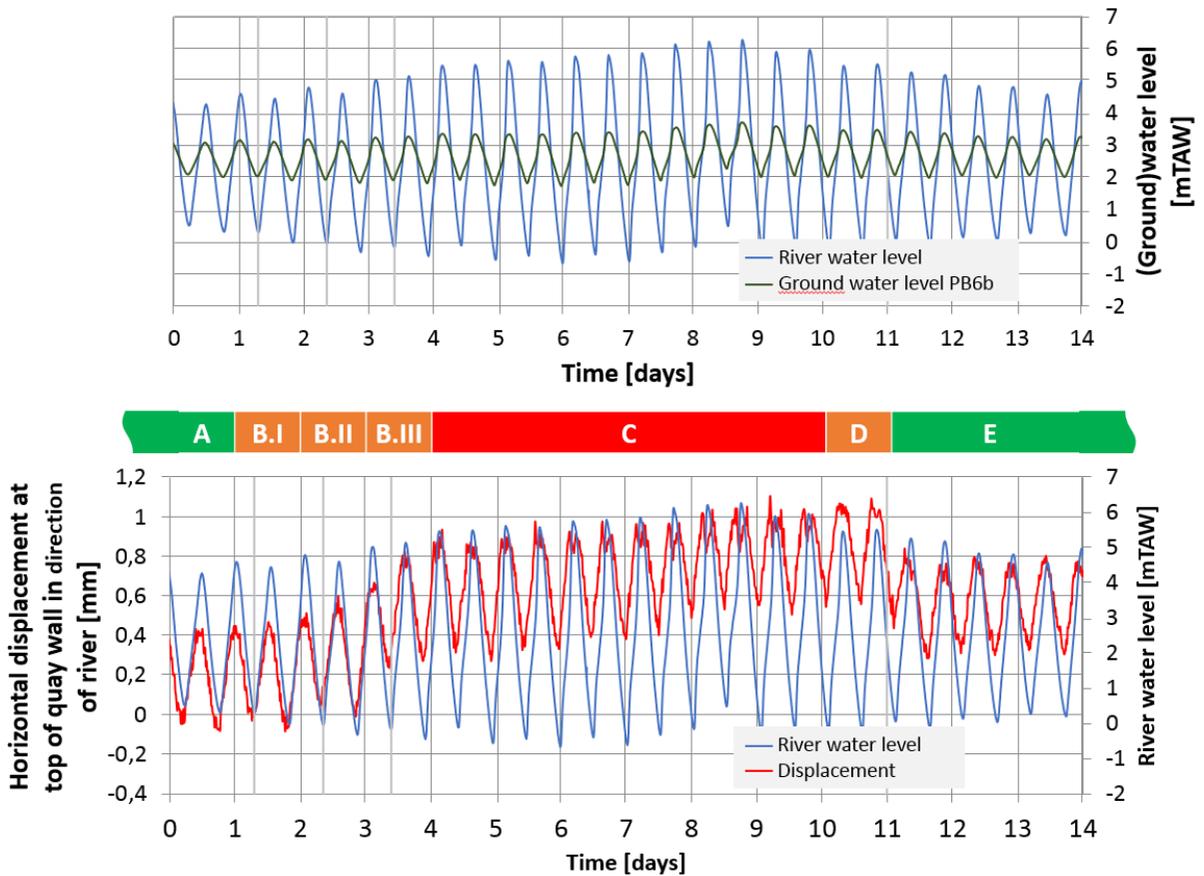
Figure 7: Measurements Quay Wall D

The measured water levels are shown in Figure 7. The maximum load is present during a spring tide period. The tidal influence in the ground water level is clearly visible.

The In-Place Inclinometer (Model 6150C MEMS, Geokon inc.) has an accuracy of 0.05mm/m, so the overall accuracy at the top of the quay wall is in the order of 0.9 mm. The results in Figure 7 clearly show the influence of the tides. Every tide, the top of the quay wall moves about 0.5 to 0.6 mm in the horizontal direction normal to the quay wall. At a high water level, the top of the wall shifts towards the river which seems contra intuitive: on other gravity walls in tidal environment, shifting towards the river is observed during low tide, for example (Turner, 2013). The tidal movements of a gravity wall are caused by two mechanisms: 1) The weight of the water at a high water level compresses the subsoil in front of the quay wall so the wall tilts towards the river; 2) A negative water level difference over the gravity walls at a low water situation causes a resulting force and hence movement towards the river. For quay wall QWD (and also QWC) the influence of the first mechanism appears higher than the second one.

As can be seen, the load increase during phase B causes an additional horizontal displacement of about 0.6 mm towards the river. At the end of phase C, the movements tend to stabilise, however a prolongation of phase C should be desirable to make this effect more visible. Contractual restrictions made this prolongation not feasible.

After phase D, when the load is removed, the top of the wall shifts back about 0.3 mm landwards. Two weeks after phase D, the irreversible

horizontal displacement of the top of the wall remains 0.2 mm relative to the pre-load test situation.

Although the measured displacements are small, the effects of the tides and the load test are clearly visible. The displacements never exceeded the threshold values in Table 2.
