A case-history of remedial measures against sand beach erosion preserving its aptitude for bathing

C. Valore

Department of Engineering, University of Palermo, Palermo, Italy

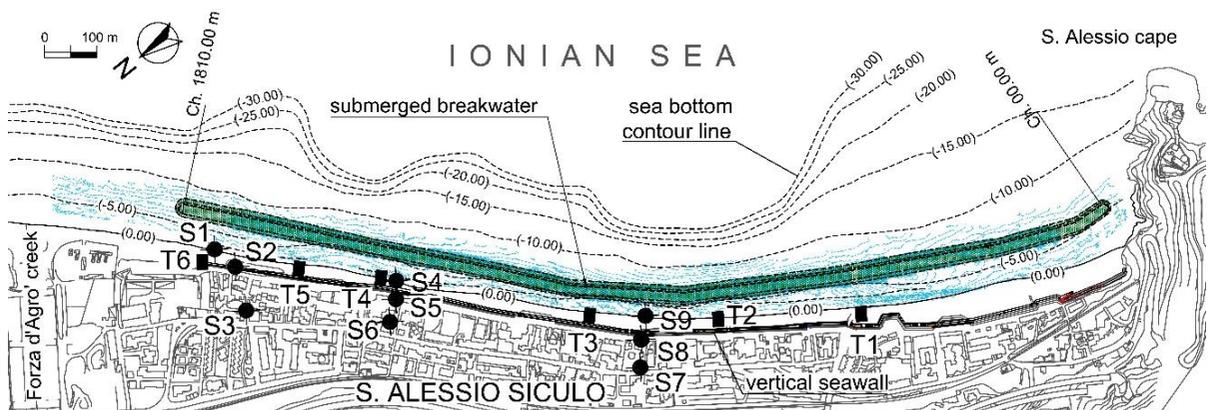
Figure 1 Plan of the site, submerged breakwater, boreholes S and exploratory trenches T. Elevations in metres (m) referred to mean sea level.

S. Alessio Siculo is a small seaside village located near Taormina in Sicily. Its main touristic attractiveness is the sand beach (about two kilometres long) which stretches from Cape S. Alessio to the mouth of Forza d'Agro creek, Figure 1. A long row of dwellings, built near the coastline, was once protected against wave actions by a system of sand dunes whose height reached 6m. Regrettably, about forty years ago the dune system was dismantled to make room for an embankment road (promenade) which was retained on the seaside by a vertical reinforced concrete seawall. The effects of this improvident modification soon started to be evidenced by the intense erosion of the beach and the scour and collapse of the seawall (see Figure 2) and also by the damage to dwellings. In 1997 the beach width underwent a reduction up to 70m, and the municipal administration appointed Eng. F. Giordano as designer of remedial works and the senior author as geotechnical consultant.

The subsoil was explored by means of 9 vertical boreholes (S1-S9, Figure 1) and 6 shallow trenches (T1-T6, Figure 1). The depth of boreholes ranges from 10 to 20 metres; the depth of the trenches varies from 2 to 3 m. The boreholes S1, S2, S4 and S9 and all the trenches T1-T6 are located on the seaside of the promenade, while boreholes S5 and S8 are located on its upstream side. Boreholes S3, S6 and S7 are located at a distance of 50-70m upstream from the promenade.

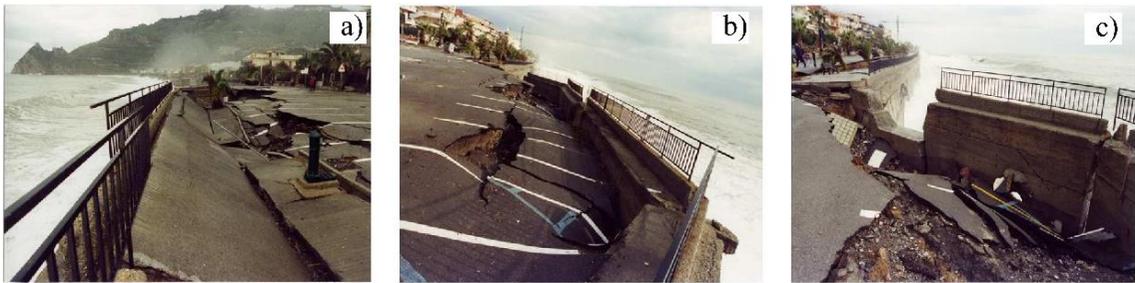
Figure 2 Typical rupture patterns of the seawall and the promenade.

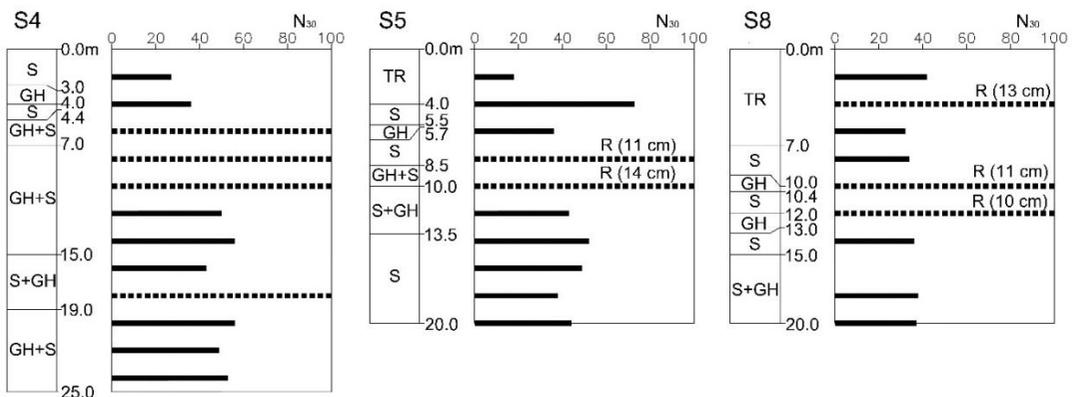
Figure 3 Typical schematic profiles of the boreholes S4, S5 and S8 and results of standard penetration tests. Key: TR: embankment material made of sand and gravel mixed with subangular rock blocks; S: graded gray sand; GH: polygenic gravel. R: “refusal” when the penetration depth is lower than 30cm at 100 blows of the hammer.

Typical schematic profiles of the boreholes are shown in Figure 3. The soil found in all exploratory trenches is made prevalingly of gravelly coarse sand.

Standard penetration tests were carried out in all the boreholes; the results, plotted in Figure 3, show that the sands and gravels are dense or very dense.

Sand is the main component of the beach and of the underlying soil. The sand fraction ranges from 77 to 87%; the gravel fraction varies from 11 to 20%. A typical grain-size distribution of the sand is shown in Figure 4. Rather thin layers of gravel have been found at different depths; they are evidenced by very high or refusal values of the N_{30} index of the standard penetration tests (see, Figure 3). The specific weight γ_s varies from 26.5 to 26.8 kN/m³. The saturated unit weight γ_{sat}

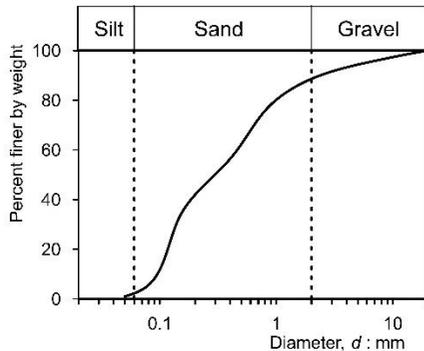
Figure 4 Typical grain size distribution of sandy soil.

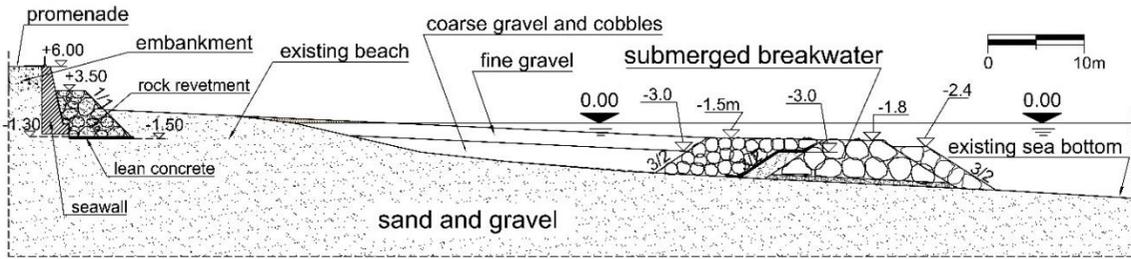
Figure 5 Schematic cross section of the beach and stabilisation works. Elevation in metres above mean sea level. Revetment made of stones $d=500-700\text{mm}$ "bonded" by concrete.

The fundamental aims of the remediation works were identified soon after the start of the study in 1997, namely (i) to protect existing houses and the promenade, (ii) to restore the beach to its former configuration or at least to its full functionality for bathing; (iii) to avoid spoiling the attractiveness of the site associated to barriers rising out of the water. The selected solution, shown schematically in Figure 5, consists of:

- a submerged breakwater, 1810 m long (see Figure 1), with the crest at 1.5-1.8 m below mean sea level and a layer of sacrificial stones on the seaside, and an internal geotextile sheet as a filter to prevent the sand of the beach from passing through the breakwater and being lost in the open sea;
- a layer of coarse gravel and cobbles overlain by a layer of sandy fine gravel to nourish the depleted coast (Figures 5 and 6);
- a rock revetment adjacent to the seawall (rebuilt where necessary) to stabilise and protect it from scouring processes (Figure 7). Staircases were built in the revetment to permit people to access the beach from the promenade.

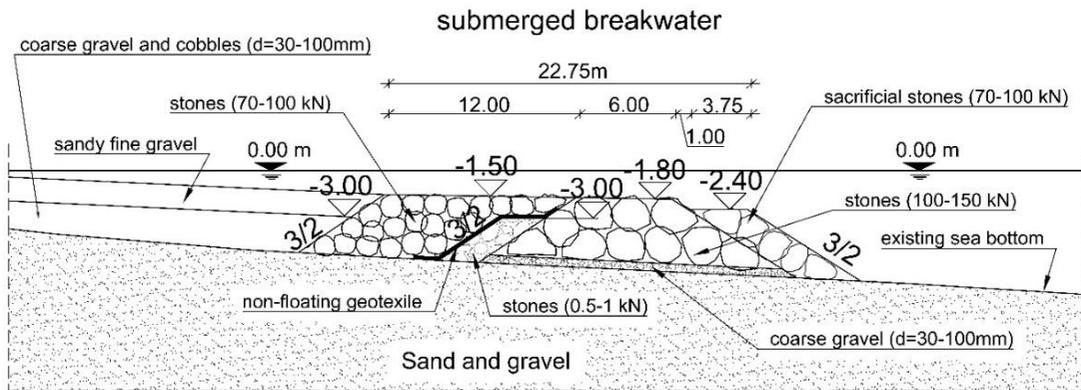
Figure 6 Details of submerged breakwater (cross section).

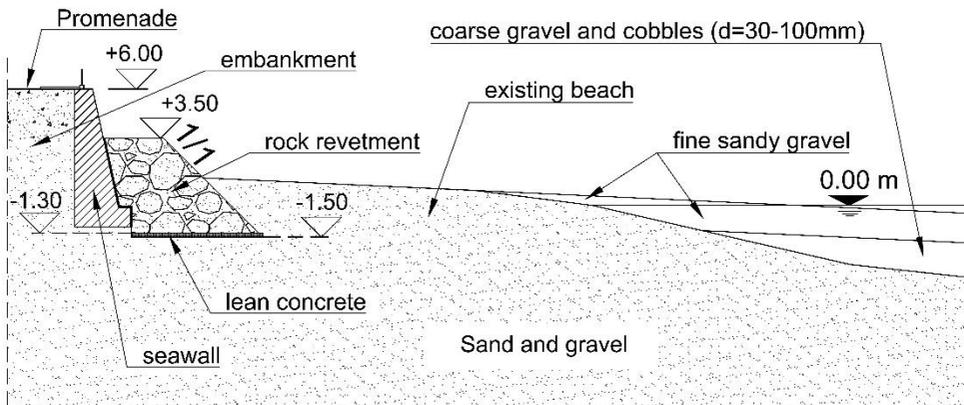
Figure 7 Details of seawall and rock revetment (cross section).

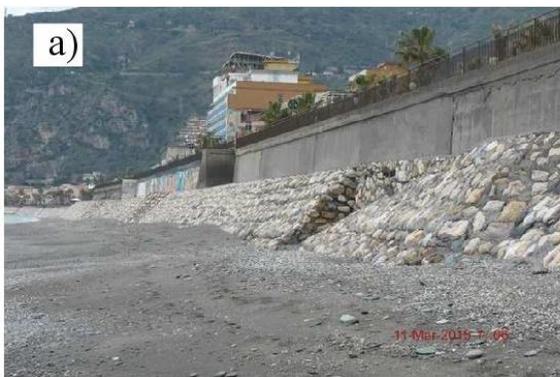
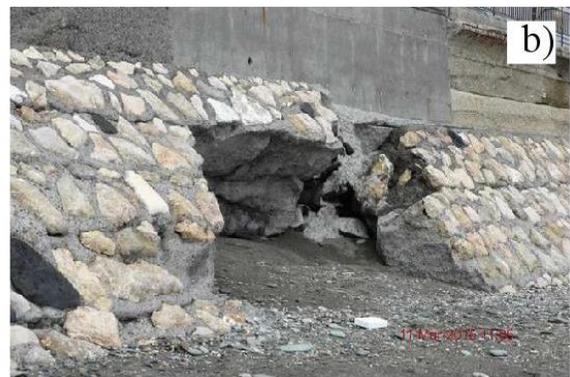
Figure 8 a) The submerged breakwater has been already built: the beach is protected during sea storms against erosion, and the revetment does not suffer scour. b) The submerged breakwater has not been built yet in the zone facing the rock revetment that undergoes scouring and breaching.

system is clearly shown by the comparison of figures 8a and 8b. Figure 8a refers to a beach stretch where the submerged breakwater has been already completed when a sea storm occurred: it may be seen that there did not occur any scour at the base of the rock revetment on the contrary of what happened in another stretch of the same beach, Figure 8b, where the revetment underwent scour and breaching because the corresponding submerged breakwater was not yet built at the time of the storm. Figure 9 shows the breaking of sea waves on the submerged barrier during a storm, and the strong attenuation of the wave effects on the beach. Figure 10 portrays the initial part of S. Alessio beach during the summer season after the completion of the defence works; it may be observed that the sand beach is preserved and fit for recreational activities.

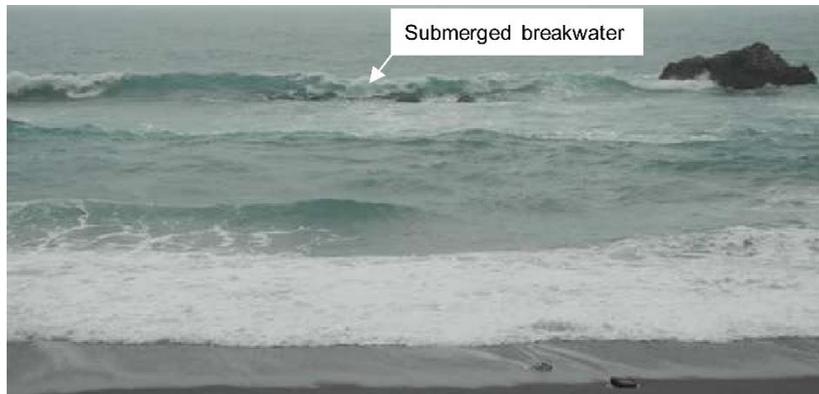
Figure 9 Sea waves break on the submerged barrier and do not damage the beach nor compromise bathing activities. (Photo taken from the promenade).

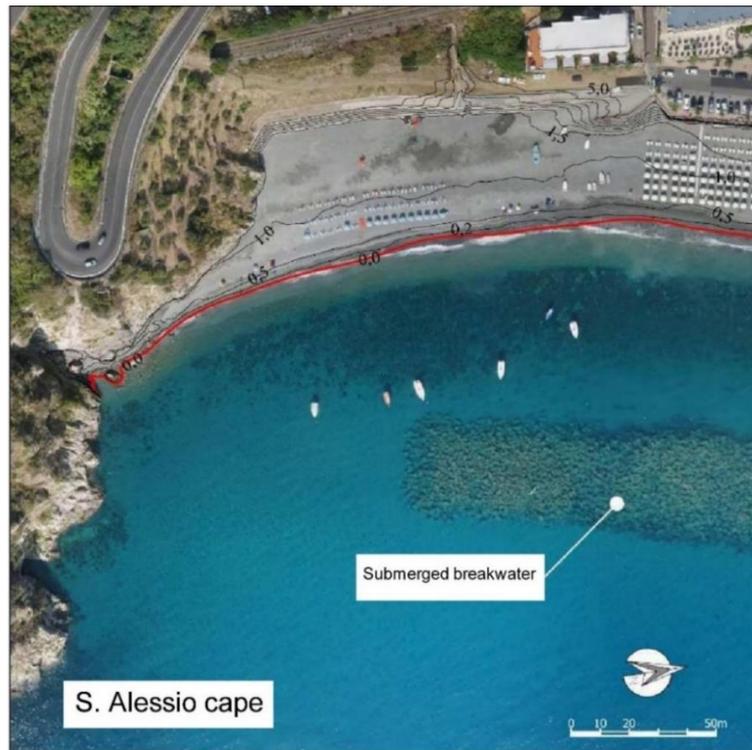
Figure 10 A stretch of beach returned to bathing and recreational activities after the completion of remedial works.
