Support of extended foundation pit in urban area

ABSTRACT: This paper deals with engineering solution for stabilization of existing foundation pit intended for construction of new hotel. The foundation pit is excavated up to 6,5 m depth and supported by reinforced concrete cantilever retaining walls. It was left for several years without any construction activities but in 2017 it was decided to proceed with the construction of the hotel but according to updated, modified design. In order to comply with the Client's requirement for extension of the foundation pit for one extra underground level a new design for support of foundation pit was developed. Considering the fact that the existing retaining walls are design to support the foundation pit to the depth of 6,5 m additional support structure was needed to be designed and constructed to provide support of the extended foundation pit (one extra underground level). The new excavation depth was set to 10,65 m which means it is approximately 4,0 m more that the depth of existing foundation pit. The new underground level which actually will be the third underground level of the hotel will have smaller area than the other two undergro

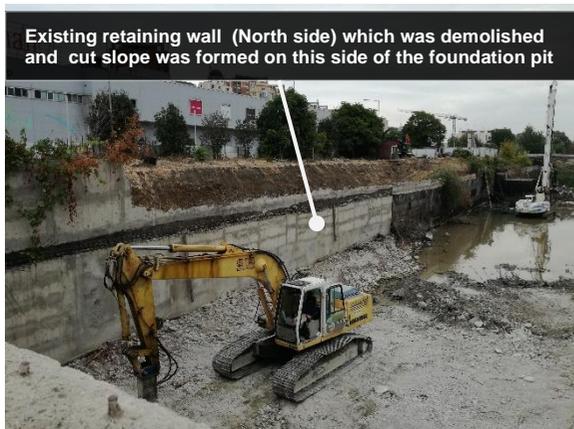
Figure 1 Demolishing of the existing foundation pad at level -6,5 m

The proposed design for support of section 1 involves construction of pile wall and installation of anchors to restrain excessive displacement of the structure. The pile wall was planned to be constructed behind the existing cantilever wall. According to the Client's requirements the stem of the existing wall should be kept attached to the pile wall in order to provide smooth surface for installation of hydro-insulation before construction of the hotel. The foundation of the existing wall was cut off.

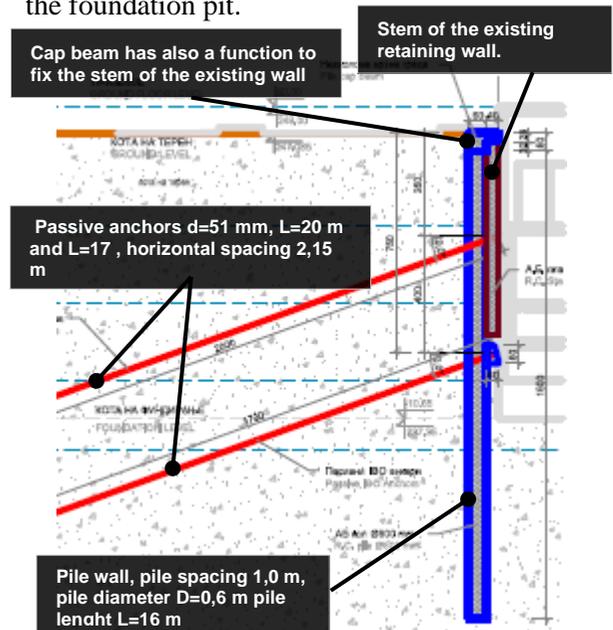
Figure 2 Anchored pile wall – section 1 of the foundation pit

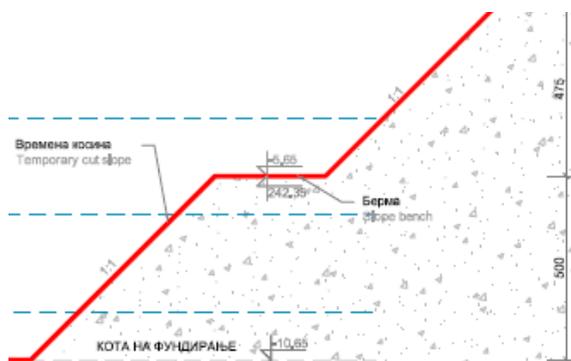
Figure 3 Slopes of the foundation pit – section 4 of the foundation pit

Section 4 of the foundation pit are the north and east side of foundation pit. On both sides there is large space which enables forming of cut slopes without any need for construction of support structures.

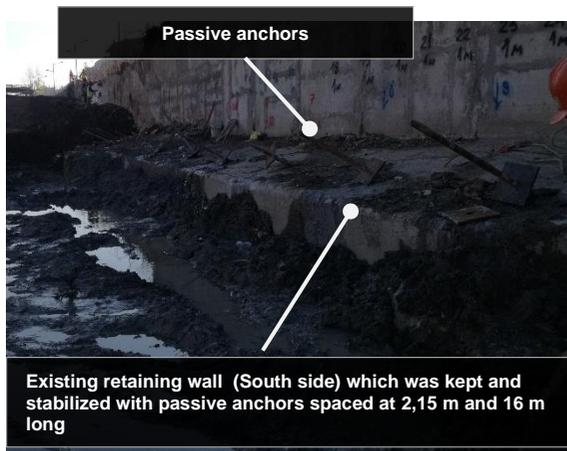
Figure 4 Installed anchors (before locking off) on the existing retaining structure on south side of the foundation pit

Having in mind that the existing foundation pit will be extended (the excavation will be deeper) stability of the existing support structure should be reconsidered and verified. The existing support structure is consisted of reinforced concrete retaining walls which have construction joints spaced at 2,15 m along the perimeter of the retaining structure. The construction joints are intentionally left in order to comply with the method of construction of the retaining wall. Precast reinforced concrete thin segments were used for construction of the facing of the retaining wall. The precast segments are 2,15 m wide and they are separated by construction joints. Later, they were concreted with the rest of the wall stem and the wall foundation. The existing retaining wall is constructed along entire perimeter of the foundation pit with exception of the east side where cut slopes were formed. Behind the retaining wall extraction wells are constructed at approximate spacing of 20 m which were used and will be used for lowering of the ground water level. It is important to emphasize that the existing retaining wall is not designed to withstand the hydrostatic pressure from the ground water level. Therefore, the extraction wells should be used all the time until underground levels of the hotel are constructed. Considering all this, the first step was to stabilize the existing retaining wall. In order to achieve this objective passive anchors were introduced for each 2,15 m wide segments of the

retaining wall. The bearing capacity of each anchor is estimated at 400 kN. The anchors were installed in the middle of each wall segment at 5,5 m vertical distance from the wall crest.

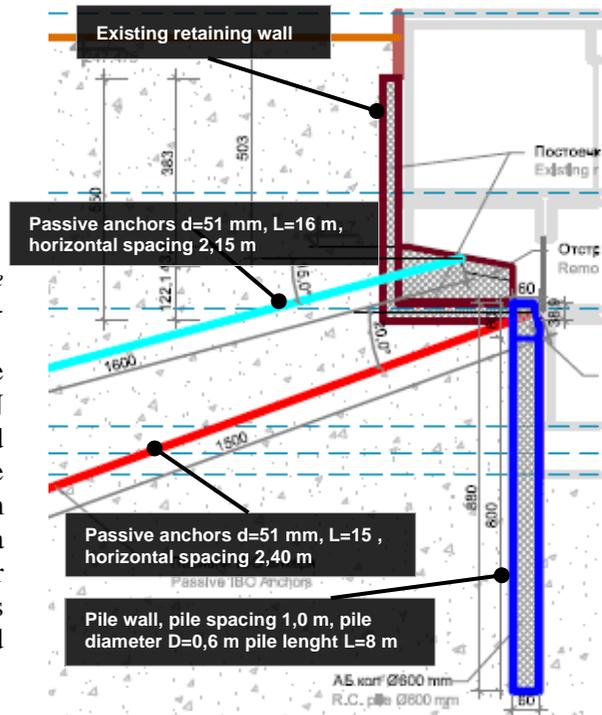
Figure 5 Anchored pile wall – section 2 of the foundation pit

Adopted design option for section 2 and 3 are involving stabilization of the existing cantilever wall using passive anchors and construction of reinforced concrete pile wall in front of the existing wall. In order to prevent excessive displacement pile wall will be restrained with one row of passive anchors installed through the capping beam and spaced at 2,4 m.

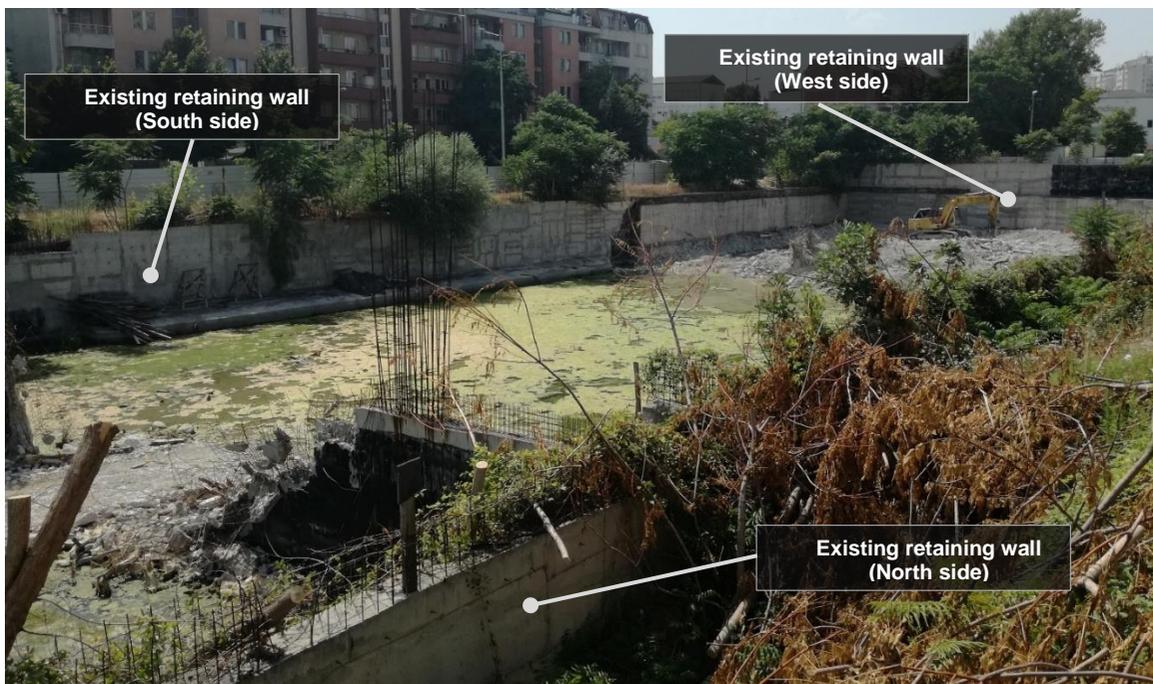
Figure 6 Existing foundation pit (before proceeding of the construction works), August 2017
