# Slope stabilisation in earthquake prone environment – with a flexible high-tensile steel chain-link mesh

## Stabilisation de pente dans un milieu propice aux séismes – avec un filet flexible en acier à haute limite élastique

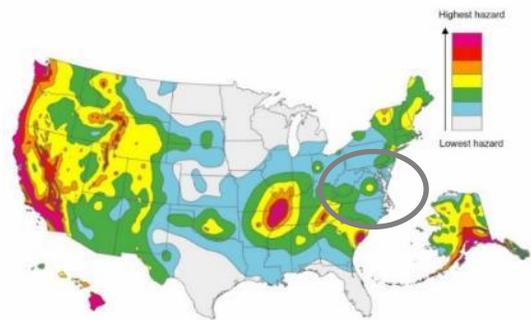
Figure 1: adapted seismic hazard map after the 2011  $M_w$ 5.8 Louisa earthquake (grey ellipse, USGS)

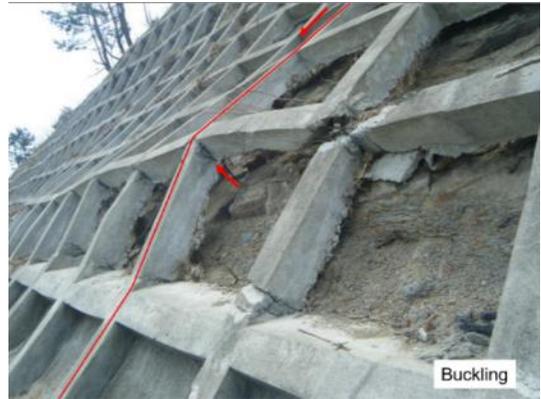
Figure 5: Collapse of shotcrete grating crib work in Kuji City after the earthquake. Buckling and shearing of the concrete ribs are observed.

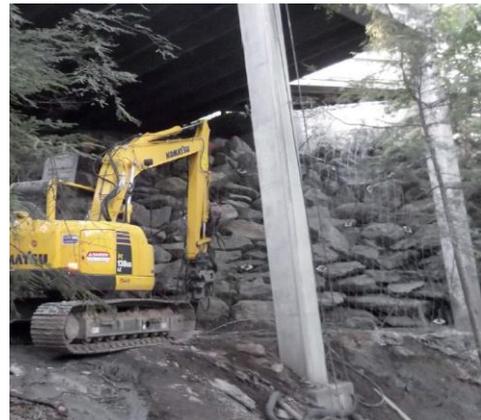
Figure 9: Slope stabilisation under a newly built residential car park. No damages were observed during and after the earthquake. The potential damage of slope failure would have resulted in the collapse of the residential compound and the car park.

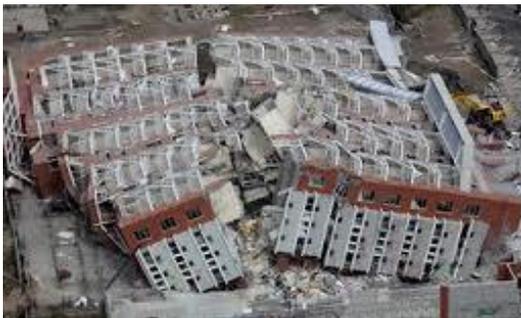
Figure 11: Damage in Caleta Tumbes, Talcahuano after the earthquake.

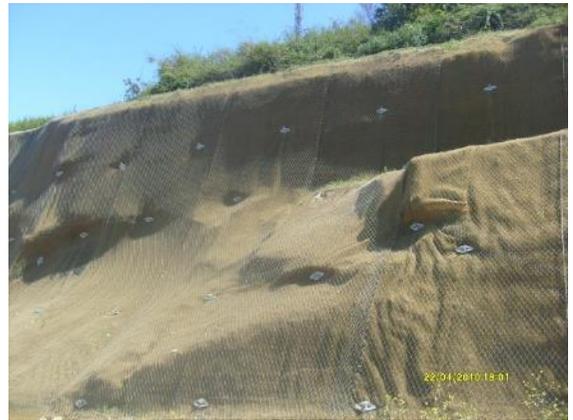
Figure 12: Previously installed Tecco system, which did not sustain any damage during and after the earthquake. The slope remained stable.

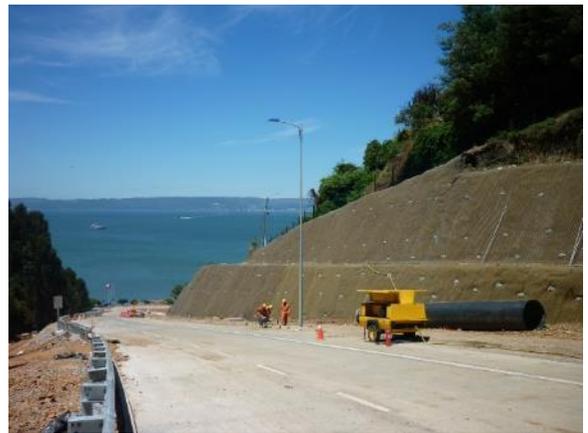
Figure 13: Overview of the stabilised road stretch being. No deformation or failure after the earthquake.
