Timber compaction piles as part of seismic retrofit for a 110-year old railway bridge

J. D. Williams

Klohn Crippen Berger Ltd., Vancouver, Canada

Keywords: Ground Improvement; Timber Compaction Piles; Liquefaction

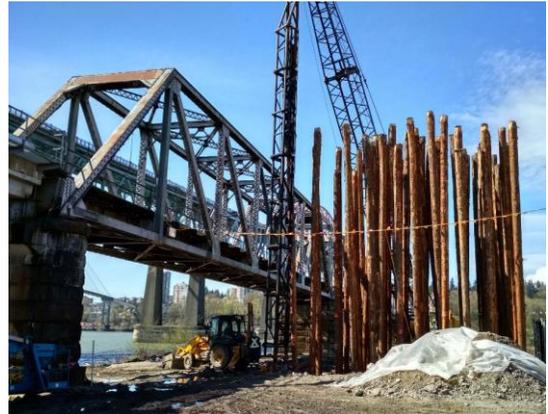
Figure 8. Pile driving adjacent to railway track

The owner required that the railway bridge remain in operation during the ground improvement work. As such, the pile installation immediately adjacent to the track had to be paused as trains were passing. The frequency of trains ranged from 30 to 35 trains per day. The diesel piling hammer was able to be shut down immediately when a train was approaching. Figure 8

shows the proximity of the piling equipment to the operational track.

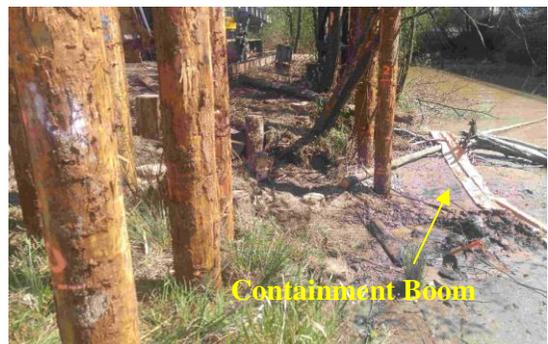
Figure 9. Pile driving adjacent to the river bank

The GI area southwest of the rail track had multiple timber piles located on the riverbank and within a tributary of the Fraser River. Materials or surface water from the GI area were not allowed to enter the watercourse. These timber piles were installed during low tide with containment booms surrounding the working area. Timber piles were driven between trees on the riverbank rather than removing the trees. The integrity of the bank was maintained during pile driving.

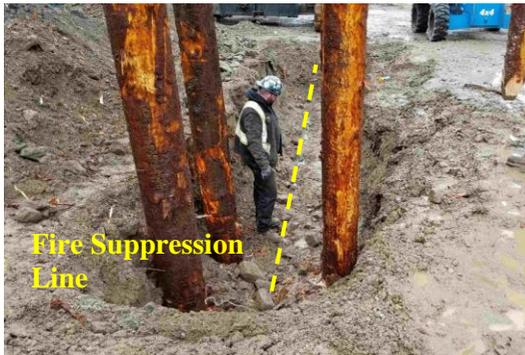
Figure 10. Pile driving adjacent to utilities

Both underground and overhead utilities were in the vicinity of the GI area. Underground utilities including a fire suppression water line (Figure 10) and a power supply line for the bridge

were located and daylighted prior to pile driving. The layout of the timber piles needed to be adjusted and one pile eliminated to avoid impacting the fire suppression water line. An overhead communication cable which intersected the GI area had sufficient slack to be held away from timber piles during driving.

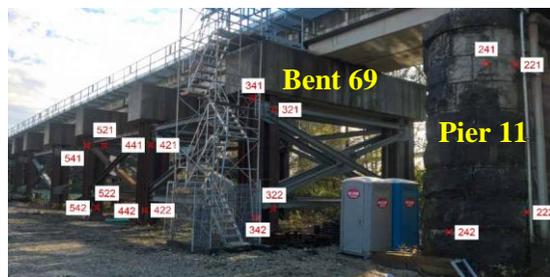
Figure 11. Typical monitoring points

Monitoring points were installed on the structure near the ground and close to the track level on both sides of the track. Typical locations of the monitoring points are shown on Figure 11.

The monitored settlement of Pier 10, Pier 11, Bent 67, Bent 68 and Bent 69 were less than 5 mm after the completion of piling. The measured horizontal movement either in the northing or easting direction at Piers 10, Pier 11, Bents 69, Bents 68 and Bent 68 were less than 17 mm. The greatest movement was observed at Pier 11 and Bent 69, which are located nearest to the GI area.
