Quay Operational Capacity Extension in Cernavoda Port Area by Consolidating the Old Structure

V. Dumitrescu

C. Culita,

C. Stefan

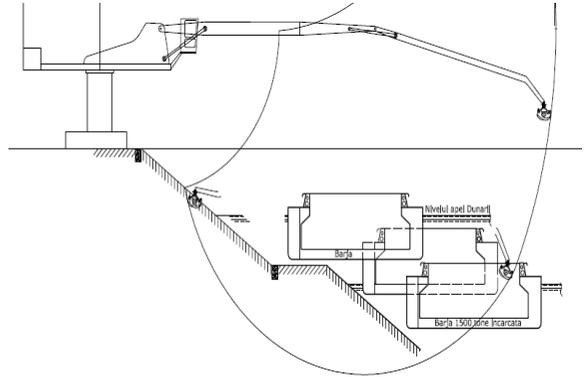
Figure 2. New crane operating outline for different Danube water levels

Under operating conditions (shiploads throughout the year - both at high but most of all for Danube low water levels), it was necessary to move the crane runway closer to the water. The quay's crest level (reinforced concrete beam) was set at + 8.45m local Cernavoda and the

minimum level of the Danube for which operation was requested was proposed to be -1.00m local Cernavoda (figure 2). The quay stability verification as a result of crane runway relocation was done in accordance with the eurocodes and Romanian norms (Eurocode 7/SR EN 1997-1, Eurocode 8/SR EN 1998, NP 124/2010, NP 123/2010, P100/2013, SR EN 19921-1, SR EN 1536) .

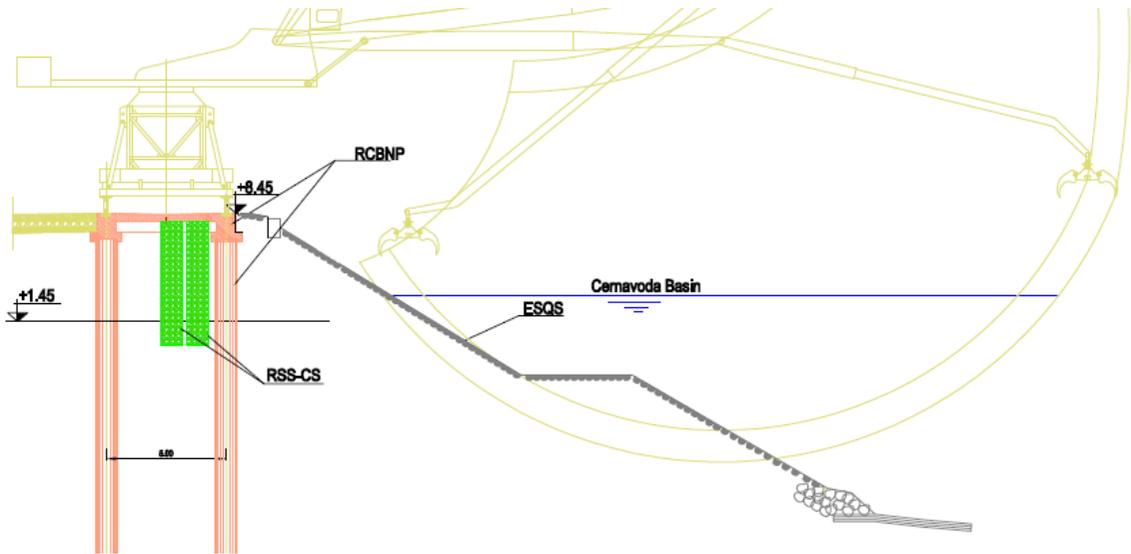
Figure 3 shows the existing sloped quay structure (ESQS) and new proposed structures RCBNP (reinforced concrete beams network founded on piles) and RSS-CS (replacement of soft soil-crushed stone).

Figure 3. Existing quay structure (ESQS) and new proposed structures (RCBNP) and (RSS-CS).

Quay crest level in our location is +8.45m local Cernavoda, which corresponds to level Nmax 5% + a safety clearance $g=1.00m$. New crane runway was founded on large diameter piles and the reinforced concrete platform plate was fixed in-between the beams grid (figure 3). Reinforced concrete beams grid have deep foundations, two rows of 900 mm diameter

drilled piles, 22.00 m in length, with spacing of 5.00 m in-between the two rows. For each of the two parallel rows the piles were located every 3.00m interax distance. Each of the two longitudinal reinforced concrete beams composing the new crane runway had a cross section of $B=1.30m$ and $H=1.20m$. New crane runway stiffness was reached with reinforced concrete cross-beams with the section 45 cm x 80 cm, located at points of intersection with piles. In order to be able to accommodate a surcharge of 25 kN/mp, a reinforced concrete plate was proposed in-between the two longitudinal runway beams with $B=4.20m$ and a variable $H=27-35cm$. The concrete slab was embedded in the transverse and longitudinal beams. As mentioned before the very soft yellow clay presence (depths between 2.00m and 4.50m) with very low consistency ($\phi'=10^{\circ}$ si $c'=5kPa$) required limited soil replacement and a secondary consolidation with crushed stone filled 900mm diameter drilled piles.

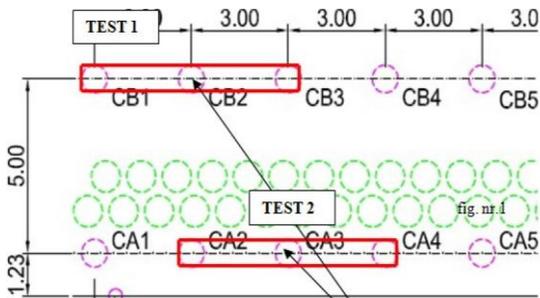
Figure 4. Axial load tests 1 and 2 locations.

In order to check the piles bearing capacity, two static load tests have been performed, one for each of the two piles rows. Each test included loading of a group of 3 piles, central pile was compressed and the two marginals were tested on pulling out forces (figure 4).

During execution, static pile load tests were carried out (Bauer, 2014) to confirm the preliminary bearing capacity in the project (axial stress, compression and tension) according to NP 045-2000 (figure 4);

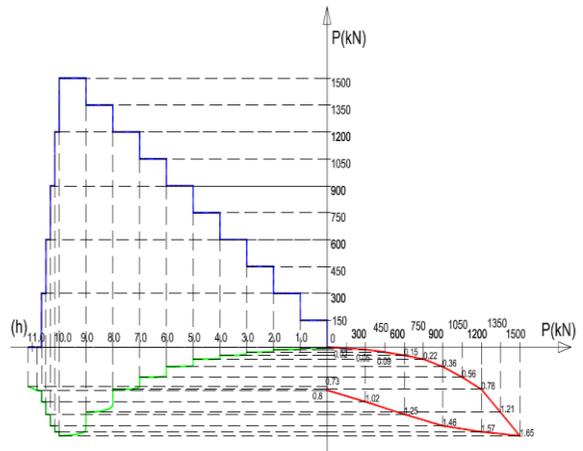
Maximal vertical force applied was 1500 kN, tested with loading steps according to diagram presented in figure 5 resulting in a shore / water pile a 1.65mm / 1.69mm settlement and a residual settlement after unloading of 0.73mm / 0.49mm.

Figure 5. Loading steps, settlement diagram

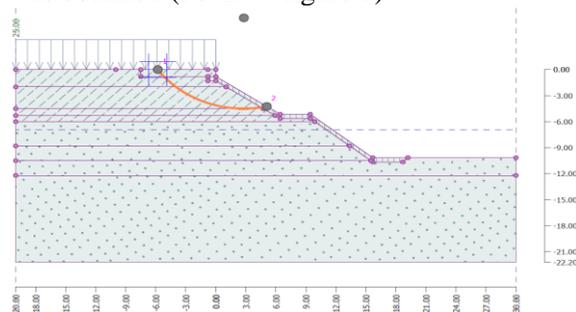
Figure 6. Unstable sloped quay (*ESQS*)

According to the Romanian similar experience for a slope, in order to be stable, the minimum factor of safety required is $F_s=1.50$, the study considering the safety factors methodology. The analysis using Geo 5 software indicated that on the initial state, the sloped quay (*ESQS*) was unstable ($F_s=0.99$ figure 6). By adding the designed structure (*RCBNP*) a stable situation was obtained ($F_s=2.44$ figure 7).

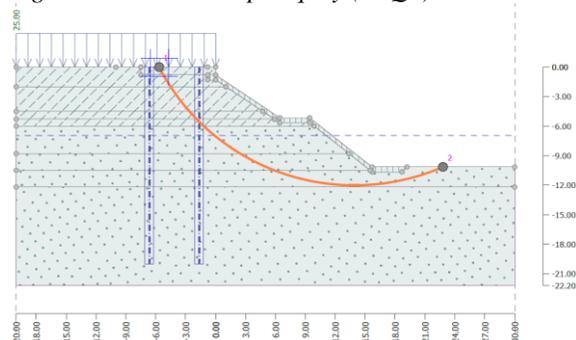
Figure 7. Stable sloped quay (*ESQS*) + (*RCBNP*)

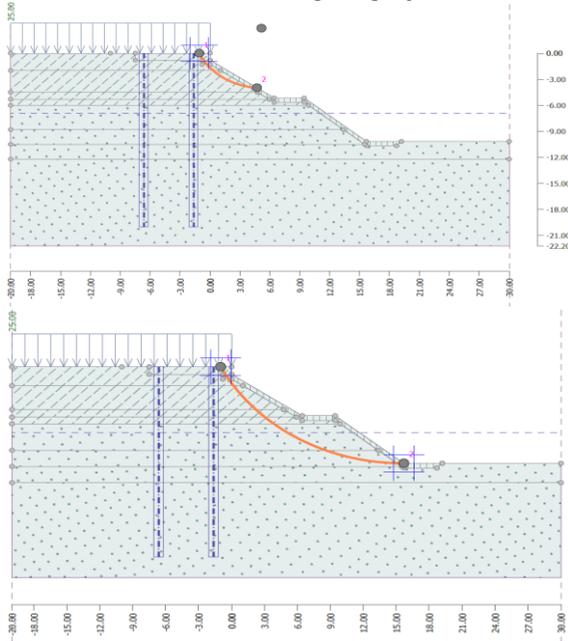
Figure 8. $F_s=1.37-1.44$ sliding surfaces may occur in front of the structure

However some cvasi-instable sliding surfaces (close to $F_s=1.37-1.44$) may occur in front of the

structure where only crushed stone piles have a limited stability role (figure 8). Those situations may occur with high risk when Danube water levels are rapidly decreasing to very low waters levels and so monitoring/supervising equipment have been installed in front of the sloped quay.

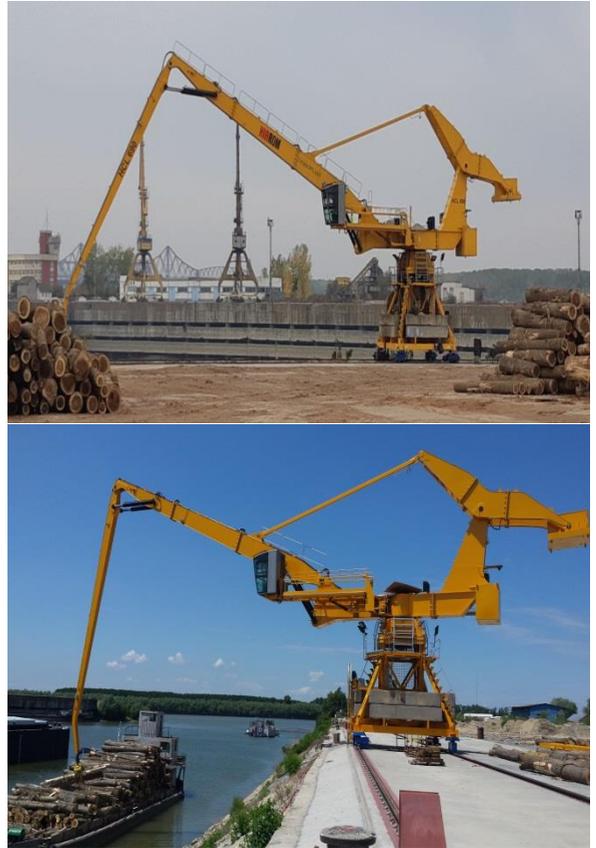
Figure 9. New crane operating safely to the sloped quay in Cernavoda Port area.

which generated additional stability. Actually, works have been finalized and the new quay structure is safely operational with the new crane (figure 9).
