Budarahals HEP – Headrace tunnel excavation – a project review

Jon Smari Ulfarsson-Project Manager/Geological Engineer
Landsvirkjun, National Power Company of Iceland

Matthias Loftsson-Geological Engineer
Mannvit Engineering Consulting Company, Iceland

ABSTRACT: The Budarahals HEP 95 MW, in the lower highlands of southern Iceland, is harnessing about 40 m head in a 4 km long 140 m² in cross section elliptical shaped headrace tunnel. The rock mass on the tunnel route consists of 1 to 2-million-year-old igneous and sedimentary rock formations underlying hiatus and much younger and highly permeable moberg formation. Interpretation of extensive geological exploration revealed several different geological formations on the tunnel route of different geotechnical properties. The actual geological profile did only to a minor extent vary from the geological tender profile. However, unexpected difficulties were encountered. Statistical analyses and comparison to older comparable projects were performed on the quantity of installed rock support, and evaluation made on the excavation progress advance through different geological formations. This paper summarizes the result of rock mechanica

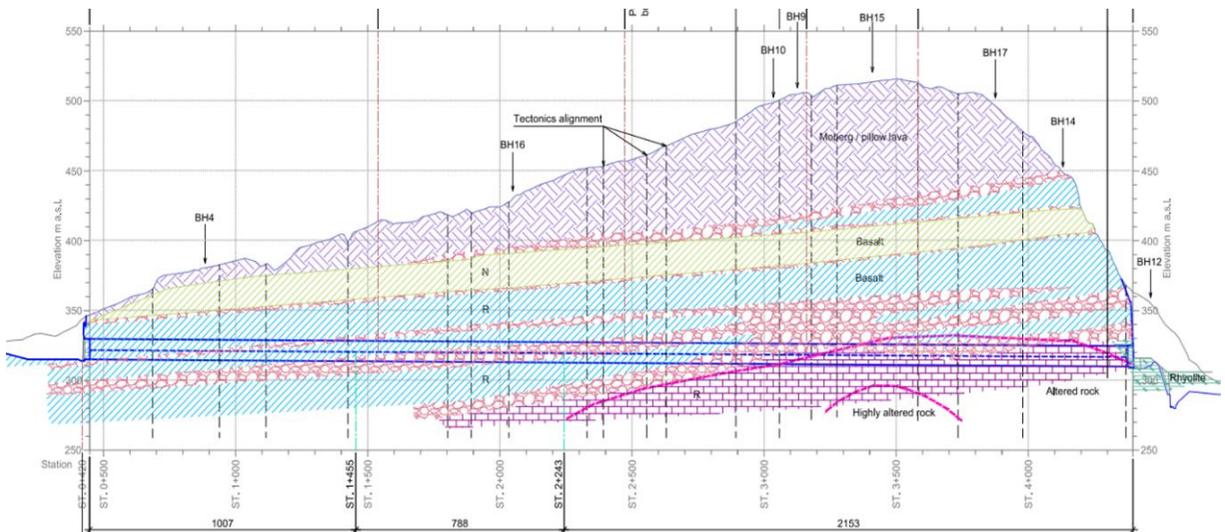
Extensive geological exploration revealed several different geological formations, of different geotechnical properties, to be encountered on the tunnel route, see figure 2. This included among other three different types of basalt; fractured tholeiite basalt, large columnar porphyritic basalt and geothermally altered olivine basalt, rhyolite and sedimentary rock, mainly sandstone and conglomerate.

Figure 2. Geological section through the Budarhals as interpreted from exploration core holes.

At exploration stage, the strike and frequency of tectonic lineaments was mapped from aerial photos, plotted on the geological section model as single broken vertical line, see fig.2

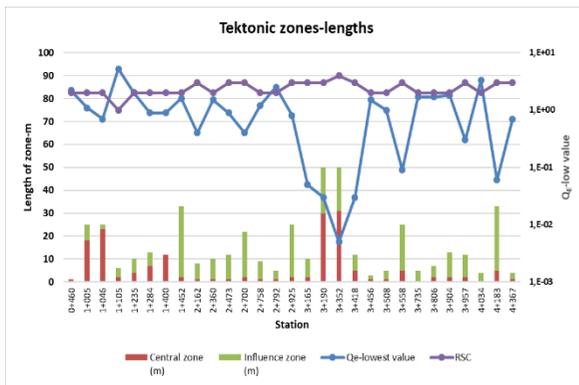
In all, 29 fault zones were mapped with average length of the influence zone of 15 m, thus about 11 % (450m) of the total tunnel length, see figure 3.

Figure 3. Analyses of the tectonic zones crossing the tunnel route (red is central zone, green influence zone).

Location of some of these faults and fractures coincide with predicted, but other not, thus being older than the overlaying rock. Movement was mostly normal of up to 10m, however reverse and transverse were mapped of up 4m displacement.

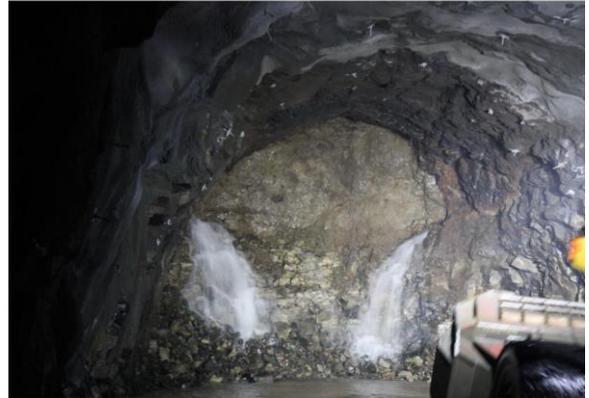
Based on permeability tests in boreholes and field mapping of tectonic lineaments it was evaluated that water ingress would in general be relative limited mainly associated with tectonic fractures and dikes, see figure 4.

Figure 4. Inflow of water from fault plane 5m ahead.

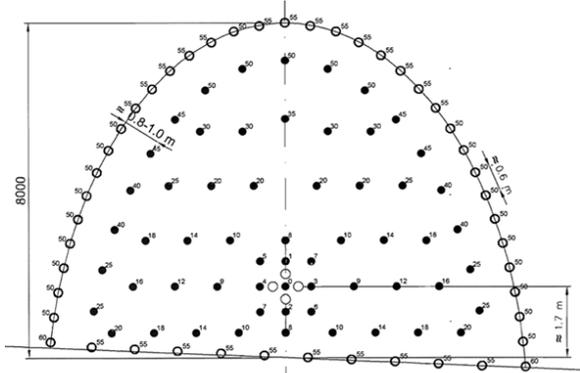
The contractor's method statement revealed number of drill holes in the top heading of 110-125, 51mm wide blast holes and four 105mm cut holes. Drilled depth was assigned 5.3 m and the charging (Q-value) was around 2.3 kg explosive/m³ rock. (Landsvirkjun, 2016).

Figure 5. Typical blasting pattern for the top-heading.

The tunnel excavation was divided into two sections, top heading and bench, each cross-section of 70 m², figures 5 and 6.

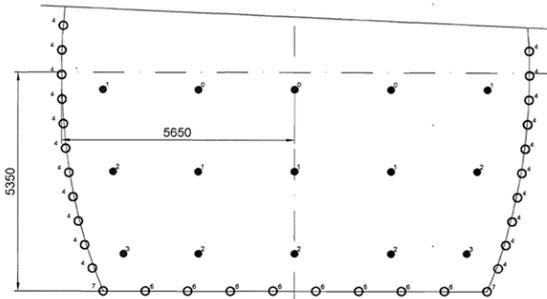
Figure 6. Typical blasting pattern for the bench.

For the bench excavation, number of blast holes of 46 eu., 4.8m long and of 57 mm diameter. Charging (Q-value) was about 1.08 kg/m³. (Landsvirkjun, 2016).

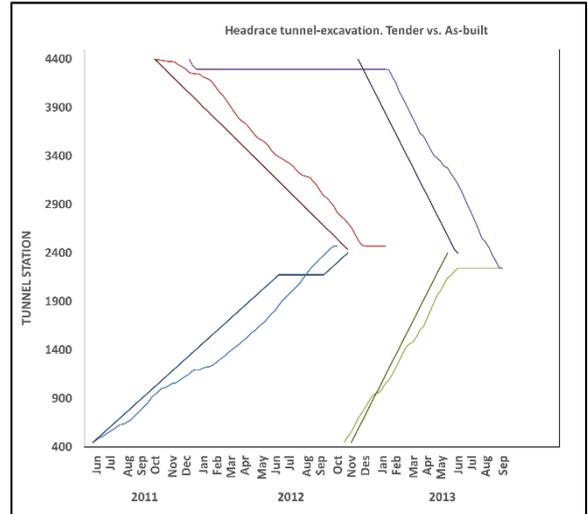
Figure 7. Contractor's scheduled versus as-built progress of excavation.

The effective as-built progress of the excavation for the whole tunnel, taken into account all variables, was 34.2 m/week for the top heading and 58.1m/week for the bench. The contractor's effective estimation in tender was 41,9 m/week for top-heading and 59,5 m/week for the bench, see figure 7, thus 82% and 98% respectively of his estimate.

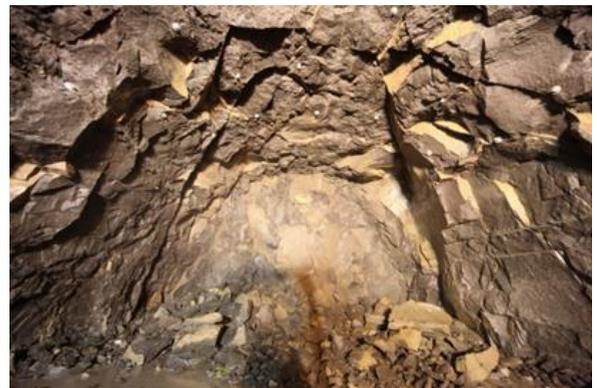
From the upstream portal and about 1100 m ahead the tunnel is excavated through a 10 to 15 m thick porphyritic basalt formation, with up to 3 m in diameter columns, irregular spaced, undulating joints sometimes filled with up to few centimetres of silt/clay, figure 8.

Figure 8. Large columnar basalt, diameter of 2-3m.

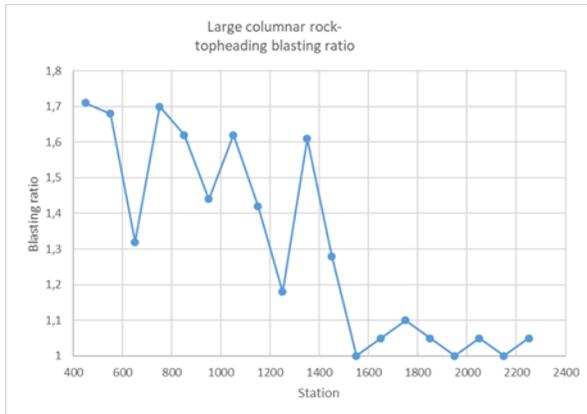
From the start of the tunnel excavation, progress was delayed considerably due to frequent underbreak and re-blasting, see figure 9, and the average progress of excavation was only about 26 m/week.

Figure 9. Re-blasting ratio in the first 2 km long large columnar top-heading section. Up to 70% re-blasting occurred in the large columnar basalt, st. 450 to 1550.

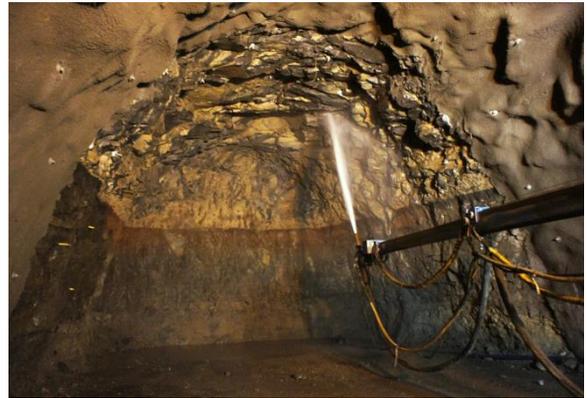
Underlying the large columnar basalt is a sedimentary rock containing cobbles and boulders of over 1 m in diameter in sand/gravelly matrix, figure 10, and mixed face condition existed for next about 1,5 km. Excavation through those conditions, underbreak diminished considerably and progress of tunnel excavation was ascending, becoming between 35 to 45 m/week.

Figure 10. Mixed face, columnar basalt overlaying, sedimentary rock, st~2.200

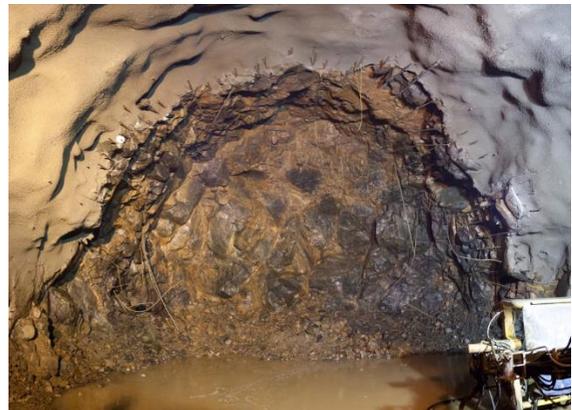
Figure 11. Mixed face, highly altered and unstable intensively weathered rock (rounded boulders) overlaying coarse gravel and boulders. Profile preserved by 6-8m long spiling bolts.

Excavation through the alteration zone, excavation progress decreased due to increased rock supporting as per RSC 3 and 4, directing intensive temporary supporting by 6 and 8m spiling followed by sprayed concrete ribs support.

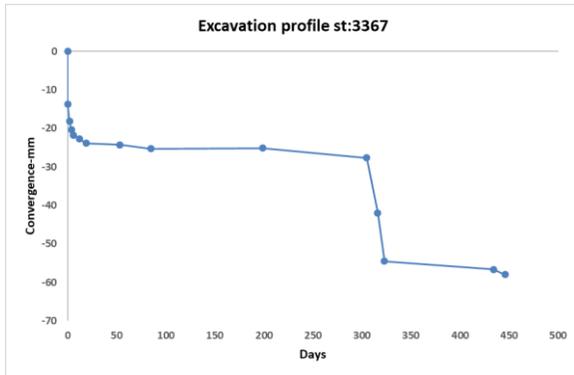
To evaluate stability (deformation) of the tunnel cross section, eye-bolts were installed at several tunnel lengths for convergence measurements, and further rod extensometers in two sections in the alteration zone. Horizontal deformation (convergence) was from few millimetres in solid basaltic rock to up to 60 mm in the alteration zone, benching with gallery 90% fully supported.

Figure 12. Convergence measurements in the alteration zone, top heading and benching 300 days later.

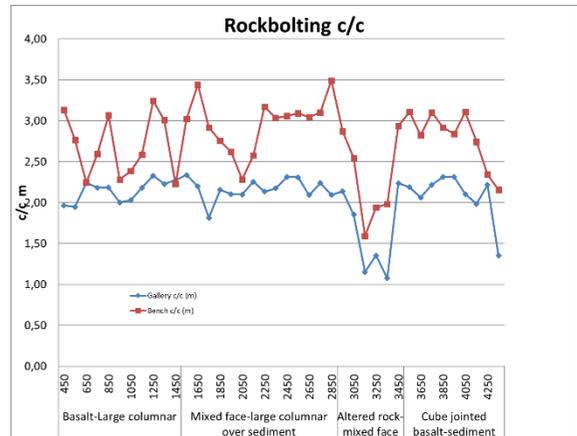
In the alteration zone, installed rockbolts are longer and spacing of 1 to 1,5 m in the top heading and 2 m in bench walls, see figure 14. In addition, 8 m long spiling bolts with 0,4 m spacing were installed in the top-heading perimeter in the weakest sections.

Figure 14. Average spacing of installed rockbolts in top-heading and bench - 100m sections (Landsvirkjun 2016).

About 23.000 rock bolts were estimated in the tender contract, i.e. 5,8 bolts/m tunnel, mostly 3 and 4 m long bolts. In all 31.670 bolts were installed, on average about 7,9 bolts/m tunnel. This is about 37% more rockbolts than anticipated. Bolts were mainly 4 m long and much more spiling bolts were installed than estimated, in the alteration zone and through fault zones.

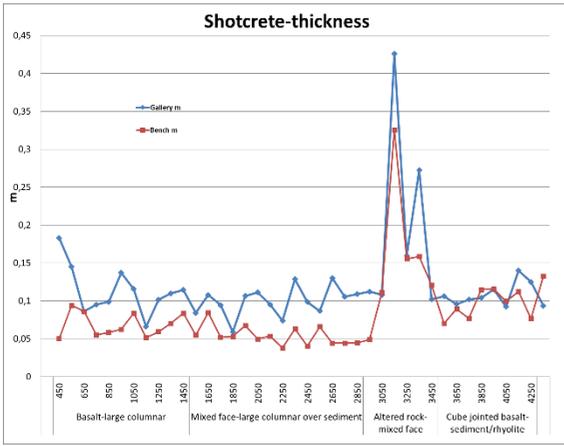
In the large columnar basalt, thickness of sprayed concrete was on average of 100 mm in top heading and 60 mm in the bench walls.

In the mixed face, thickness was between 80 and 100 mm in the top heading and 40 to 60 mm in the bench.

In the alteration zone, thickness of sprayed concrete was increased to up to 300 to 400 mm in

Figure 15. Averaged shotcrete thicknesses in top heading and bench-100m sections.

The tender volume of shotcrete of 12.000 m³ equated 3 m³/m tunnel length. Applied sprayed concrete increased by 80% up to 21.600 m³ equating 5,4 m³/m tunnel length. This increase was mainly due to underestimate of rock surface roughness (~50%) and shotcrete rebound volume (>10%) in the columnar basalt, and underestimated volume of sprayed concrete applied in the alteration zone.

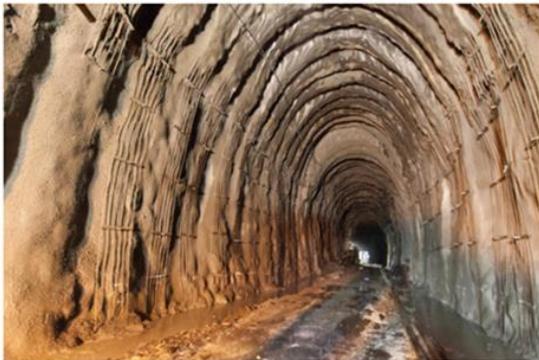
Figure 16. Sprayed concrete reinforced ribs under construction. Bending of the tunnel alignment ahead.

To be on the save side rock support was though assigned much greater for the top-heading than estimated at tender stage, deemed necessary from Q-value and geotechnical testing. Spiling bolts were installed over about 340 m section and over a 65 m long weakest part reinforced sprayed concrete ribs were installed with about 1 m spacing between 1 m wide ribs, see figure 16.

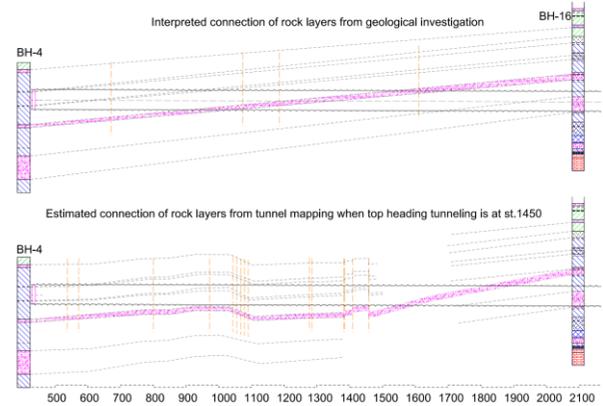
model, typically due to fluctuation of layers caused by tectonic faulting and layer's surface irregularity, see figure 17,

Figure 17. Tender vs. as-built geological model over 1000 m tunnel length in the large columnar section.

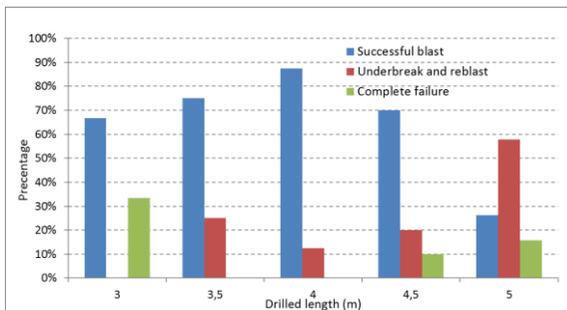
By statistically comparing results from different approaches in order to minimize the problem, results showed that better results were obtained by reducing the pull length from 5.2 m to 4 m, see figure 18, increase the number of blast holes with less diameter (48 mm) instead of fewer wider holes (64 mm) for the same weight of explosive and use more energy releasing explosives with higher shock wave velocity, such as primer and dynamite along with the slurry.

Figure 18 Successful blast (blue), complete failure (green) and underbreak (red).

The most likely reason for the blow-out and underbreak was reflection of the explosive energy wave away from the undulating columnar joint surfaces and energy loss in the joint fill material. Shorter rounds thus reduced this effect and the shock wave from high energy explosives gave better breakage of the columns.
