Geotechnical Challenges in Iceland

S. Erlingsson

Faculty of Civil and Environmental Engineering, University of Iceland, Reykjavik, Iceland

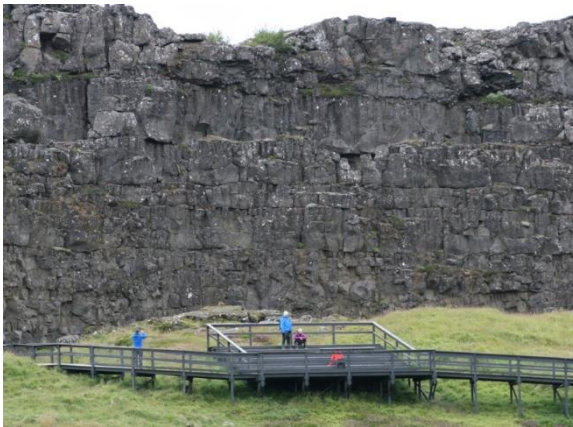
Figure 8. Cross section of typical Icelandic rock mass. Horizontal lines can be seen, forming boundaries between different lava layers. The layers are usually a few to tenths of metres in thickness.

Figure 8 shows a typical Icelandic lava stratum.

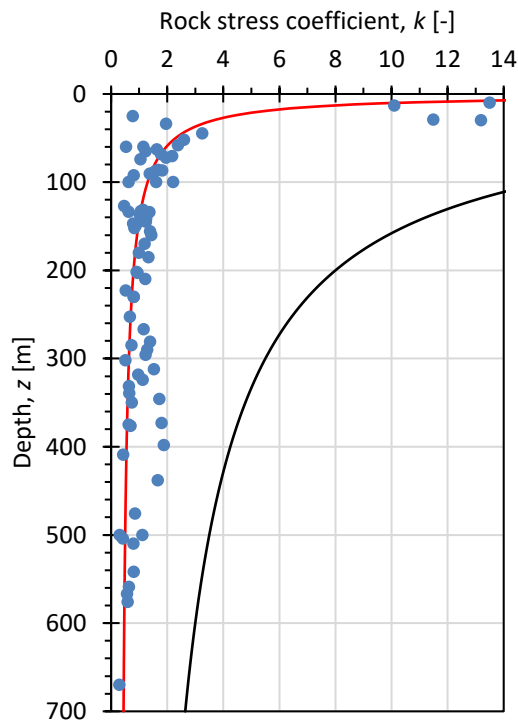
Figure 10. Rock stress coefficient as a function of depth from 17 stress measurement locations in Iceland. The black and red lines represent the upper and lower boundaries based on worldwide trends.

where σ_h , σ_H and σ_v are the minor and major horizontal and vertical stress components, respectively. The results of the rock stress coefficient measurements as a function of depth are shown in Figure 10.

The red and black lines represent the worldwide lower and upper limit trends (Hudson and Harrison 2002) expressed as

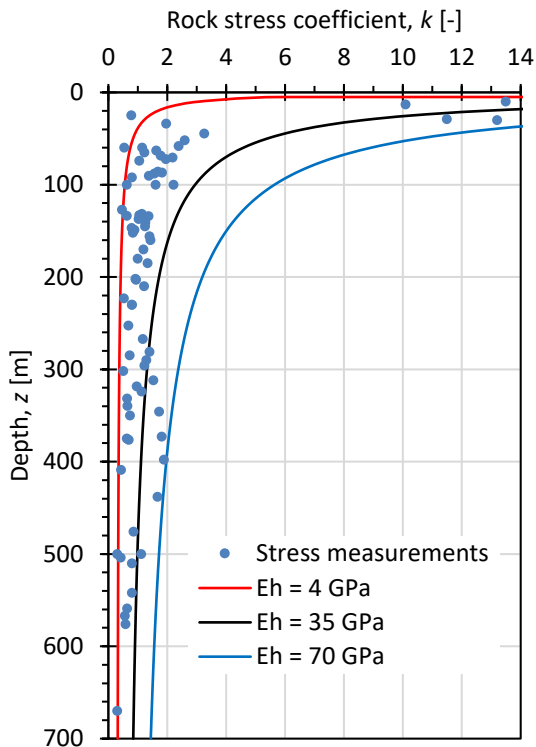
Figure 11. Rock stress coefficient as a function of depth. The lines represent three values of the horizontal deformation modulus.

Based on Figure 11 it is clear that the deformation moduli in the country lie mainly between 4 and 35 GPa, particularly at depths shallower than 300 m. At one location in the oldest bedrock (furthest away from the rift zone) a deformation modulus as high as 70 GPa was observed at depths greater than 300 meters.

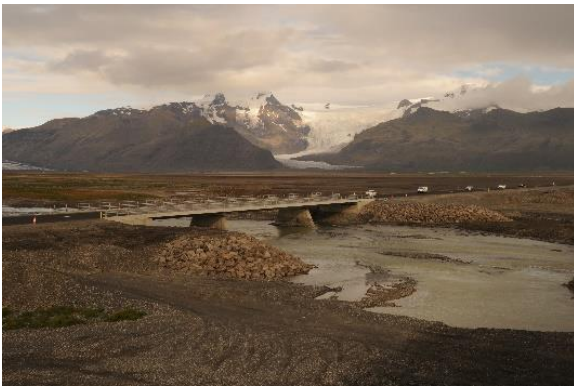
Figure 12. Thick sediments of loosely compacted sandy and gravelly soils in the forefront that have been piled up mainly in catastrophic events such as volcanic eruptions or glacial flow. Figure courtesy of by V. A. Ingólfsson.

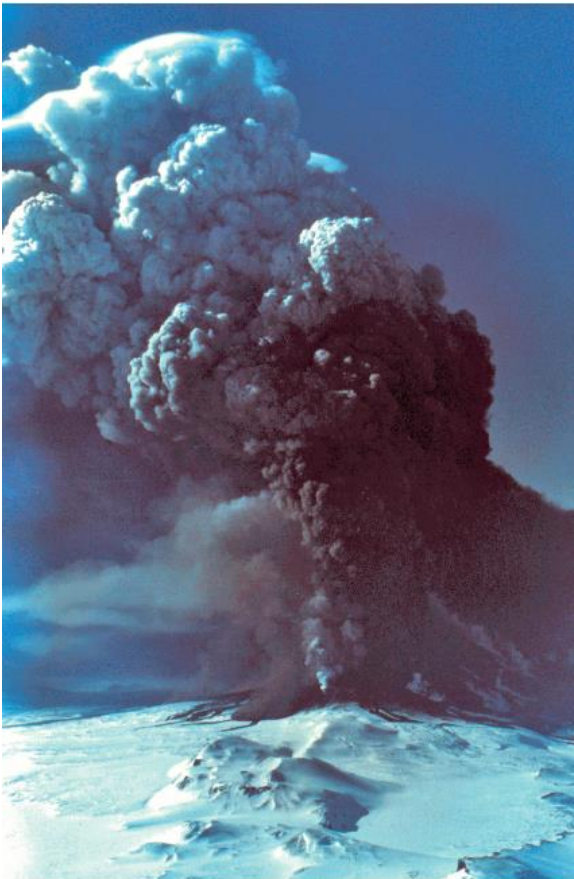
Figure 13. Mt. Hekla has created thick sediments of pumice in prehistoric eruptions. Sólmes et al. 2013 (Pálmi Hannesson/Sólarfilma).

Additionally there are soils that have been created in volcanic eruptions. Ash and pumice from Holocene volcanic eruptions can be found in some areas such as near some of the active volcanoes. Pumice is a lightweight and highly porous material of low strength. However, it also has good thermal properties and has been used in mortar or as thermal isolation layers in construction (see Figure 13).

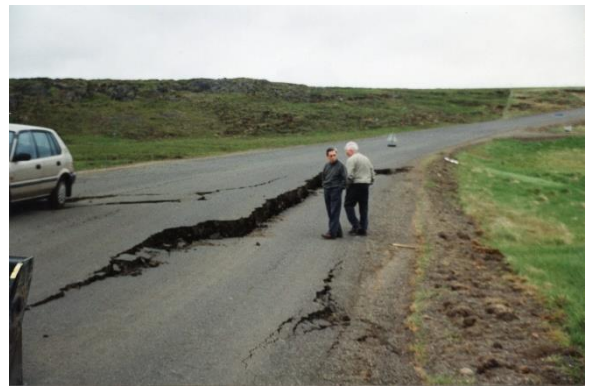
Figure 14. A pavement structure resting on a peaty subgrade in Holt, South Iceland that liquefied in the June 17, 2000 earthquake (M_w 6.5). Figure courtesy of V. A. Ingólfsson.

As in many northern European countries and in North America peat deposits can be found in some places in Iceland. The local climate, geography and environment favour bog and peat bog formations. The peat is usually lightly decomposed with a high void content and water content as high as a few hundred to one thousand per cent. Figure 14 shows a thin road structure resting on peaty land. The pavement structure was damaged in the June 17, 2000, earthquake (M_w 6.5) due to liquefaction of the underlying soft peat.

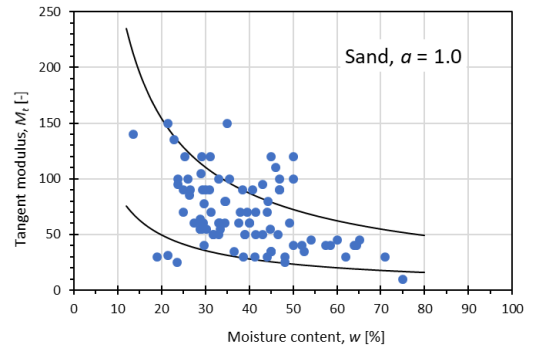
Figure 15. Tangent modulus M_t ($M_t = m\sigma_a$ as $a = 1.0$) of saturated sandy materials as a function of moisture content.

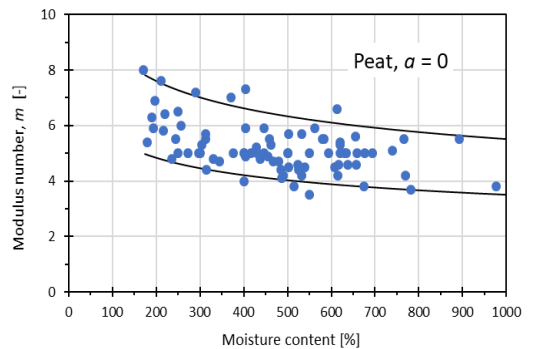
Figure 17. Modulus number m of saturated peat as a function of moisture content. Note that the moisture content is high, ranging from 150 – 1000%.

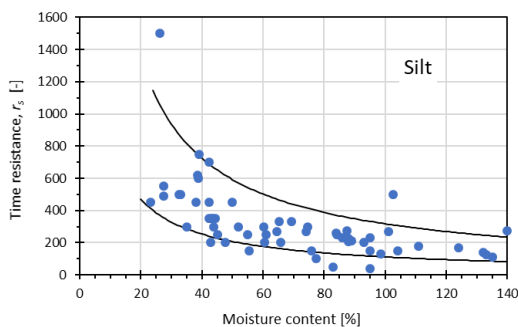
Figure 19. Time resistance coefficient r_s for silt as a function of moisture content.

The time resistance coefficient r_s for the three soil groups of sand, silt and peat are shown in Figures 18 – 20.

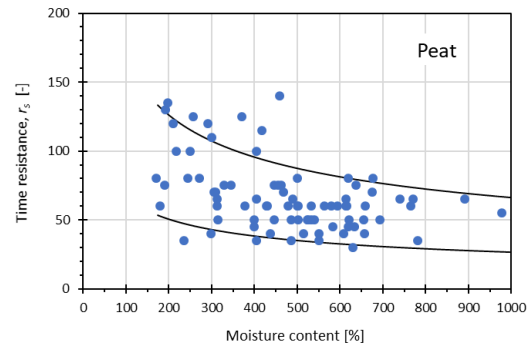
Figure 20. Time resistance coefficient r_s for peat as a function of moisture content. Note the high in-situ moisture content.

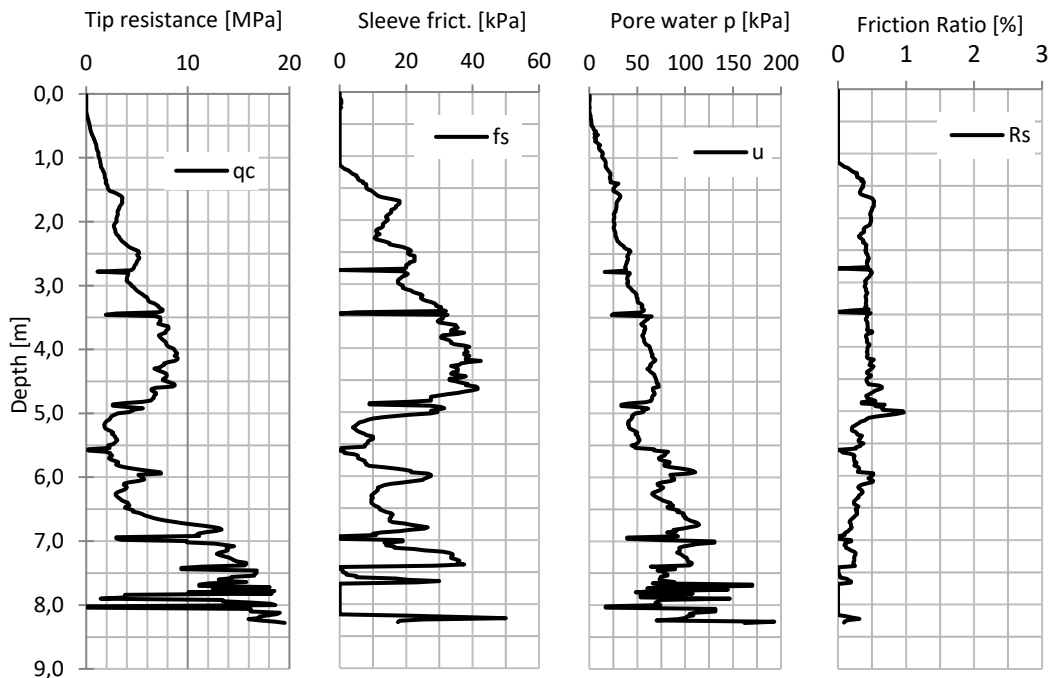
Figure 22. CPT results from a sandy site on the south coast close to Þorlákshöfn.

A Standard Penetration test (SPT) or Cone Penetration test (CPT) is further used. An example of CPT test results on the south coast at a location close to Þorlákshöfn is given in Figure 22. This is a site consisting of typical non-cohesive material with particle sizes ranging from silty particles and larger. Although the site deposit is very thick, the test was terminated at 8.3 m depth due to high resistance and consequently risk of damage to the CPT cone. This was probably due to the fact that the cone hit larger boulders that frequently occur in the local soils.

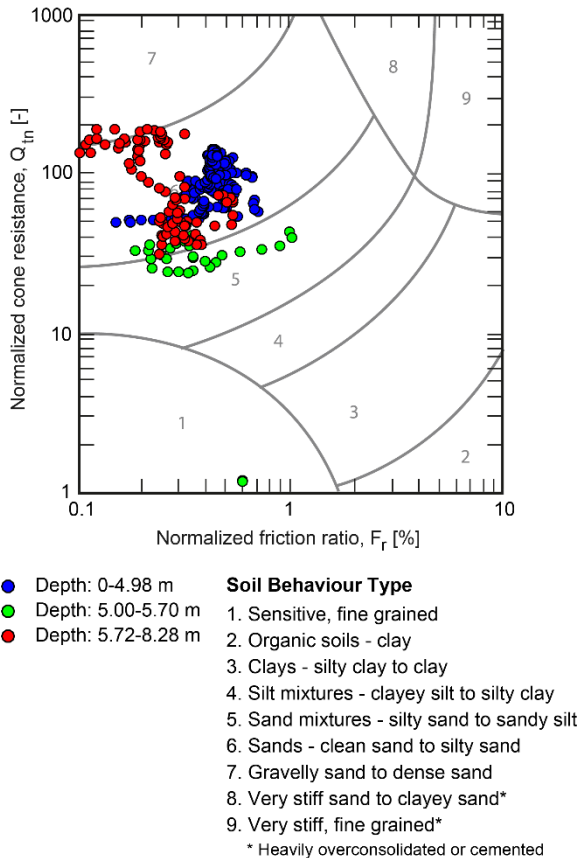
Figure 23. Normalized soil behaviour type (SBTn) chart with results of CPT measurements at the Þorlákshöfn site.

The results of the CPT measurements were then used to classify the deposit using the normalized soil behaviour type (SBTn) chart (Robertson 1990 and 2009) (see Figure 23). Most of the data points are classified as soil behaviour type 6 “sands – clean sand to silty sand”. However, some data points, mainly in the depth range of 5.0-5.7 m, are classified as type 5 “sand mixtures – silty sand to sandy silt”.

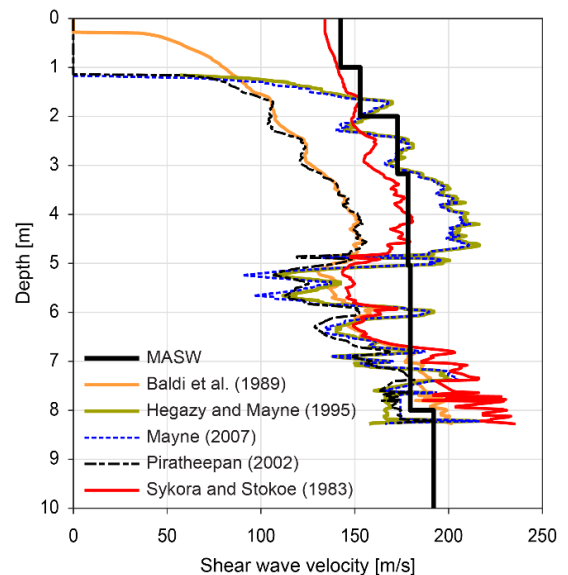
Figure 24. V_s -profiles for the Þorlákshöfn site predicted based on selected CPT- V_s correlations and obtained by MASW.

The CPT- V_s correlations in Table 3 were applied to the acquired CPT data. Figure 24 compares the V_s -profiles predicted based on the CPT- V_s correlation equations and the profile that was obtained by the MASW method.

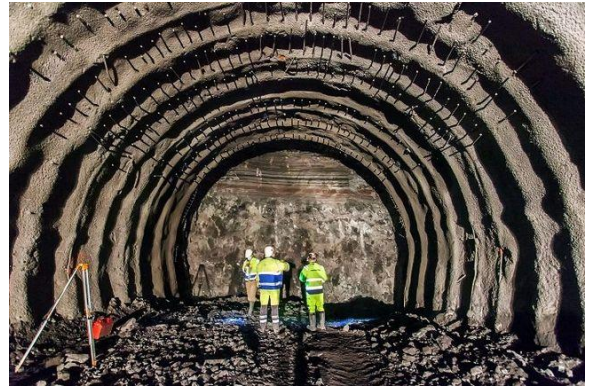
Figure 25. Lattice girders as a support in the 2-lane Vaðlaheiði road tunnel. Figure courtesy of B. A. Harðarson.

As of today, 14 road tunnels are part of the road network for a total of over 65 km of tunnels. Most tunnels include two lanes, giving a cross-sectional area of around 55 m². In addition, the total length of tunnels associated with hydropower utility is around 85 km with a cross-section area that varies from 6 to over 150 m² (Loftsson et al. 2005). Reinforcement is mainly designed according to the Q-system and on average around 3 rockbolts (3 m long) are used per metre for tunnels with ~8 m span (cross section around 54 m²) and 2.5 m³/m of fibre-reinforced shotcrete. If conditions are very poor shotcrete ribs or lattice girders provide additional support that has been proven to be both economic and durable. An example of using lattice girders is shown in Figure 25.

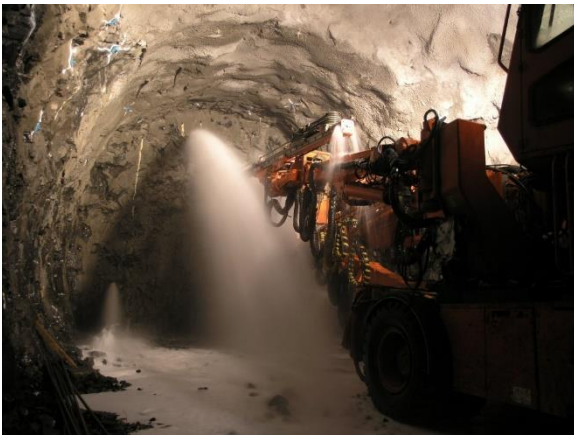
Figure 27. Water inflow into the Héðinfjörður tunnel. Figure courtesy of B. A. Harðarson.

The general low horizontal stresses and frequently fractured rock mass with irregular interbeds can lead to major water inflow into tunnels if excavation takes place under the groundwater table in the rock mass. This has happened in some tunnel excavations such as the Vestfjörður tunnel, Héðinsfjarðar tunnel and Vaðlaheiði tunnel, leading to delays and increased cost. An example of a water inflow into the Héðinsfjörður tunnel is shown in Figure 27.

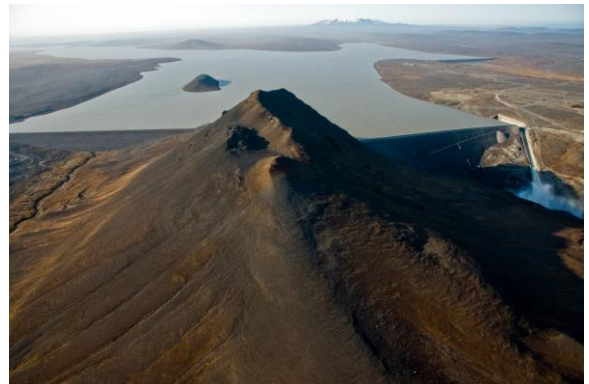
Figure 32. Hálslón Reservoir area; the Desjará Dam to the left, the Kárahnjúkar Dam and spillway in the middle, the Sauðárdalsstífla Dam to the right. The Brúarjökull Glacier (part of the Vatnajökull Glacier) in the background. Figure courtesy of H. Bjarnason.

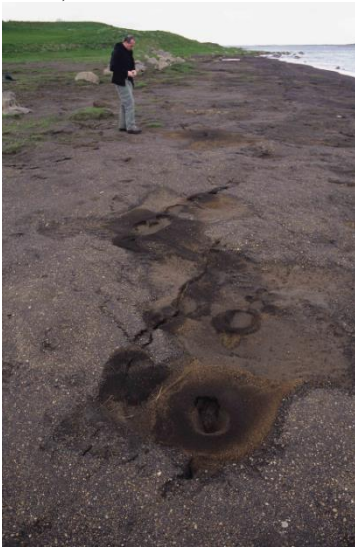
Figure 33. Sand boils (liquefaction) on the bank of the River Ölfus close to the epicentre of the 29 May 2008 $M_w 6.3$ earthquake. Figure courtesy of O. Sigurðsson.

In 2000 two earthquakes occurred within the SISZ with only a 4 day interval, on the 17th and 21st of June. Their magnitudes were both $M_w 6.5$. Eight years later on May 29, 2008, the third earthquake hit the area ($M_w 6.3$). Considerable damage was observed but no casualties (Einarsson 2008, Sigbjörnsson et al. 2009). Liquefaction was observed at Arnarbæli in the western part of the SISZ where sand boils were found on the bank of the River Ölfusá (Fig. 33).

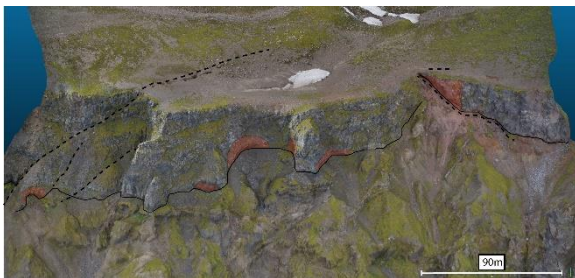
Figure 41. The Svínafellsheiði mountain slope. The solid black line marks the boundary between the topmost basalt layer and underlying móberg/hyaloclastite, the dotted black line shows the observed fracture, and the transparent red polygons shows the overhangs in the basaltic area. Figure courtesy of P. Sæmundsson.

One example of such mass movements has taken place at Svínafellsheiði due to the retreat of the Svínafellsjökull (part of the Vatnajökull Glacier). In 2014, over a 100 m long and up to 30 cm wide fracture in bedrock was discovered in the Svínafellsheiði mountain slope. The fracture is located at 850 m a.s.l. in the uppermost part of a 500 m high, almost vertical mountainside (Sæmundsson et al. 2019).
