Small extent, high risk: a landslide at the Kiel Canal and its investigation using FEM

C. Wolff

M. Pohl

ABSTRACT: The Kiel Canal is the most frequented canal worldwide and links the North Sea to the Baltic Sea. In 2015 an unusual slope movement of a 30 m wide section moving towards the canal was detected leading to a limitation for the traffic. The slope built by both cutting and embankment, consists of glacial sediments showing a typical disordered layering. A ground investigation with boreholes and CPTs showed sand lenses embedded in till as well as high and in parts artesian groundwater levels. An extensive laboratory testing program was carried out, including triaxial and permeability tests. The detection of a zone with softened glacial till was of particular significance. This irregularity can be seen as a potential sliding plane. Long term monitoring of the slope revealed a correlation between the slope movements and the local precipitation. A FEM analysis based on the above mentioned findings was carried out applying the method of phi-c reduction for the safety analysis of the slope. The resulting failure mechanism is in good agreement with the one observed in reality. To

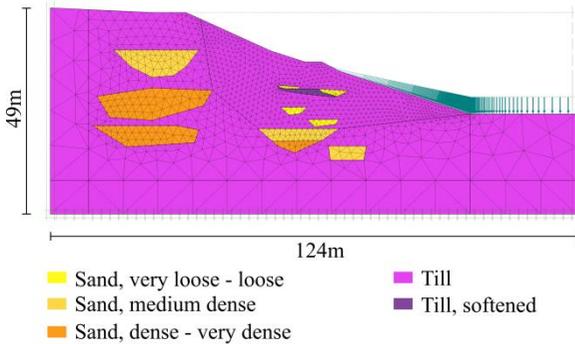
Figure 11. Plaxis model

The recalculation of the landslide is carried out using a 2D Plaxis model as shown in Figure 11. The dimensions of the finite element model are chosen according to DGGT (2014), with edge sizes of elements from 0.4 m to 8.0 m. The area which is supposed to contain the sliding surface has a finer discretisation. All in all, 2935 15-node triangular elements form the mesh.

an increasing softening of the till due to water contact. The reduction is applied to an area of till next to sand lenses underneath the maintenance road, where signs of softening were found during soil investigation (deep purple in Figure 11). The dimension of the area is chosen such that the position of the moving slope section matches the one observed in reality. The evaluation is made using equation (1):

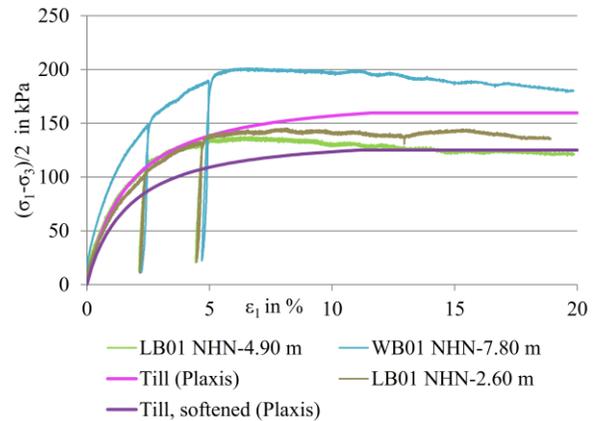
Figure 12. Stress-strain behaviour till

The calibration of the material parameters was carried out on test results of undisturbed samples from a depth near the assumed sliding surface. For the zone with the softened glacial till the parameters are adapted to the weakest soil behaviour. Figure 12 shows the stress-strain behaviour derived from triaxial tests. With $\sigma_3 = 100$ kPa the stress level was chosen accord-

The governing failure mechanism is a shear failure, therefore the focus was put on the triaxial tests during calibration. Particular attention was paid to the strain range up to 5 %. The magenta curves representing till were generated with the built-in soil-test module in Plaxis. Empirical values were used for sand.

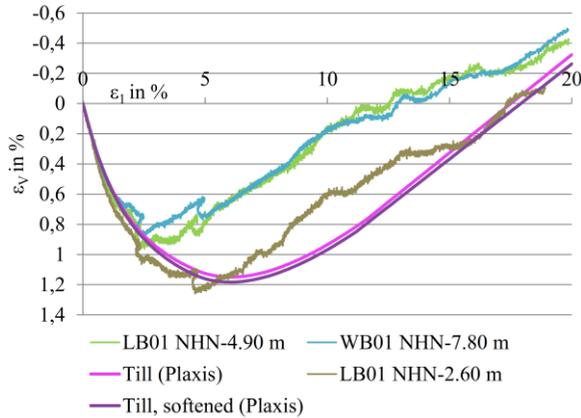
Figure 13. Volumetric expansion till

ingly. The corresponding volume expansion is shown in Figure 13.
