The cause of the landslides of 1st and 2nd April 2016 in Tosbotn, Norway

Following the Tosbotn landslides of April 2016 the local government in Nordland County, Norway, appointed the authors of this paper as an investigation committee. The present paper gives an overview of the two landslides and concludes on the most likely failure mechanisms based on an integrated geological and geotechnical study.

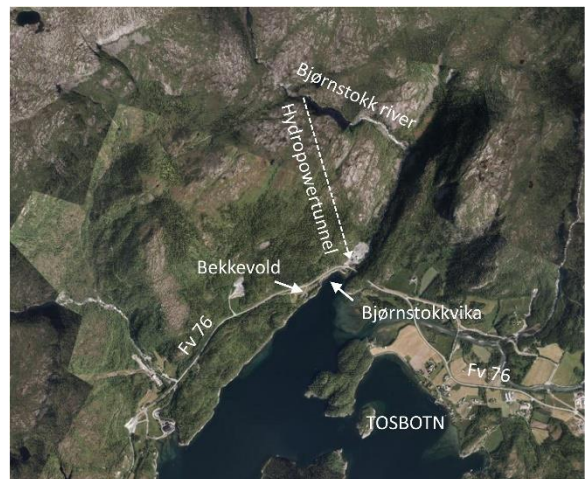
Figure 2. Aerial view of Tosbotn, the sites of the slides and the relevant hydropower tunnel.

Figure 2 shows an aerial view of the position of the hydropower tunnel relative to the slides. Figure 3 shows a vertical cut through the waterway to Bjørnstokk Power Plant. The waterway starts with a river intake at elevation 267 meter from which the water goes through a 250 meter drilled shaft, inclined 45° downward, where after the waterway continues in a wider, unlined, blasted 600 meter long rock tunnel sloping 8° downward

Hydraulic fracturing then opened cracks in the rock around the tunnel and sent water through existing rock joints down and outwards in the direction of the fjord and the landslide areas.
