# Use of Compaction Grouting as Ground Improvement Technique in Compressible Solid Waste Landfill

G. Tsitsas (corresponding author)

*GT Ground Engineering & Construction Services, Bucharest, Romania*

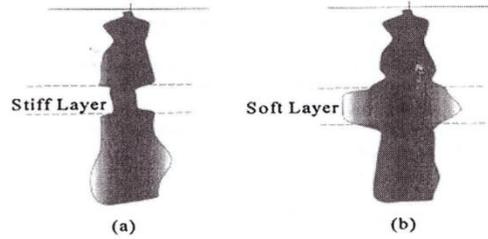
Figure 7. Effect of soil layering on column shape: (a) stiff layer leads to a reduced cross section (b) soft layer leads to enlargement (ASCE, 2010)
