Urgent Stabilization, Reconstruction and Reinforcement Solutions of High Retaining Walls in Lisbon

C. Fartaria

JETSj, Geotecnia Lda, Lisbon, Portugal

ABSTRACT: A partial collapse of a poor reinforced concrete retaining wall, built in 1955 and overcoming a 20m high slope, in February 2017, as well as the subsequent ground sliding, led to severe structural damage of the buildings located at its base. Considering both the precarious structural condition of the buildings, as well as the possible risk of the remaining retaining walls to collapse, there was an urgent need for the execution of a definitive solution that could re-establish the local and global stability of the retaining walls. The implemented solutions aimed to rebuild and to improve the confinement of the retaining walls, while increasing the local and global safety to static, hydrostatic and dynamic loads, as well as the reconstruction of the drainage systems. The works took place between March and August 2017, covering roughly 90m of retaining walls overall extension, simultaneously with the reconstruction of damaged buildings, including their structural reinforcement.

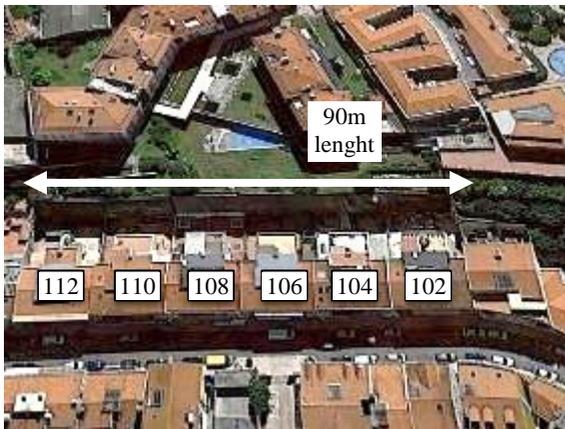
A set of lateral earth retaining walls located in Lisbon, dated from 1955 and with a height of about 20m, partially collapsed on February 27, 2017. An intervention took place comprising both earth retaining walls, covering almost 90m length, and its adjacent buildings, located at their bases, some of them also damaged (see Figure 1).

Figure 1. Aerial photograph of earth retaining walls

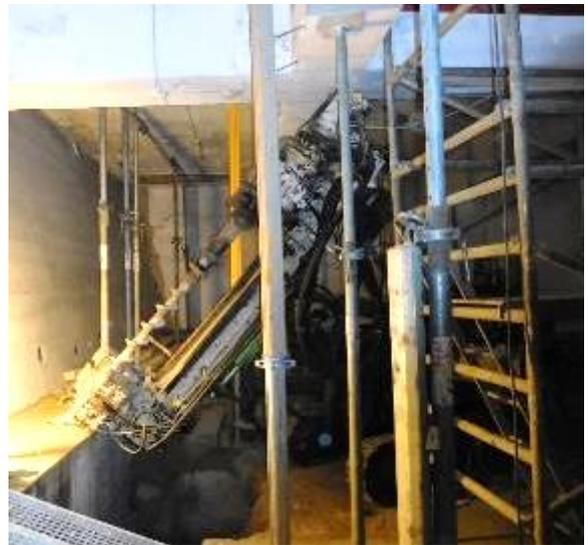
Due to lack of space and poor accessibility the tower crane was installed at the closest street, so all equipment and materials needed to be transported to the site through lifting above the buildings. These circumstances lead also to the use of small machinery equipment inside building's basements to remove of soil and debris and, also, the executions of ground anchors and micropiles (see Figure 9).

Figure 9. Micropile equipment inside building basement

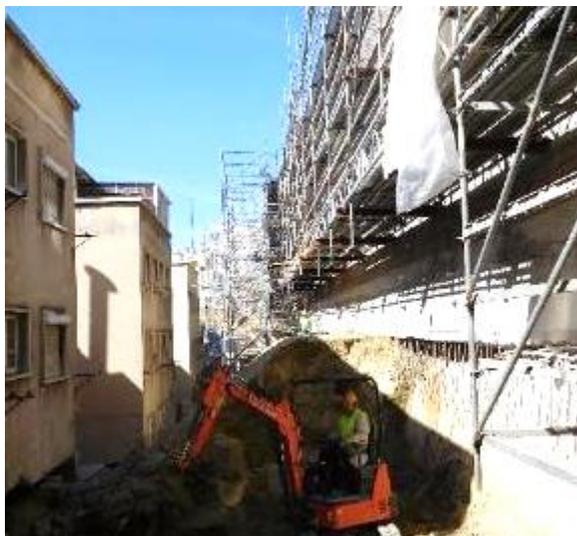
The use of climbing scaffolding on the central cantilever walls was crucial allowing two simultaneous work fronts: a) the upward reconstruction of the wall, the execution of soil nails and the filling with LWA; and b) the removal of the soil mass and debris resulting from the collapse and landslide and subsequent reinforcement of the remaining wall (see Figure 10).

Figure 10. Climbing scaffolding and works bellow

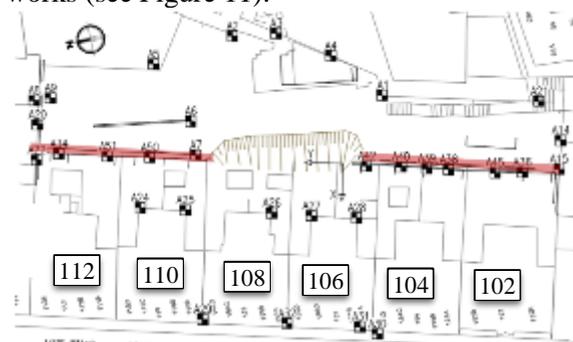
The monitoring was carried out using topographic targets, installed in the retaining walls and neighbouring buildings, aiming to measure eventual movements during the intervention works (see Figure 11).

Figure 11. Initial topographic target location on plan

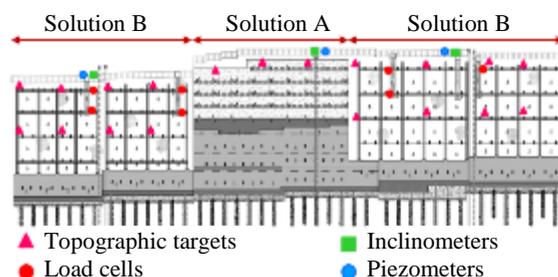
Regarding the post-construction instrumentation and monitoring plan its goal is the measure of the efficiency of the reinforcement and drainage solutions implemented during the service life of the retaining structure. The following devices were installed: topographic targets; ground anchor load cells; inclinometers and piezometers (see Figure 12).

Figure 12. Service life instrumentation and monitoring elevation view

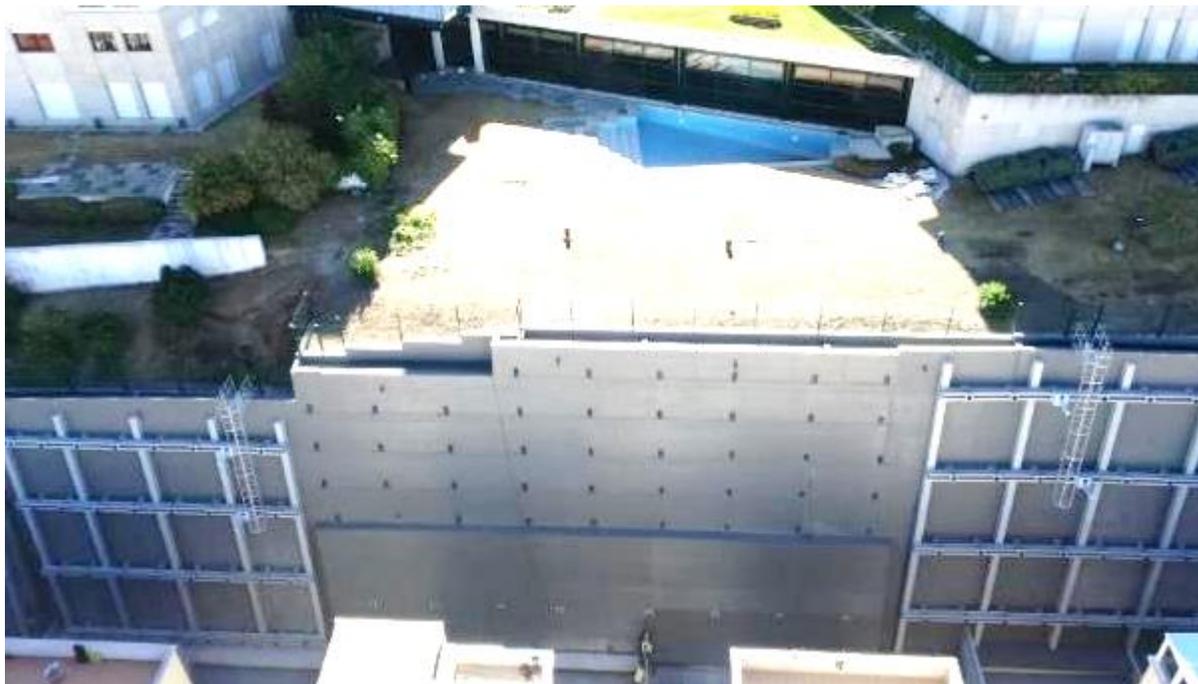
This paper aimed to present the solutions implemented as reconstruction, reinforcement and stabilization measures for urgent and definitive restore of the retaining structures safety conditions. Its design was naturally governed by the constructions conditions as well as by the imperative need of intervention, keeping in mind the aesthetics of the solution (see Figure 13).

Figure 13. View after final works

Although there is no evidence on presence of groundwater flows, the inflow of rainwater and water from other sources must be considered. Thus, the inspection and maintenance of the drainage systems must be assured in order to drain the eventual water which can eventually be accumulated behind the cantilever wall.
