# Failure of a massive geosynthetic-reinforced clay dyke for a waste disposal plant: investigation of the causes

P. Ruggeri

**ABSTRACT:** To increase the capacity of a waste disposal plant located in a hilly site in central Italy, a new 25 m high barrage has been built to bound a valley and create a new waste storage over the upstream area. To minimize environmental risks, a geosynthetic-reinforced clay dyke has been designed for the plant. Just after the completion of the works and before entering into operation, clear signs of instability appeared at the upstream side of the dyke. To prevent the growth of such mechanism the dyke was immediately re-profiled by lowering the crest. A thorough ground investigations and monitoring were carried out to understand the causes of the instability; three main causes have been identified: unfavorable local geological conditions; inhomogeneity of the foundation soil; development of high pore pressures in the dam and in the subsoil. This case history turned out to be again an example of the importance of details for design and construction of geotechnical works particularly if of great impact for the environment.

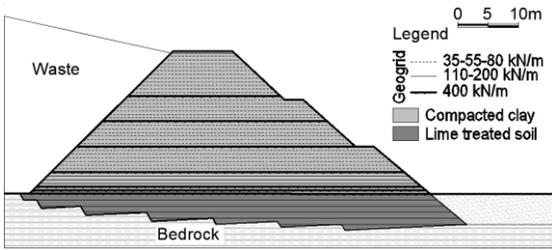
Figure 1. Typical cross section of the dyke

Besides environmental design, the main object of this paper is to examine the design of the large dyke that, enclosing the upstream area of the valley, produces a new storage volume for urban wastes. The earth embankment rises up to 23 m above the original ground profile. Including the 3 to 5 m deep excavation to reach the bedrock, its maximum height is about 25-26 m; a road along the crest completed the plant. Figure 1 shows the typical cross-section. The slope angle of the upstream face is  $45^\circ$ , while downstream the slope is  $40^\circ$ . Two berms are placed downstream, both 3 m wide. At the end of the construction, with the reshaping of the ground profile around the embankment, the maximum emerging height was about 23.5 m. In the zone of maximum height, the refill after excavation was made of soil improved with lime. The body of the dyke is made of a number of strata of

The International Standards (e.g. USBR: Design Standard n.13: embankment dams, 2012) all highlights how the stability of an earth fill in clay must rely on the effectiveness of the compaction of the soil. In the present case the tender specifications required that cohesive fill materials have to be compacted to at least the 90% of the maximum modified Proctor dry density with moisture content within 2% of optimum. Maximum allowed thickness of each level in the stratum to be compacted was of 0.2 m.
