The Designing of a Three-level Excavation Pit in Soft and Sensitive Clays in Oslo, Norway

Jure Kokosin

ABSTRACT: The aim of this paper is to present the solutions and construction of an excavation pit in Oslo city. However, the soil conditions are difficult since a thick layer of soft and sensitive clay is found quite shallow under the terrain. The excavation pit, the depth of which is between 3 and 8 meters, has three different base levels making the excavation and the deformation control even more challenging. A sheet pile wall around the whole construction site and in between the different base levels was designed. Potential large deformation of the sheet pile wall and the infrastructure behind was one of the main concerns during the design and the construction phase. In order to improve the stability of the excavation pit, the soil in front of the wall was reinforced by means of lime-cement piles. Furthermore, the wall was supported by struts connected to a reinforced concrete slab for the deepest part of the excavation. A comprehensive discussion of the result is made. The technical solution proved to be cost-effective and can be used in similar projects.

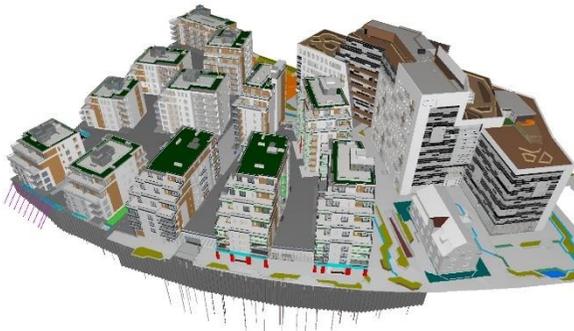
Figure 1. Model of a planned construction.

each, and one administrative building of 11 floors with a common basement on total area of 20.000 square meters (Figure 1). Sweco Norge AS has been responsible for the geotechnical design of the three-level excavation pit and the foundations; moreover we have been involved as the controller of the excavation work. The soil conditions are demanding considering the thick layer of soft and sensitive clay together with groundwater level quite shallow under the terrain. The present paper presents the construction solutions and procedures used in the excavation of the pit as well as the monitoring program with the pore pressure measurements and the displacement of targets installed on the retaining structures and the neighborhood infrastructure.

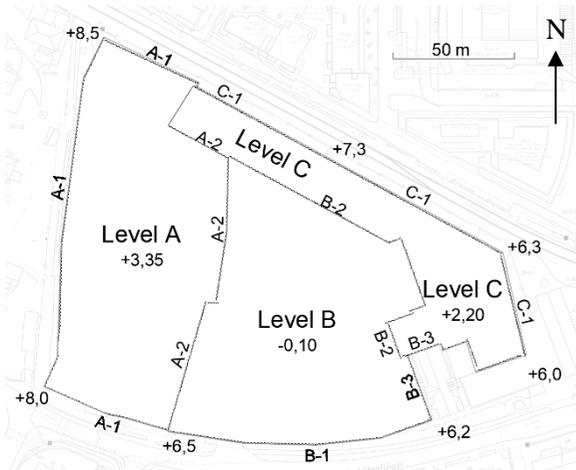
Figure 3. Overview base levels and sections sheet pile wall. Altitudes for the terrain behind sheet pile wall are presented.

The construction sequence depends on geotechnical conditions and construction progress schedule. However, conclusions on general excavations sequence have been made: Level C, Level A and Level B (Figure 3).

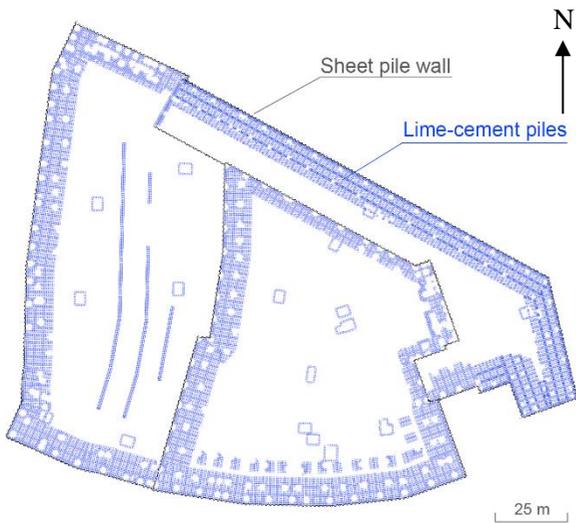
Figure 4. Phase 1; driving sheet pile walls in black colour and installation of lime-cement piles in blue colour.

Sheet pile wall and lime-cement piles were established around the area and also inside the area in order to divide different excavation levels (Figure 4).

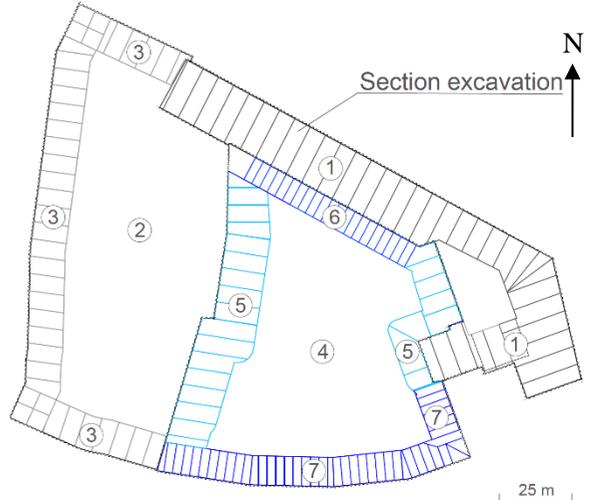
Figure 5. Phase 2; the sequence of section excavations. Note different size of sections.

The excavation started in the central area approximately 10-12 meters out from the sheet pile wall. After the excavation of the whole area, the concrete slab was established. Afterwards, concrete slab was established in the area. Section excavation to the sheet pile wall was done in 3-6 meters width and afterwards the concrete slab was immediately established. (Figure 5).

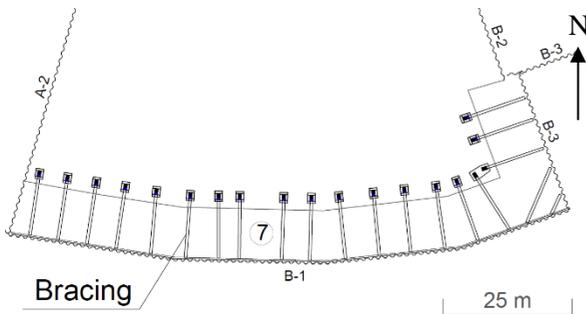
Figure 6. Phase 3; bracing with CHS steel-tubes on section B-1 and partially on section B-3.

A part of the south wall has excavation depth of 7 meters, and we used bracing of CHS steel-tubes. The bracings were prestressed with 400 kN. Section excavation to the sheet pile walls was done in 3 meters width and afterwards the concrete slab was immediately established. (Figure 6 and 7).

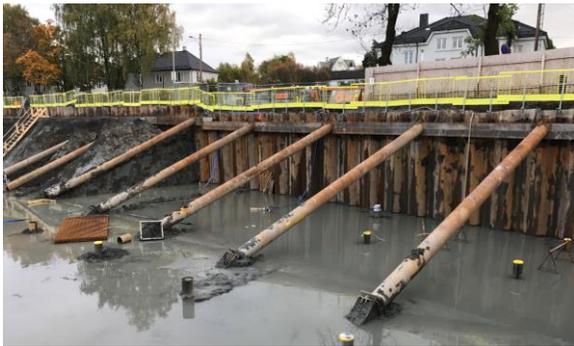
Figure 7. Bracing of sheet pile wall in section B-1. The concrete slab to the sheet pile wall is established on the right side. There is however sheet pile wall still supported by soil on a part of the section B-1 on the left side.

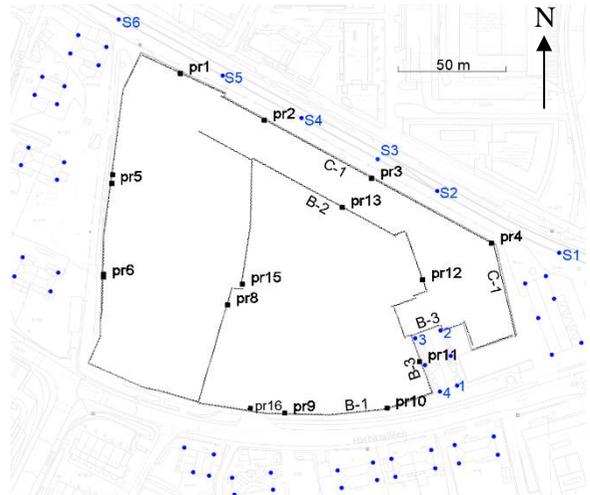
Figure 8. Locations of displacement targets on the sheet pile wall are presented by black squares and displacement targets on the structures are presented by blue circles.

The displacement targets were established on the following infrastructures (Figure 8):

- top and bottom of the sheet pile wall,
- corners of the neighborhood buildings
- tram line track

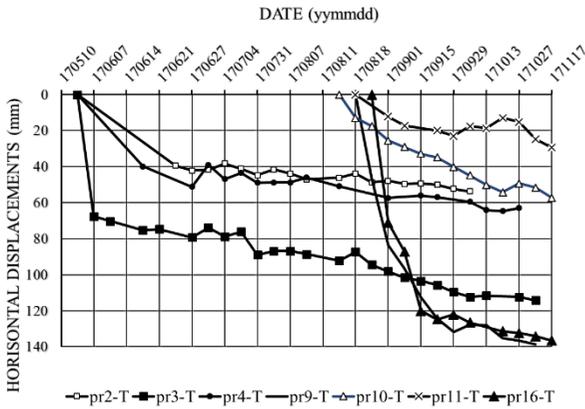
Figure 9. Horizontal displacements for targets installed on the top sheet pile wall for section C-1 (pr2-T, pr3-T, pr4-T), section B-1 (pr9-T, pr10-T, pr16-T) and B-3 (pr11-T).

This paper focuses on the monitoring of the displacements in excavation sections C-1, B-1 and B-3. The results of the horizontal displacements on targets installed on the top of the sheet pile wall are presented in Figure 9.

Displacements in the selected sections were the most extensive and have locally exceeded modeled values. As can be seen for section C-1, the initial horizontal displacement for pr3-T was particularly extensive in the beginning, which is associated with rather wide and imprecise opening of excavation sections towards sheet pile wall C-1. Apparently, measurements for pr2-t and pr4-T show that horizontal displacements have been significantly lower. Displacements for section C-1 in July 2017 are associated with the excavation of a central part of Level B and those in August 2017 are associated with section excavations toward the sheet pile wall section B-2. The horizontal displacements for pr9-T and pr16-T were however exceptionally high in the end of August 2017 and the beginning of September 2017, which is related to three extensive cases of leakage from the communal pipes along Harbitzalleen Street. Measurement results for pr10-T and pr11-T show that the displacements have been moderate even though the excavation depth is the same as by pr9-T and pr16-T. Evidently there is a lack of measurements for the section B-1 and B-3 between May and August 2017. This implies that the absolute displacements for targets installed on sheet pile sections B-1 and B-3 can be bigger. On the whole, the presented horizontal

displacements measured on the top of the sheet pile walls, followed the upper limit of displacements modeled in those cases where no irregularities were presented. A lack of measurement data is however not within the scope of this paper.

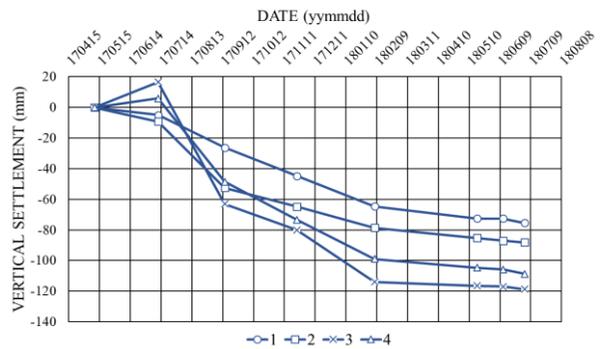
Figure 10. Vertical settlements for targets installed at the corners of the laboratory building. Look at the locations 1, 2, 3, 4 on Figure 8.

The impact of the sheet pile wall displacements was observed on the displacement targets installed on the neighborhood buildings and infrastructure. Vertical settlement of the old laboratory is presented in Figure 10 and vertical settlement of the tram-line track is presented in Figure 11.

The old laboratory has suffered the biggest settlements of all neighborhood buildings. The most significant settlements are observed in July and August 2017 when the Level B was excavated. However, settlements were being continued with significantly lower magnitude until February 2018. It may be assumed that the groundwater lowering has caused part of the settlements. The tram-line track has been monitored with 6 targets. The most settlements have undergone target S3 which was installed at the sheet pile wall C-1 beside the opening excavation section where some additional settlements were observed. It is apparent that the target measurements on the tram-line track are following the same pattern as for residential target measurements.

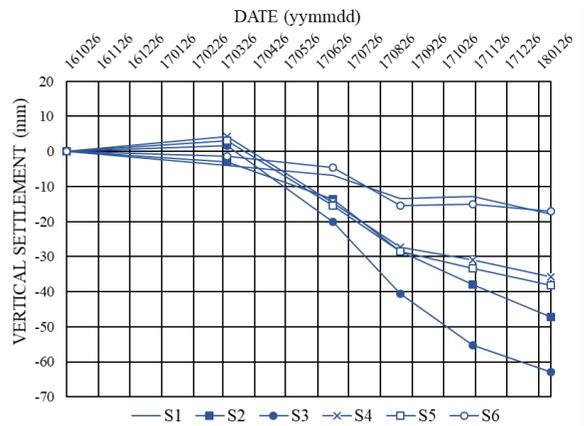
Figure 11. Vertical settlements for targets installed on the tram-line track. Look at the locations S1, S2, S3, S4, S5 and S6 on Figure 8.

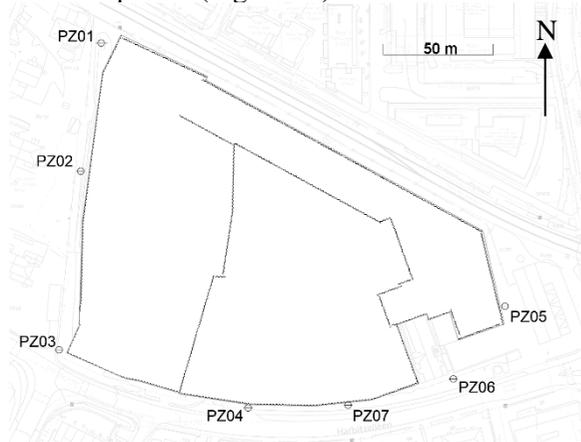
Figure 12. Locations of piezometers.

Totally seven piezometers have been monitored around the excavation before and during the excavation period (Figure 12).

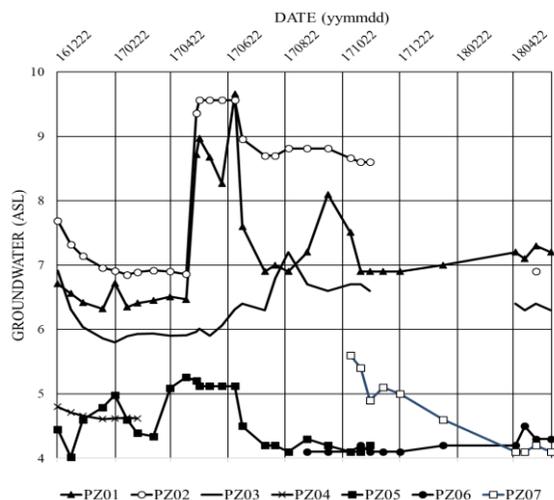
Figure 13. Observed groundwater level in meters above sea level (ASL) in a period from December 2016 to June 2018.

The registration of the groundwater level was on the regular basis registered manually every 2 weeks. The entire data has not been acquired due to difficult access to piezometers during building period. Furthermore, PZ04 was damaged and later replaced with PZ07. The results of the monitoring piezometers from December 2016 to June 2018 are presented in Figure 13.

Recently installed piezometers showed matching groundwater level with historical data before the building period. Changes in pore pressure were observed in the building period. Moreover, the changes are to some extent associated with excavations and installation of lime-cement piles nearby piezometers. Selected observation program has some limitations on quick groundwater changes, though in the long term the results seem to be valuable. The piezometers PZ01 and PZ02 are located on the NW where the terrain and the groundwater levels are the highest. Measurements indicate that the groundwater has been preserved on approximately the same level. The measurements for piezometers PZ05 and PZ07 show a drop of about 0,5 – 1 m in pore pressure which can be associated with excavation along B-1 and B-3. Due to excavation depth up to 8 meters, the pore pressure drop is considered to be small.
