Learning from recent destructive earthquakes in Iceland

Bjarni Bessason

Faculty of Civil and Environmental Engineering, University of Iceland, E-mail: bb@hi.is

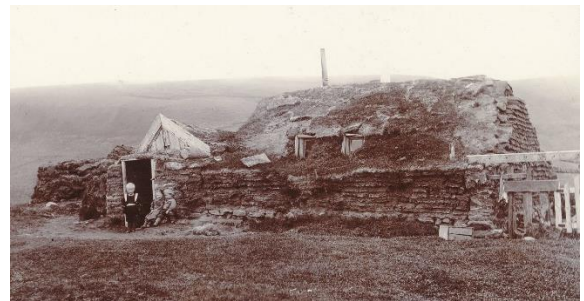
Figure 3: Turf and stone building from 1900.

dominated before 1900 AD (Fig. 3) and, although these houses collapsed, they were easily rebuilt and the losses were limited.

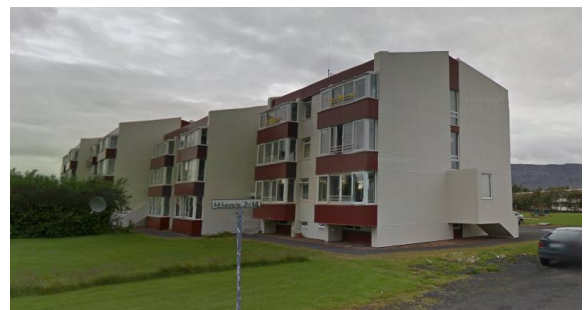
Figure 4: RC wall building from around 2000.

Construction of modern types of buildings started in the twentieth century, along with denser settlement (Fig. 4). In 2008, when the last destructive earthquake (Mw6.3) hit the area, the population was around 18,000. The great majority of the buildings have been built after 1940, though the oldest one is from around 1875.

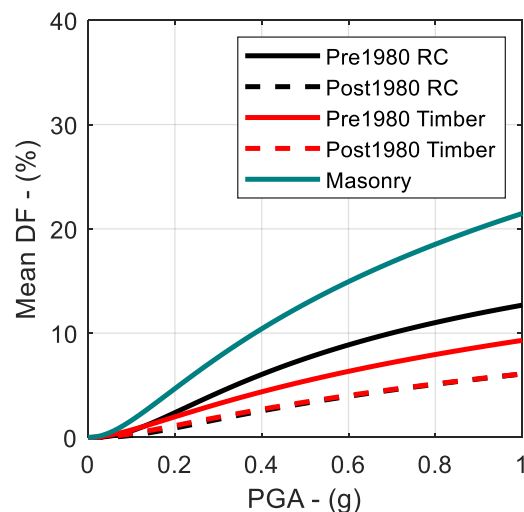
Figure 5: Empirical vulnerability curves for low-rise RC, timber and masonry residential buildings in Iceland. Pre-1980 are buildings built before 1980 and Post-1980 after 1980.

most vulnerable. This is reflected in vulnerability curves presented by Bessason and Bjarnason (2016) and Bessason and Rupakhety (2018) (Fig. 5). The damage factor, DF, on the vertical axis is defined as the ratio of estimated loss divided by replacement value. As an example, when the $PGA=0.4g$ the DF is close to 3% for both post-1980 (built after 1980), RC and timber buildings, whilst it is close to 10% for masonry buildings.
