# Application of soil mixing (CSM) in stiff clay for dike stabilization

**ABSTRACT:** Along one side of the river Scheldt (Belgium), several slope instabilities have occurred over the last decades. All instabilities are related to a stiff tertiary clay layer with a limited thickness (3m) and with very low residual strength characteristics. Due to the low strength, it is nearly impossible to restore the slopes with a natural gentle slope and stabilizing measures are required. One of the aspired techniques is to install transverse soil mix panels in the dikes to stabilize the slopes. An on-site test was performed to validate the possibility of improving the soil characteristics of the stiff clay by using the cutter soil mix (CSM) technique. It is well known that stiff clays are difficult to mix, therefore, different W/C ratios, mixing depths and mixing energies were used to optimize the results. An extensive set of laboratory tests was performed to quantify the obtained strength. Furthermore, 3D finite element calculations are performed to validate the stabilizing technique with the obtained soil mix characteristics. An overview will be given of the laboratory tests, as well as the

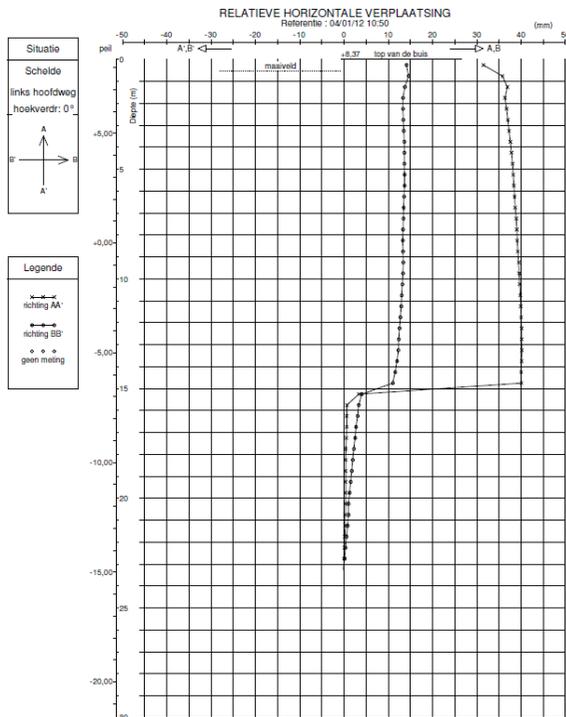
Figure 1. Example of inclinometer measurements within an instable area

Figure 1 shows inclinometer measurement within one of the largest instable areas, which demonstrates a horizontal displacement of 4 cm over a period of less than 1.5 year. The inclinometer measurements show a very localized displacement at the depth of the sliding surface. At

most locations, the displacement does not continuously occur in time, but rather in small steps, when high ground water tables and low tides in the river coincide.

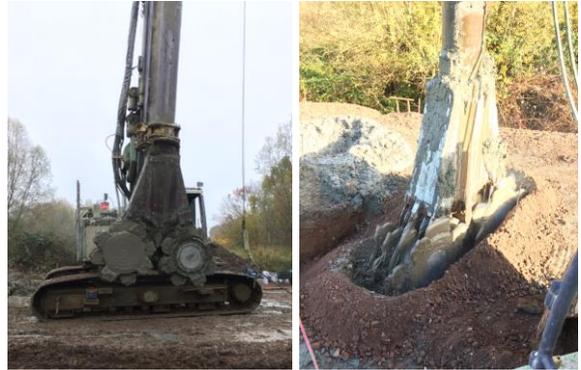
Four continuous shear walls, each made of three distinct panels, were executed, by the company Soetaert NV (Jan De Nul Group), with a CSM machine presenting two sets of counter rotating, vertically mounted cutter wheels. During the process, a water-cement slurry is injected, while the wheels cut the surrounding soil to form panels (see Figure 2). Different W/C ratios, mixing depths and mixing energies were used for the different panels, looking for the optimal result. For all panels, an amount of cement of 400 kg/m<sup>3</sup> was used (binder type Holcim® Dorodur H50). The details of the CSM panels are shown in Table 1. For each second panel, the rotary cutter made an extra up and down movement. On this specific site, below the tertiary clay layer lies a clayey sand layer. Above the tertiary clay layer, the soil varies between soft clayey material and sand.

Figure 2. CSM machine and cutter on the test site of Melle

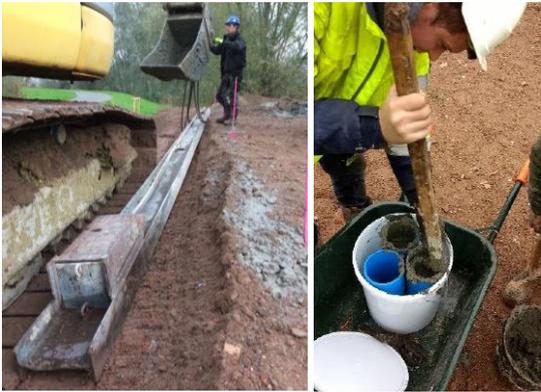
The wet grab samples were obtained by the use of a wet grab sampler, allowing to take samples over the height of the clay layer. Samples were composed by tamping material in PVC cylinders (see Figure 3).

Figure 3. Wet grab sampling

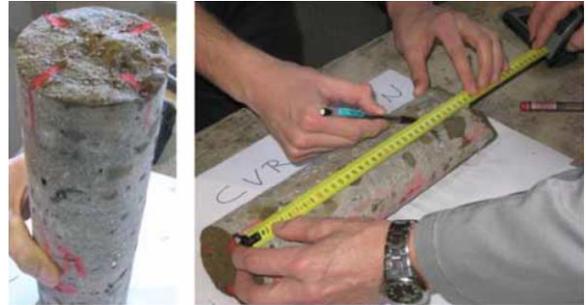
The drilled core samples were taken along the full height of the soil mix panel, but the lab tests were only performed over the height of the clay layer. The visual analysis, determining the percentage of unmixed soft soil inclusions was performed over the full length of the soil mix panel. This is performed by measuring the lengths of soft soil inclusions along 4 lines (applied every 90° around the core) and dividing the sum through the total length of the lines (see Figure 4).

Figure 4. determination of soft soil inclusions (BBRI/SBRCURnet, 2018)

A soil inclusion analysis was performed according to Denies et al. (2012) and the percentage of unmixed soft soil inclusions varies between 0 % and 18 % for the largest part of the cores. Some exceptions with percentages of inclusions larger than 20, 30 to 40 % were found, but they are probably due to the fact that the drilling was performed at the edge of the concerned panels and thus, the samples partly contain pure soil. Since the inclusions are local, it is assumed that this will not have an influence on the average strength along the sliding plane.

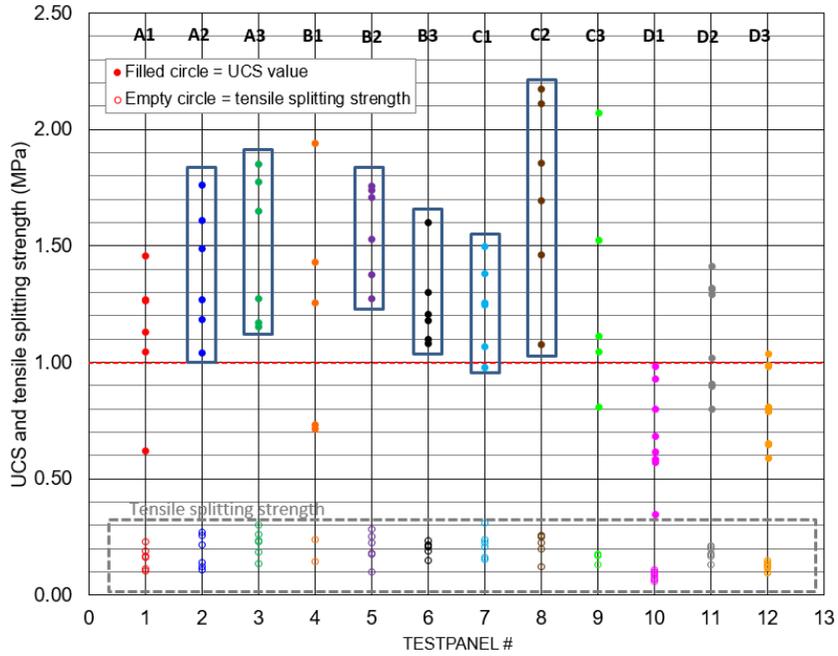
Figures 5 and 6 show compressive and tensile splitting strengths, respectively after 28 and 77 days. After 28 days, the unconfined compressive strength varies between 0.6 and 2.2Mpa, with most samples giving a strength larger than 1Mpa. After 77 days, the UCS varies between 1 and 2.85Mpa. The minimum tensile splitting strength is 0.1 MPa after 28 days and 0.15 MPa after 77 days. It is clear that the strength of shear wall D (with a W/C factor of 2) is much lower than the strength of the other walls. The results of this panel were not taken into account when deducing the strength parameters of the soil mix material for the calculations.

Figure 5. UCS and tensile splitting strength after 28 days

The following parameters were retained for the soil mix material in the calculations, based on the minimal obtained values in the laboratory tests after 28 days: UCS value of 742 kPa, tensile strength of 109 kPa, E-modulus of 1196 MPa.

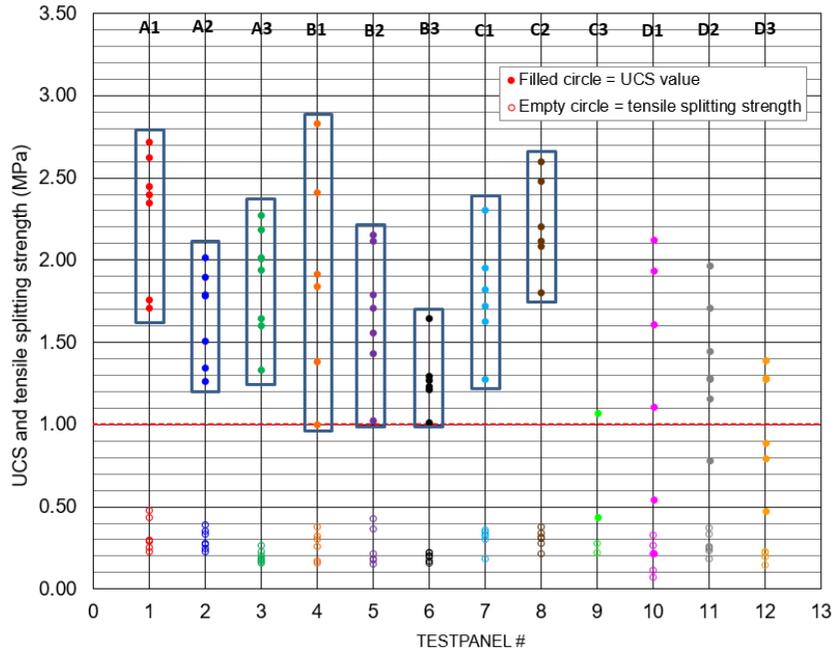
Figure 6. UCS and tensile splitting strength after 77 days

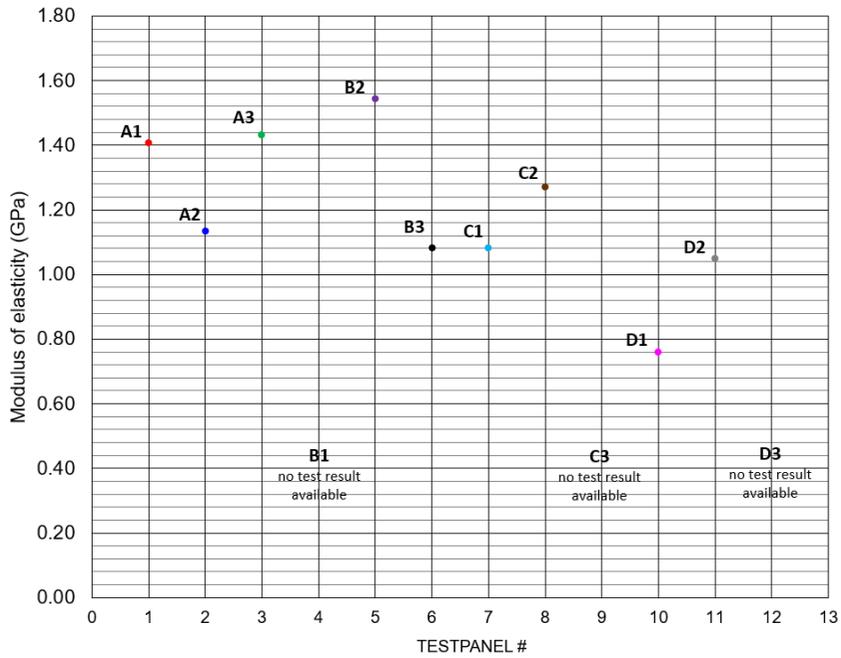
Figure 7 shows the modulus of elasticity after 28 days. Apart from the shear wall D, all E-values exceed 1.1GPa.

Figure 7. Modulus of elasticity after 28 days

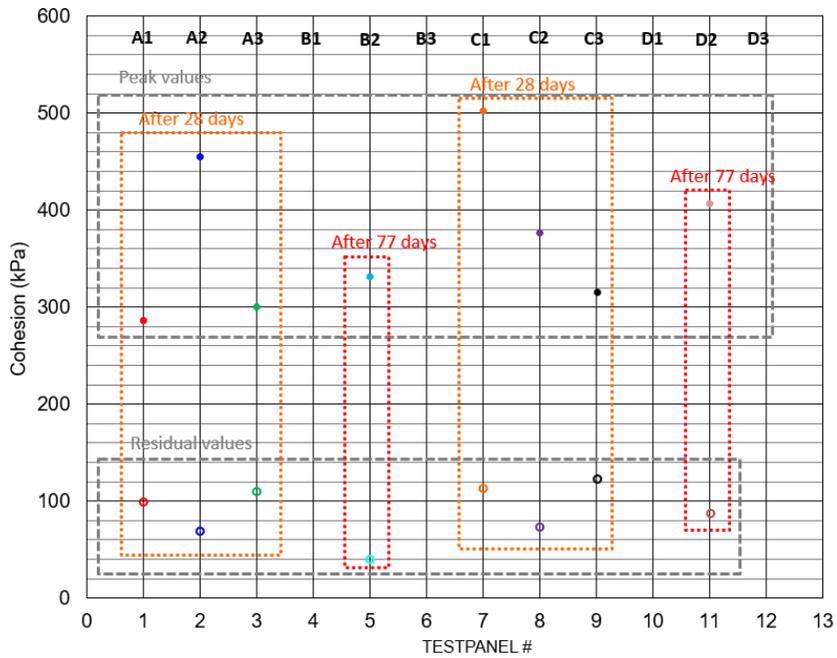
Figures 8 and 9 show the cohesion and the friction angle (both peak and residual values), based on the results of direct shear tests. The direct shear tests were performed on quite large samples of 100 mm diameter. Peak cohesion exceeds 280 kPa for all samples, residual values vary between 40 kPa and 120 kPa.

Figure 8. Cohesion, based on direct shear tests

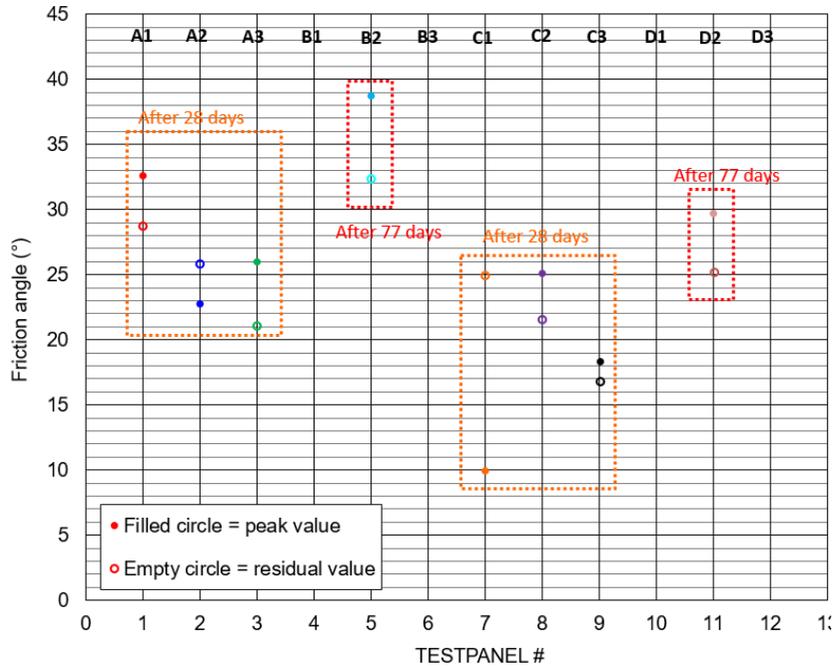
Figure 9. Friction angle, based on direct shear tests

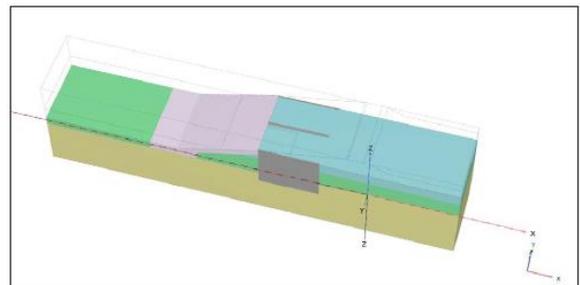
Based on the results of the on-site test, a 3D finite element model was built in Plaxis 3D (see Figure 10). A "slice" was modeled, with centrally one whole shear wall and at the edges two "half" walls. The required center to center distance of the shear walls to obtain a stable situation is 6 m. In order to obtain a stable temporary situation and

Figure 10. 3D finite element model in Plaxis

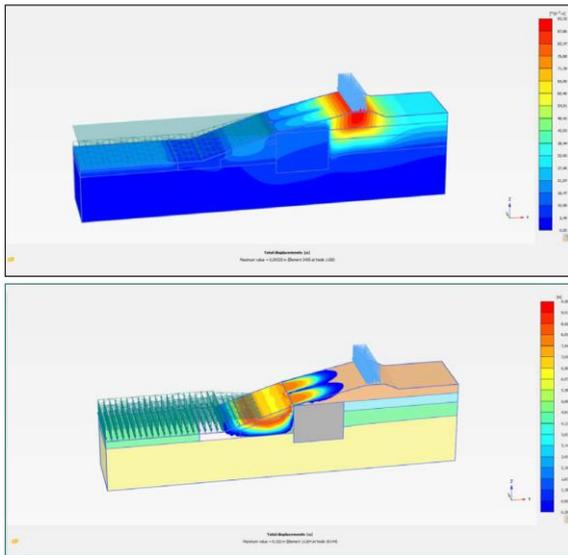
Figure 11 shows the displacements and the failure mode in the final stage (after levelling the dike to its original height). From the bottom figure, the arching phenomenon developing between the shear walls can clearly be seen.

Figure 11. Results of the 3D-FEM calculation: top: displacements in the final situation & bottom: failure mechanism
